RIVER DYNAMICS AND RESTORATION
DESIGN OF THE NAKHU KHOLA

A DISSERTATION

THE CENTRAL DEPARTMENT OF GEOLOGY
INSTITUTE OF SCIENCE AND TECHNOLOGY

NOVEMBER, 2010

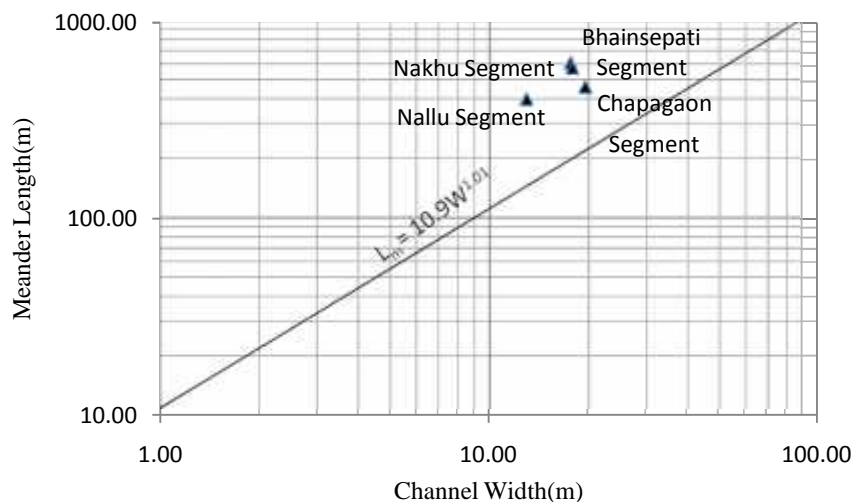
From the graph (Figure 9.1), the Meander Length Plotted against Channel Width, the Bhainsepati segment is plotted away from the predicted curve (Lepold and Wolman, 1960) indicate stream instability.

Figure 9.1: Meander geometry relations showing stability of the Nakhu Khola.

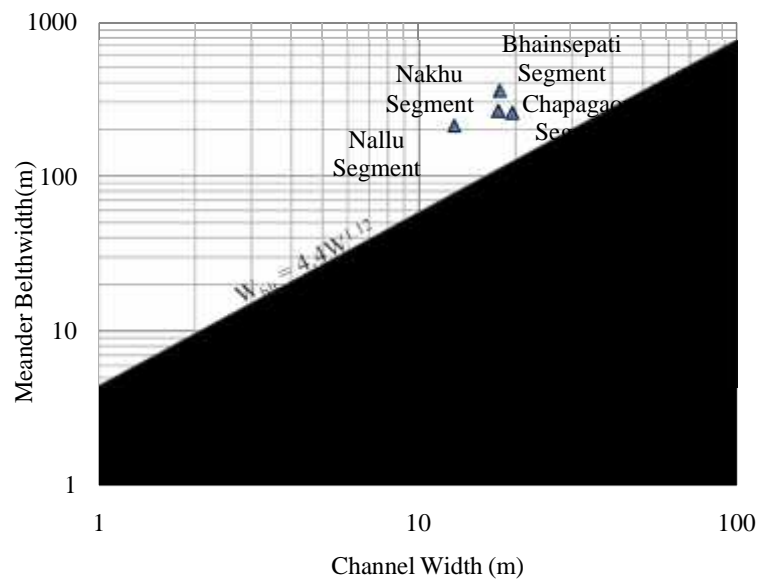
From the graph (Figur 9.2), the Meander Belth Width plotted against Channel Width, the Bhainsepati segment is plotted away from the predicted curve (Lepold and Wolman, 1960) indicate stream instability.

Figure 9.2: Meander geometry relations showing stability of the Nakhu Khola.

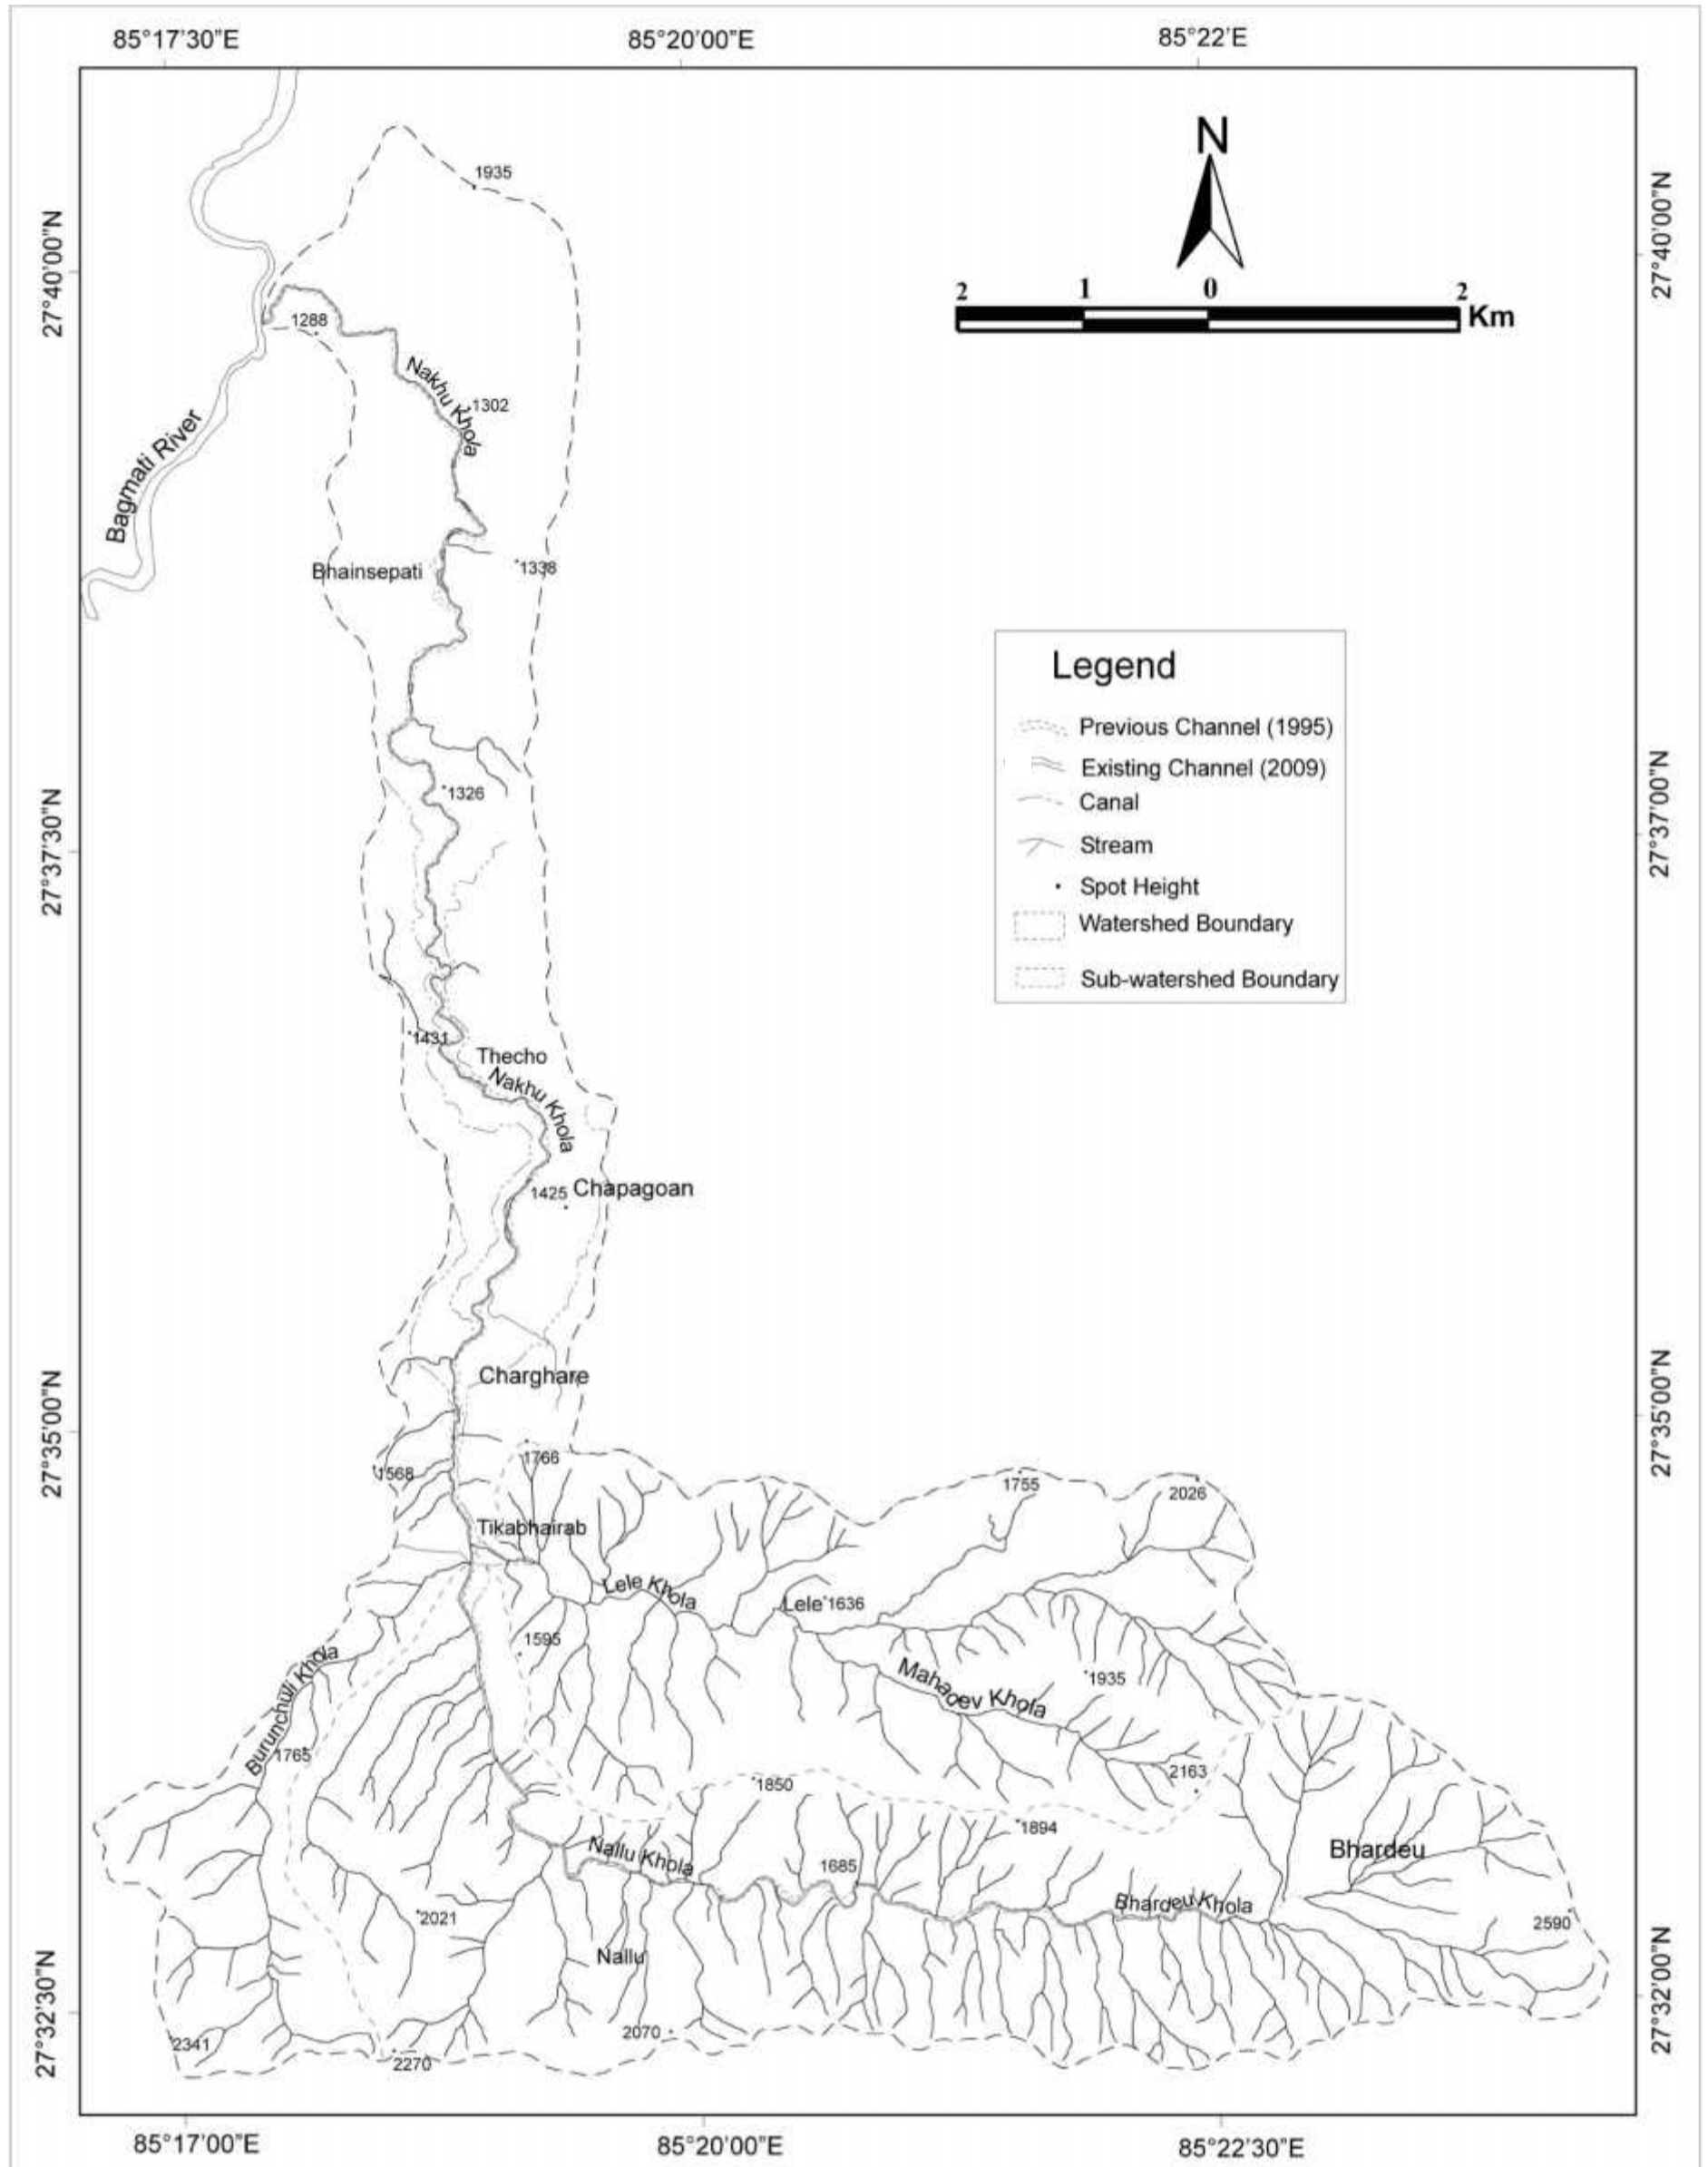
The channel shifting of the Nakhu Khola is not only caused by vegetation and high flow but also caused by neotectonic activities. Two major fault; Danwargoan fault running SW-NE and Chandragiri fault running NW- SE and other minor faults at southern part of basin developed during upliftment of Mahabharat Range; lies in the watershed. Sharp bending of the Nallu Khola at the Nallu village is due to these faults.

Figure 9.3: Channel modification map of the Nakhu Khola

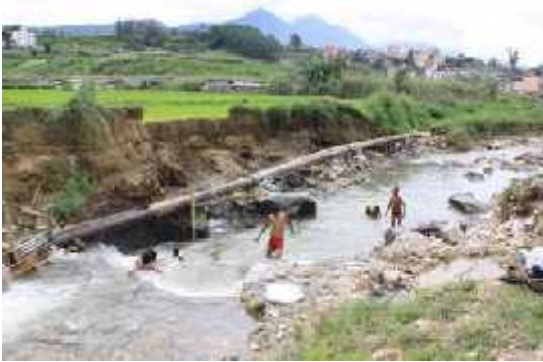
Figure 9.4: Scour of the river near water intake site at Nakhu Bazar

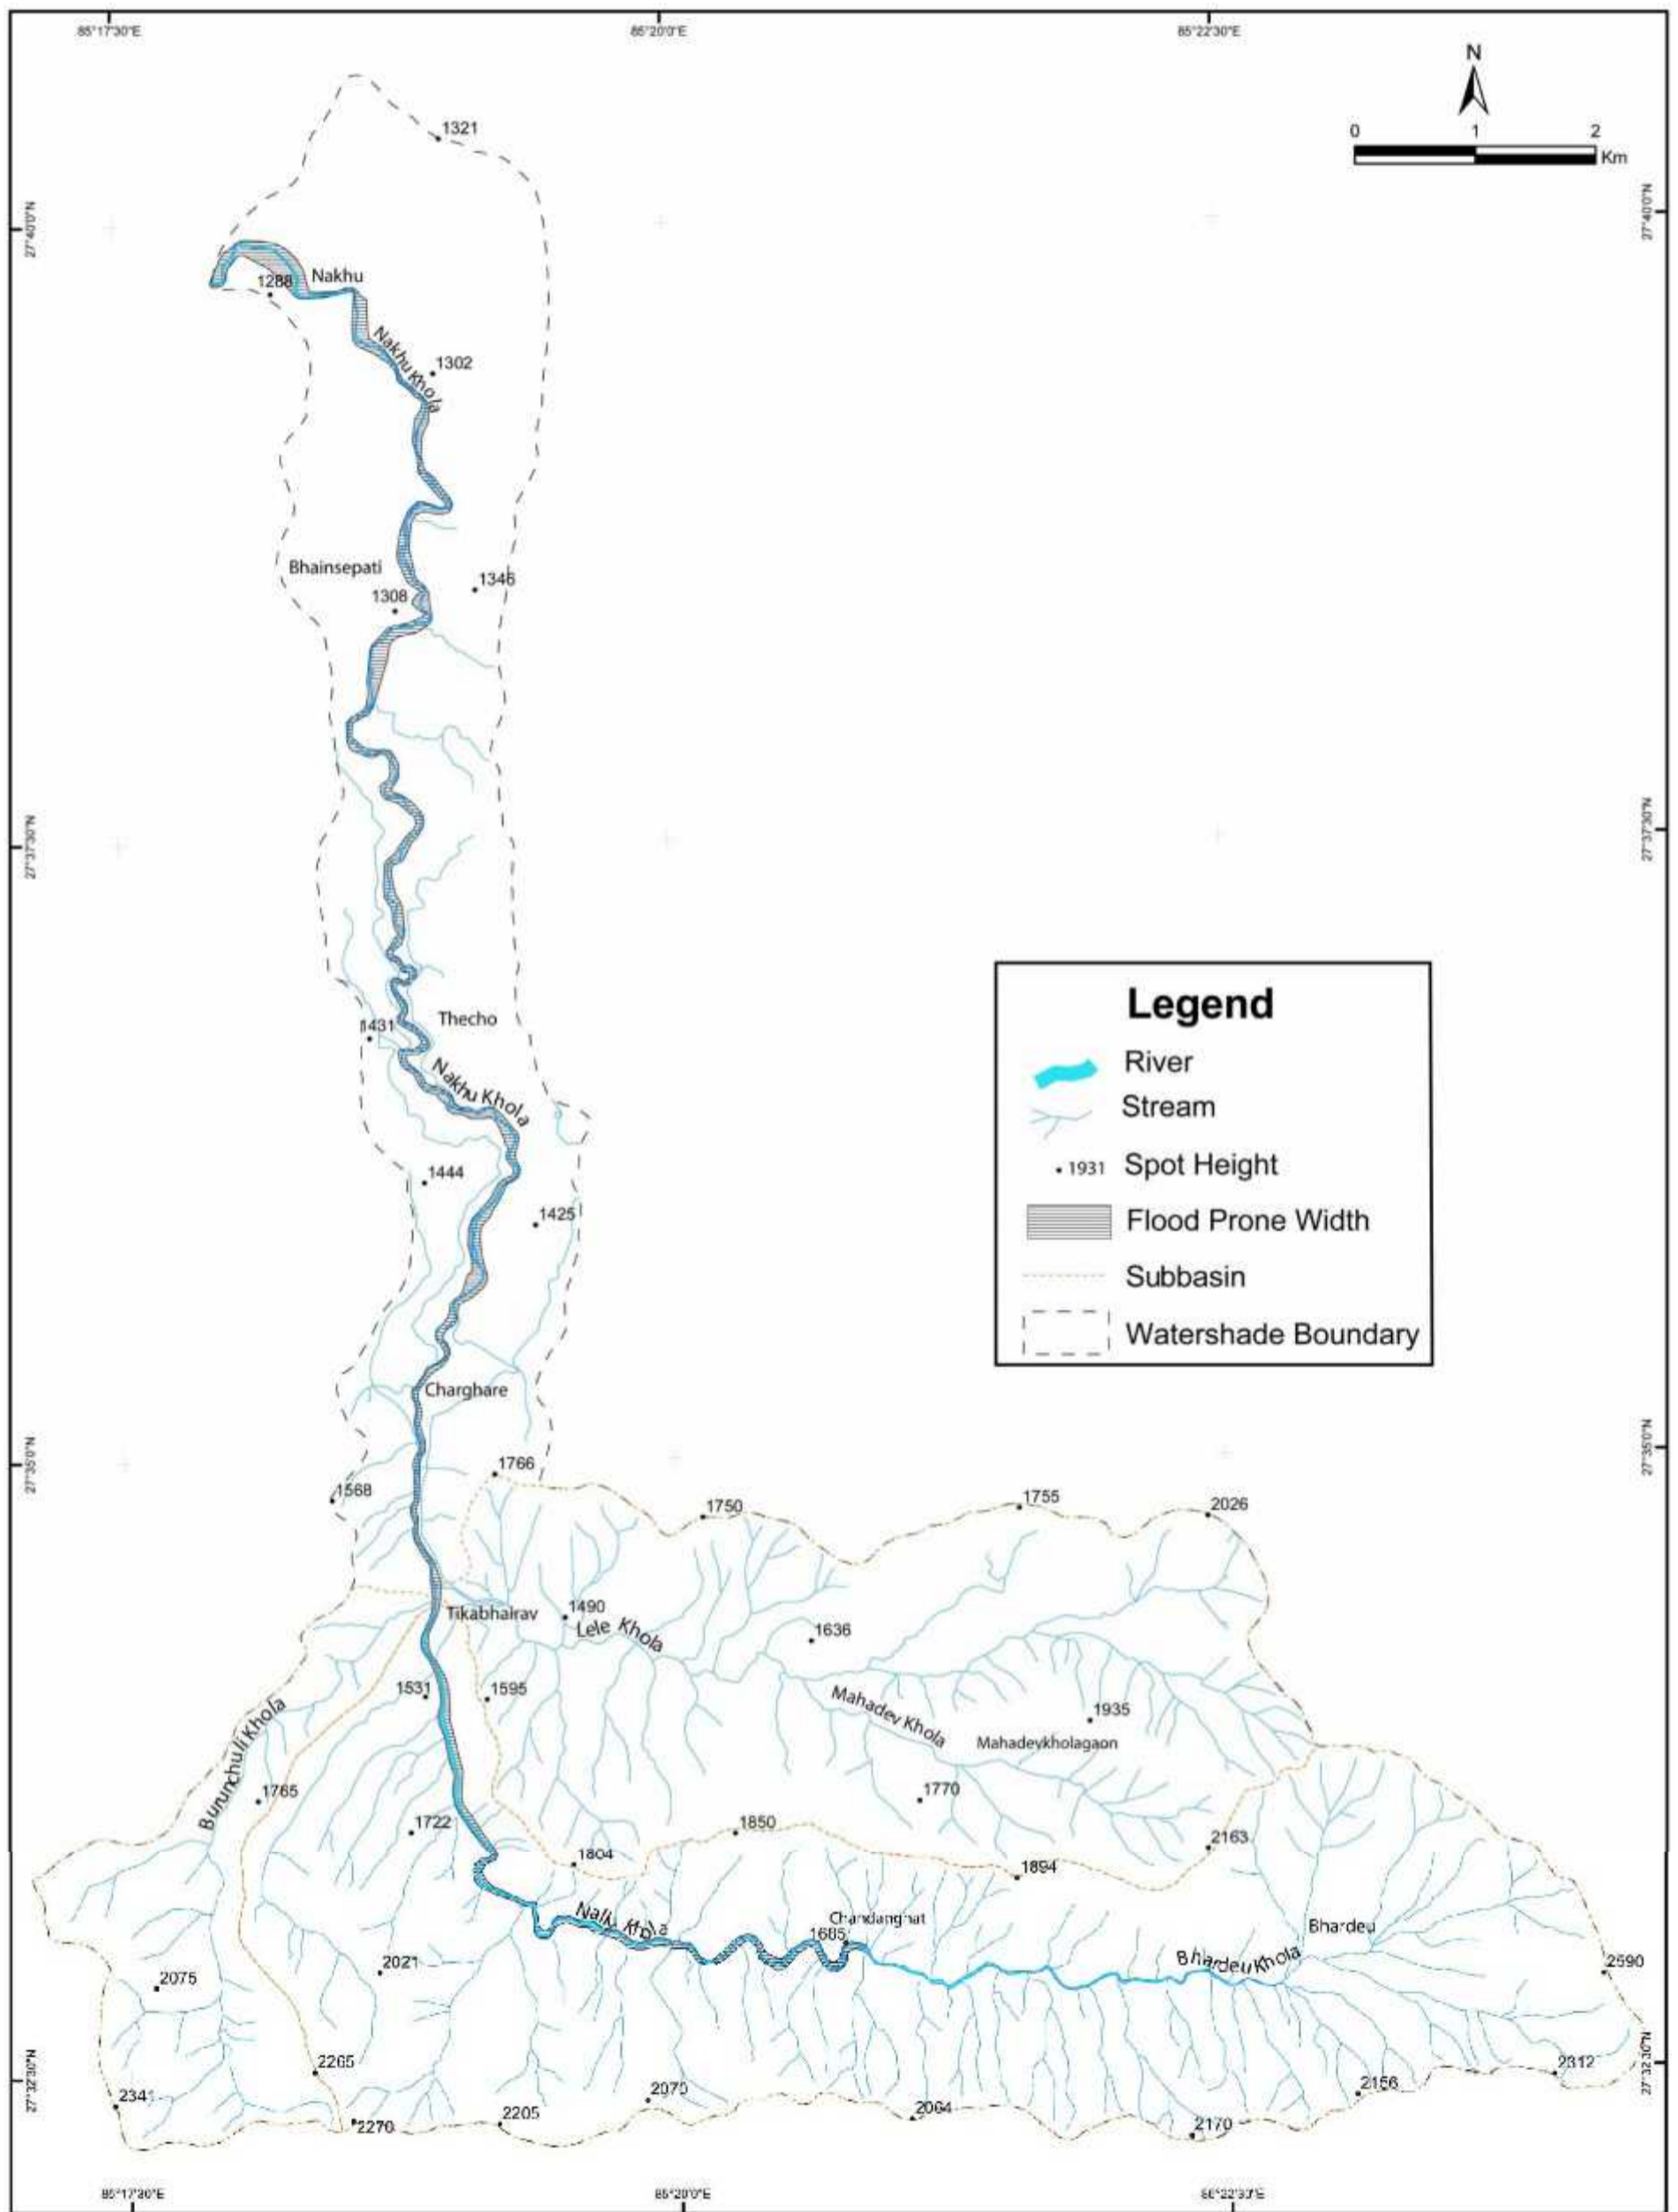
flooding during 1981 A.D killed 70 people and destroyed huge property (P.C.L. Rajbhandari, 1981). Most of the flood plains of the Nakhu Khola is used for settlement and cultivation, which can bring huge loss during flooding. Unplanned settlement, cultivation and other activities in the flood prone zone should be stopped or other preventive measures should be implemented.

Figure 9.10 : Flood prone area map of the Nakhu Khola from the confluence of the Nakhu Khola with the Bagmati River

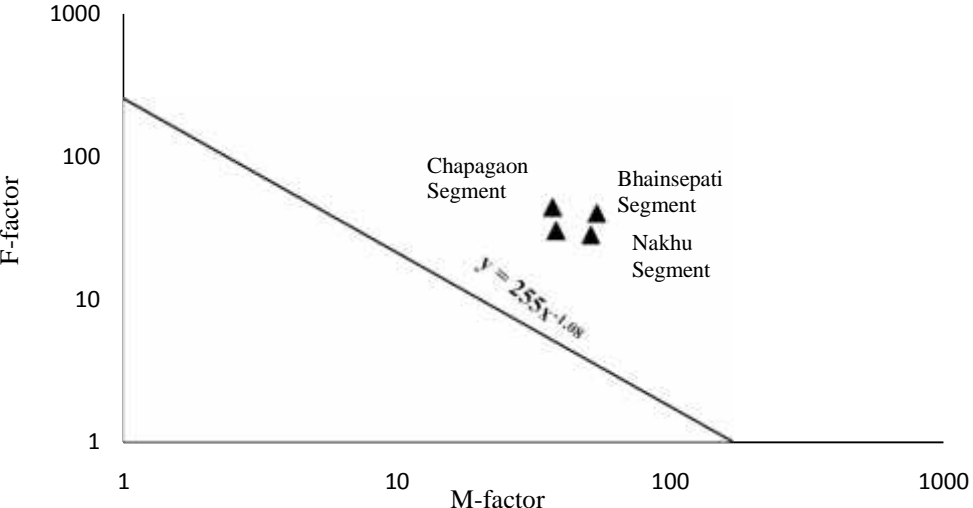
The plot shows that all four segments of the Nakhu Khola are in aggradation condition. Excessive sediment input at upstream segment from quarry site and high bank erosion might be cause of agragation in the Nakhu Khola.

Figure 9.1: Schummis (1963) F-factor versus M-factor plot

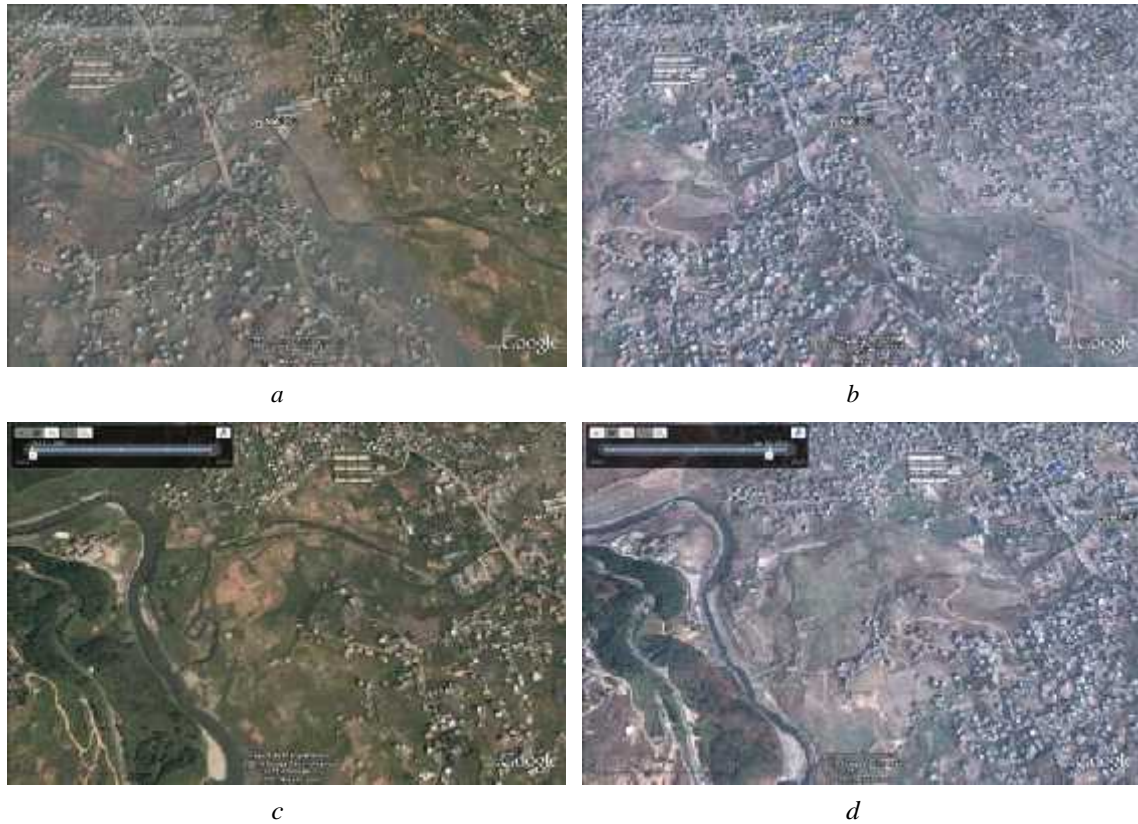
Figure 10.5 : Landuse change at (a) and (b) Nakhu bazaar area (2004 and 2010) and (c) and (d) near confluence of the Bagmati and Nakhu River (2003 and 2010)

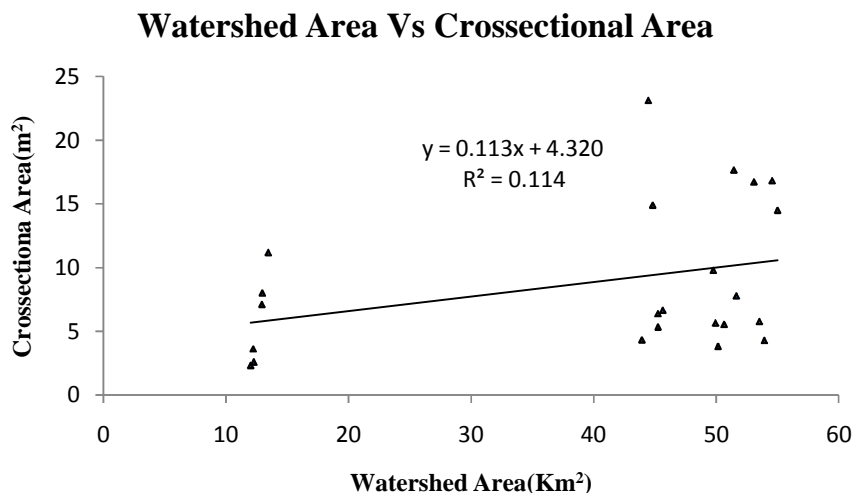
A natural channel with no any disturbance generally has positive correlation between crosssectional area and watershed area. Crosssectional area of river increases with increase in watershed area. But this relation may or may not hold true for human influenced channel. Nakhu Khola is very much impaired due to human activities which are also shown by Figure 10.8 clearly shows that crosssectional area does not have good correlation with watershed area. Most of the Nakhu Khola segments are channelized and modified for different purposes. Therefore hydraulic geometry relationship shows that the Nakhu Khola is impaired and degraded and human activities are one of the causes.

Figure 10.8: Graph showing crosssectional area versus watershed area
