**THESIS NO.: 080/MsCoM/001**

**A Comparative Study of Facade Guideline Compliance and Construction  
Management Issues in Residential Buildings within Heritage Zones of Bhaktapur  
and Patan**

**SUBMITTED TO THE DEPARTMENT OF CIVIL ENGINEERING  
IN PARTIAL FULFILLMENT OF THE REQUIREMENTS FOR THE  
DEGREE OF MASTER IN CONSTRUCTION MANAGEMENT**

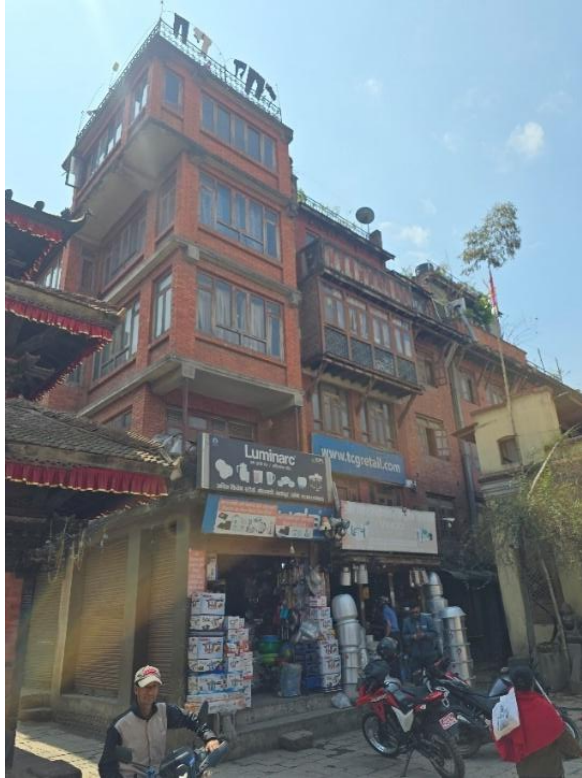
The two buildings classified as Non-Compliant BKT-09 in Golmadi, Bhaktapur (Picture 3) and PTN-20 in Tichhu Galli, Patan (Picture 4) both scored 47.6%, the lowest in their respective cities. Both buildings exhibited flat concrete rooftops, aluminium window frames, metal rolling shutters on the ground floor, painted or plastered exterior walls, and storey counts exceeding the permitted maximum. These buildings illustrate how comprehensively a building within a designated heritage zone can depart from the guidelines when effective enforcement is absent at the individual building level (Maharjan, 2019) (Subedi & Shrestha, 2023)

*Picture 3 Least compliant buildings - BKT-09, Golmadi, Bhaktapur*

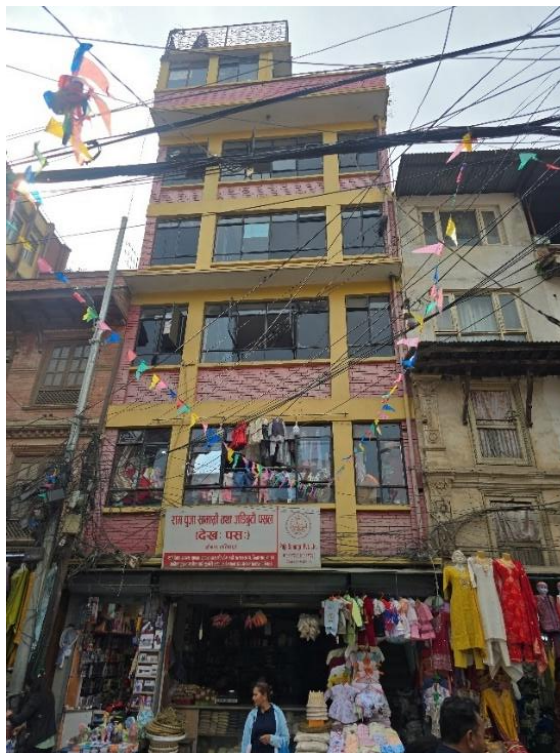
*Picture 4 Least compliant buildings - PTN-20, Tichhu Galli, Patan*

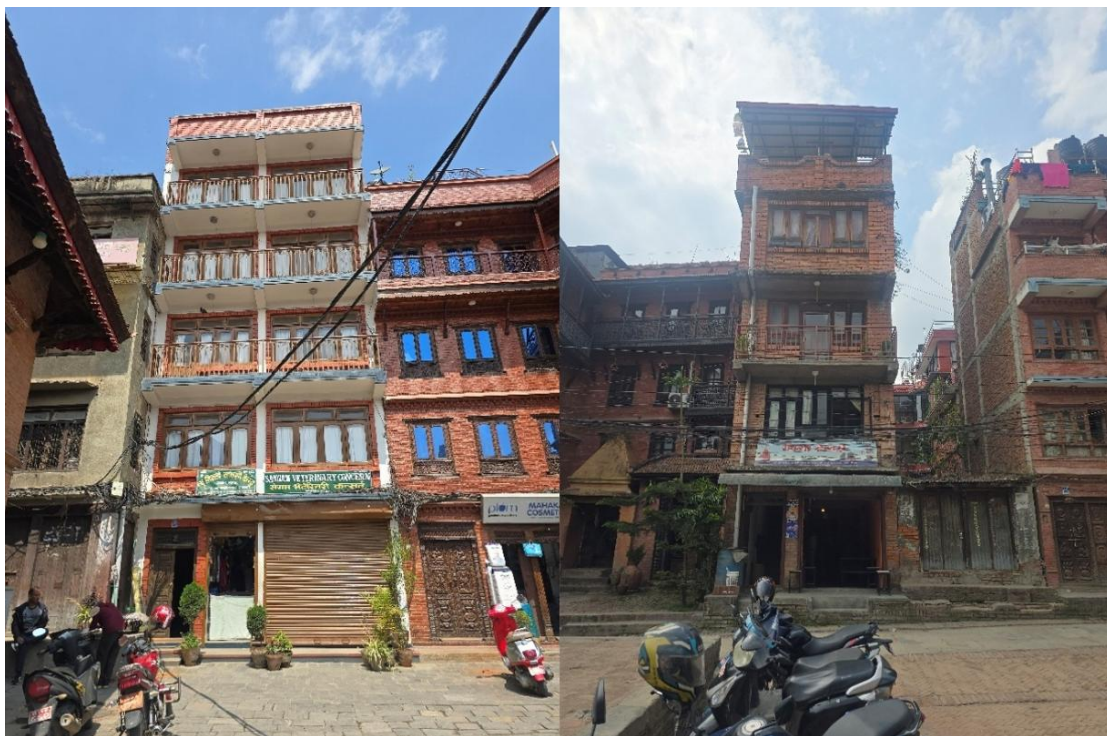
The two elements with the lowest compliance rates in both cities are the prohibition on visible metal rolling shutters and the requirement for a traditional sloped clay tile roof. Rolling shutter non-compliance was recorded on 60.0% of Bhaktapur buildings and 50.0% of Patan buildings, making it the single most widespread violation in both cities. Metal rolling shutters are found almost exclusively on ground floor shopfronts, where building owners prioritize security and ease of operation over compliance with heritage design standards. All three regulatory sources explicitly prohibit visible metal rolling shutters on heritage facades and require wooden doors or shutters to be used instead. This finding aligns with (Maharjan, 2019), who identified the prioritization of practical daily needs over heritage compliance as a primary driver of non-compliance in all three Durbar Square areas.

Picture 5 Examples of Non-compliance (rolling shutter violations)

f. Introduce a graduated response framework for non-compliant buildings A tiered remediation system should be established rather than relying on punitive enforcement alone. Excess storeys should be screened using traditional parapet forms at next renovation. Buildings with rolling shutters should be offered a subsidized wooden facade panel as a condition of future permit approval. Flat rooftops should be eligible for a phased Jhingati tile conversion scheme with municipal technical support. Practical, staged remediation tied to the renovation cycle is more likely to achieve lasting improvement than enforcement action alone.

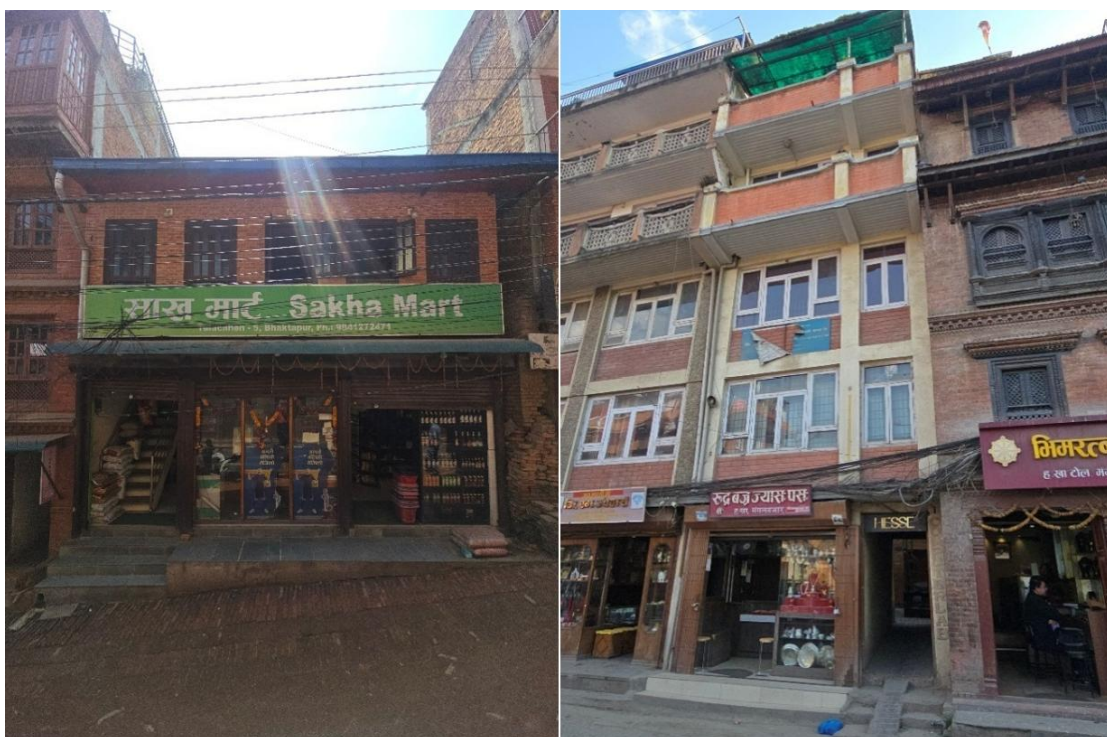
The traditional sloped clay tile roof was absent - replaced by a flat concrete rooftop - in 55.0% of Bhaktapur buildings and 37.5% of Patan buildings. This finding is consistent with (Shrestha, 2021), who identified the *Jhingati* tile roof as one of the costliest elements to construct or restore traditionally, and documented that many building owners opt for flat concrete rooftops as a cheaper, lower-maintenance alternative. The higher rate of flat rooftops in Bhaktapur compared to Patan is consistent with the overall pattern of weaker compliance in Bhaktapur's outer areas, where enforcement pressure is lower.

Picture 6 Examples of Non-compliance (flat rooftop violations)

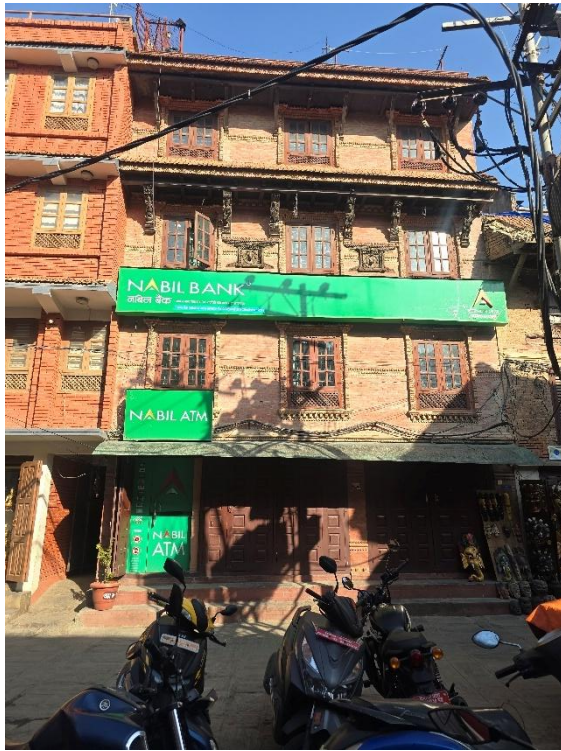
**PTN-20** Tichhu Galli

| ID | Neighborhood | Score/21 | Score % | Category | Storeys | Roof | Shutters | Key violations |
|---|---|---|---|---|---|---|---|---|
| PTN-20 | Tichhu Galli | 10 | 47.6 | Non-compliant | 5 | Flat | Yes | Multiple violations |
