THESIS NO. PUL079MSGtE003

**Stability Analysis and Mitigation Design of Excavated Slope Failure: A Case**  
**Study of Tuin Khola Landslide**

SUBMITTED TO THE DEPARTMENT OF CIVIL ENGINEERING  
IN PARTIAL FULFILLMENT OF THE REQUIREMENTS FOR THE  
DEGREE OF MASTER OF SCIENCE IN  
GEOTECHNICAL ENGINEERING

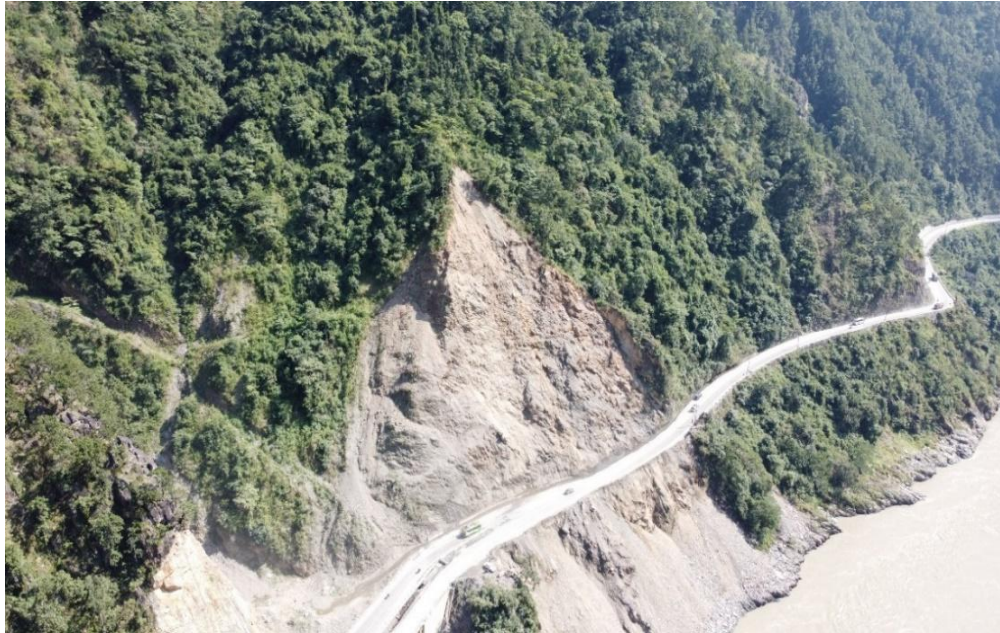
*Figure 1-1: Aerial view of after landslide after landslide.*

The specific landslide visible in the figure is a form of rock slope failure often exacerbated by the road-widening cuts that expose these unstable geological structures.

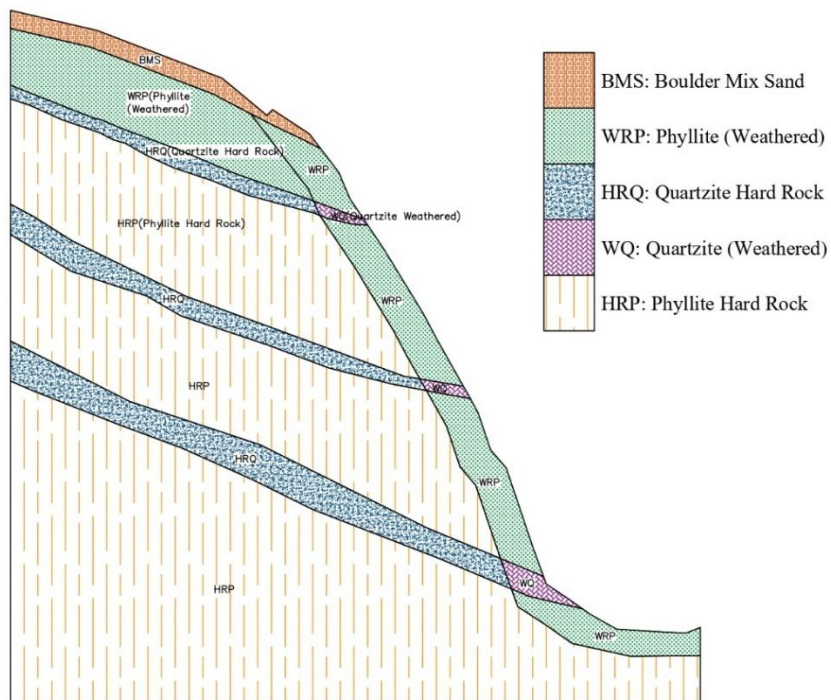
*Figure 1-2: Slope characteristic of the proposed study area.*

The Tuin Khola bridge area is known for its susceptibility to frequent rainfall-induced landslides, a result of the fragile geology of the Himalayas, which has been worsened by infrastructure development such as road construction. Local terrain comprises highly-jointed, fractured, and weak metamorphic rocks such as schist, phyllite, and quartzite. During heavy monsoon rainfall, these formations get saturated, which increases pore-water pressure in them and drastically reduces their stability (Xudong et al. 2025). Construction efforts for the NM road involved cutting into such steep and unstable hillsides. The current 60-meter arch bridge opened traffic in late 2024 or early 2025 and replaced an earlier one in a spot where widening of the road has created a new, expansive zone susceptible to landslide failure, now originating higher up the slope. The map shows the landslide area with the existing road (Figure 1-1), RCC cladding wall previously constructed. The rock outcrop and colluvium deposits were observed in all of slide's upslope to the road.

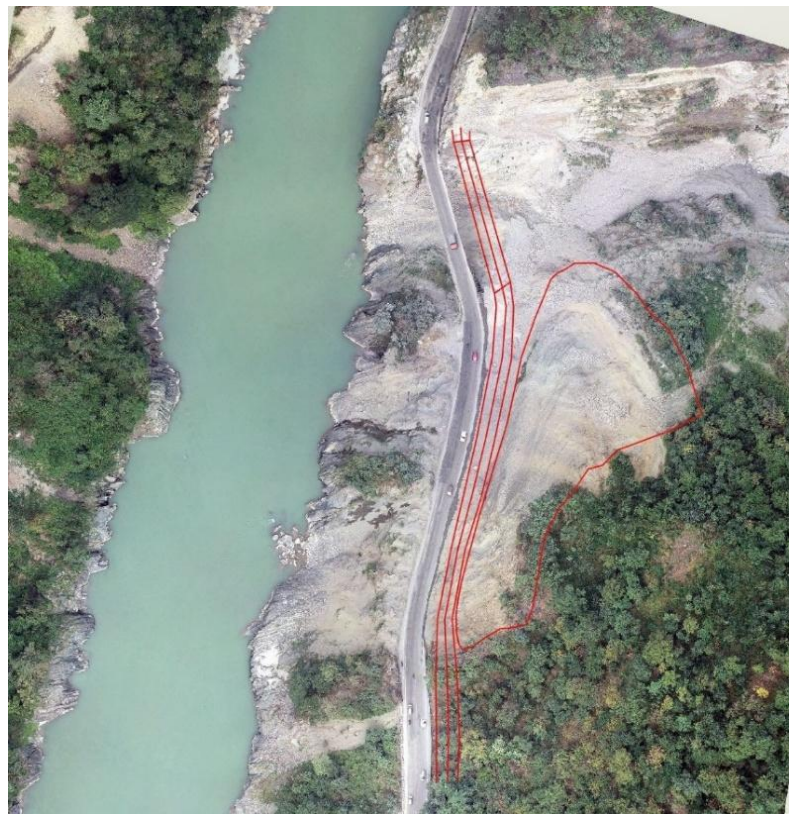
*Figure 1-3: failure plane and geometry of the landslide.*

The study place is located at 1 km from Mugling Bazar towards the southern side near Tuin khola, NM road section. The co-ordinates of this particular area is 27.842978, 84.558697. This aerial view site is shown in figure 1-3.

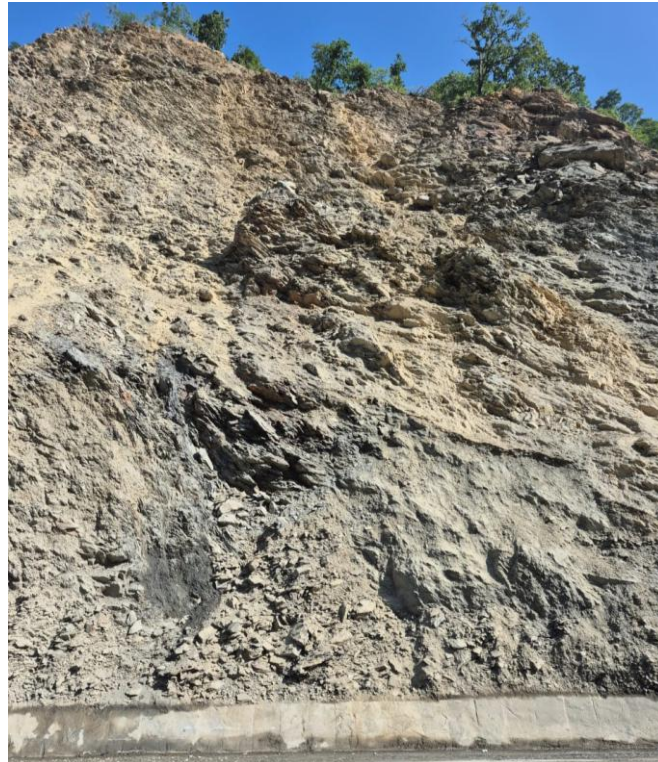
*Figure 1-5: View of slope material of roadside cut slope.*

The widening of the NM road, has severely destabilized naturally fragile, weak, and highly fractured hillsides. The lower section of the slope comprises competent rock beds, while the upper section consists primarily of colluvial soil deposits, which are loose and cohesion less. It is highly probable that the movement was caused by a combination of the slope's heterogeneous material, the erosion of toe support, and high pore-water pressure from rainfall. Given these complexities, a detailed site investigation is essential to pinpoint the primary drivers of this instability. The complex terrain highlights the need for innovative design and robust mitigation strategies to sustain the highway's functionality and ensure safe travel for its users.

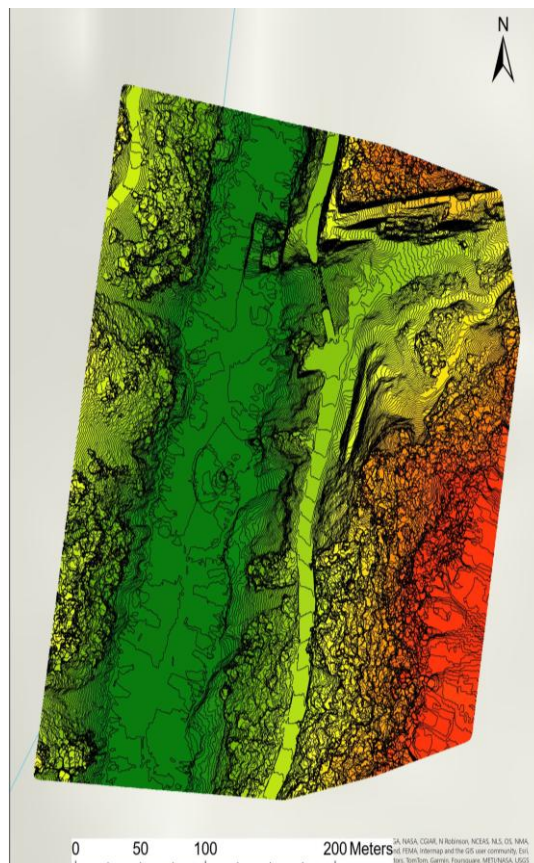
Figure 3-4: Digital elevation model of tuin khola area.

In reference to Figure 3-4, the slope morphology shows a clear contrast between the right and left banks of the Tuin Khola section. The right bank (red-orange zone) is characterized by very steep slopes with dense contour spacing, indicating a high gradient terrain composed of exposed or highly weathered rock. This area is highly susceptible to instability and is identified as a landslide-prone zone, with significant potential for rockfall and debris flow initiation. In contrast, the left bank (green-yellow zone) exhibits relatively gentler slopes with wider contour spacing, suggesting lower gradient conditions and comparatively higher stability. The elevation gradually increases outward on both sides of the channel; however, the left bank terrain appears more stable, possibly underlain by weaker but more uniform lithology such as phyllite or schist, which is commonly found in the hill regions of Nepal.

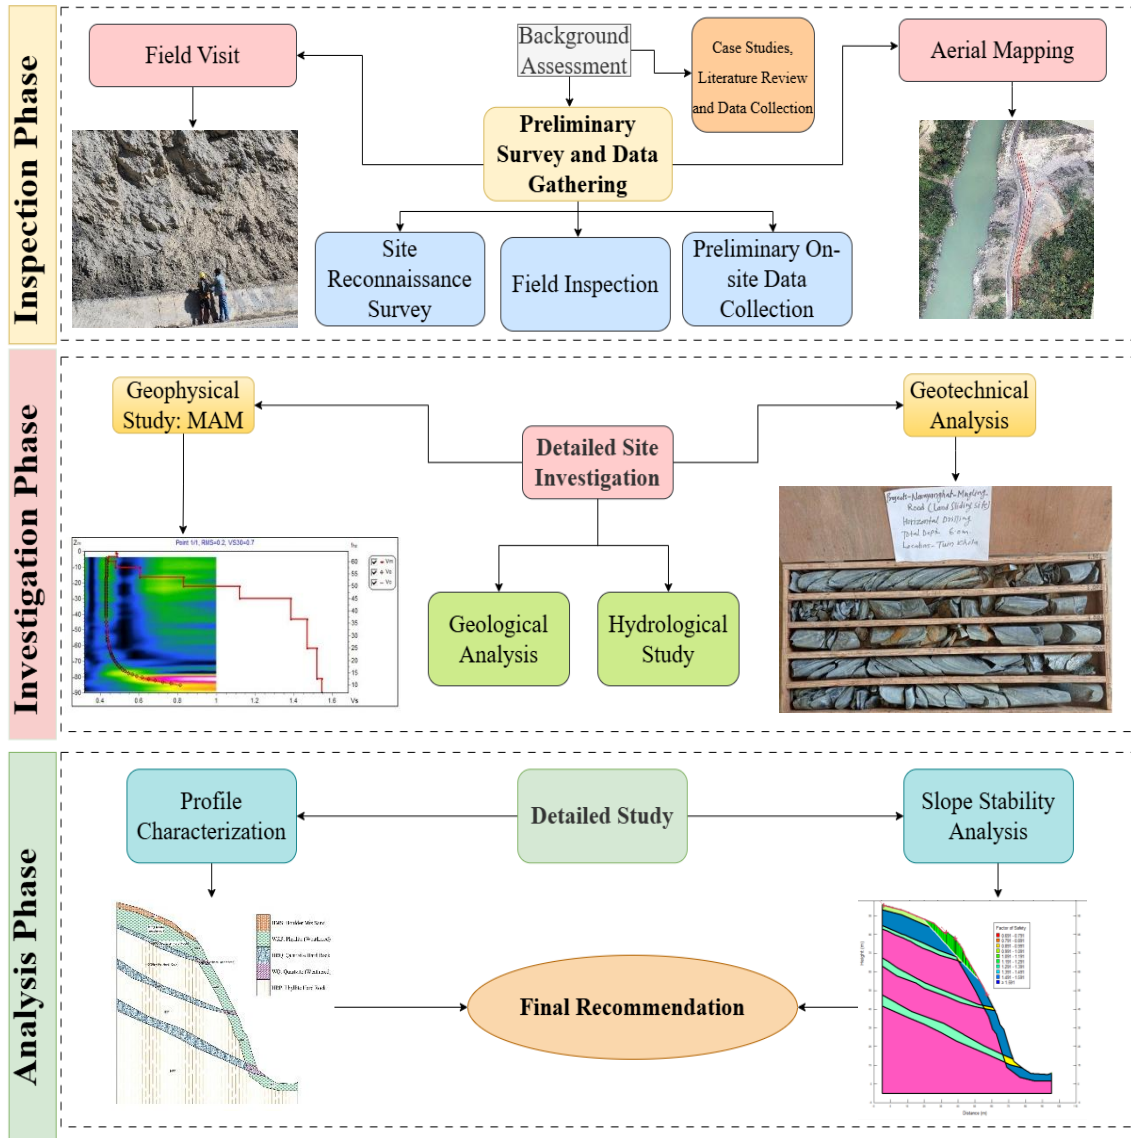
Figure 4-1: Overall methodology of the study.

The research methodology of this study consists of work flow, study steps, methods of gathering information and data analysis approaches.

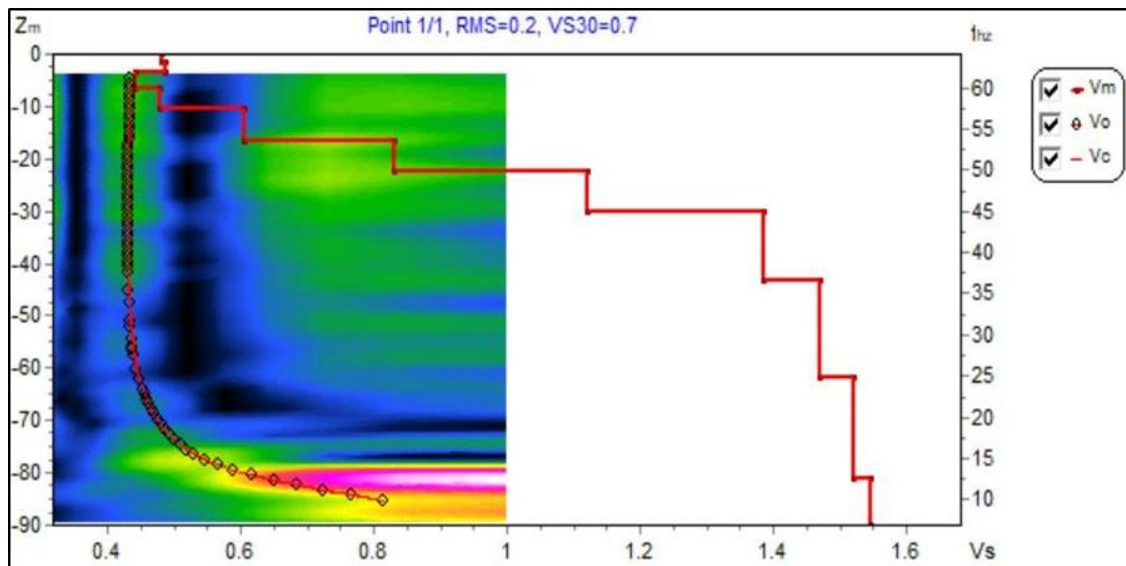
Figure 4-2: Dispersion curve of MAM.

Shear wave velocity ranging between 479 m/s - 605 m/s up to the depth of 16.46 m indicates highly weathered and fractured bedrock of phyllite with quartzite and limestone. The equivalent allowable bearing capacity of this layer varies from 239 kN/m<sup>2</sup> - 302 kN/m<sup>2</sup>. Shear wave velocity ranging between 605 m/s - 1122 m/s up to the depth 30.03 m indicates fractured to competent bedrock of phyllite with quartzite and limestone. The equivalent allowable bearing capacity of this layer is 302 kN/m<sup>2</sup> - 589 kN/m<sup>2</sup>. Shear wave velocity ranging between 1386 m/s - 1521 m/s below the depth of 30.03 m indicates competent bedrock of phyllite with quartzite and limestone. The equivalent allowable bearing capacity of this layer is 589 kN/m<sup>2</sup> - 897 kN/m<sup>2</sup>.

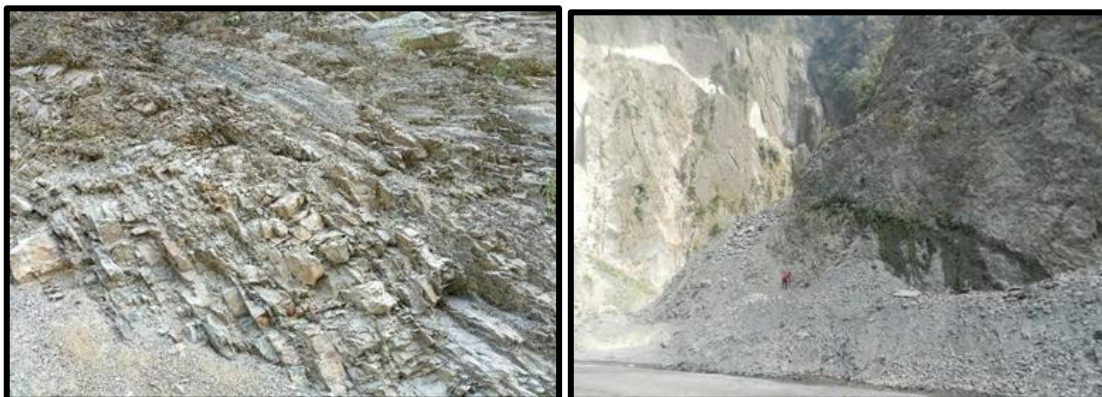
Figure 4-3: Exposure of rock mass at L1.

Location 1: RMR at the Tuin Khola Cut Slope

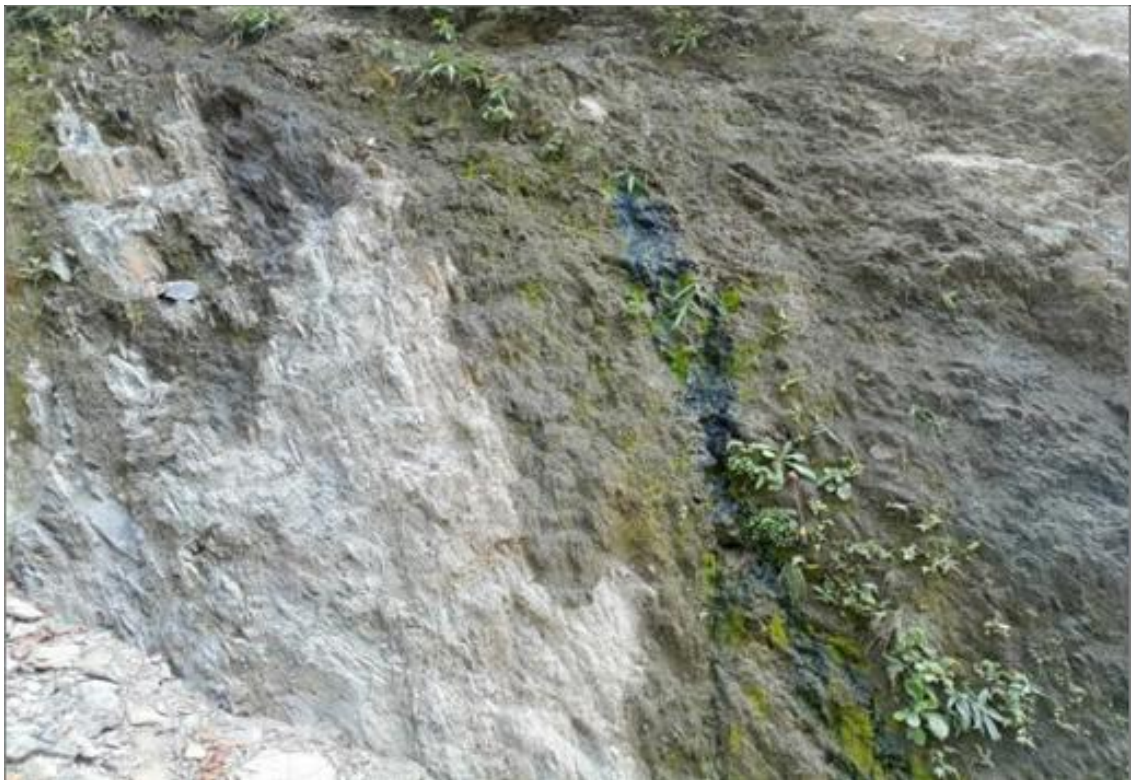
Figure 4-4: Exposure of rock mass at L2.

Location 2: RMR at the Tuin Khola Cut Slope

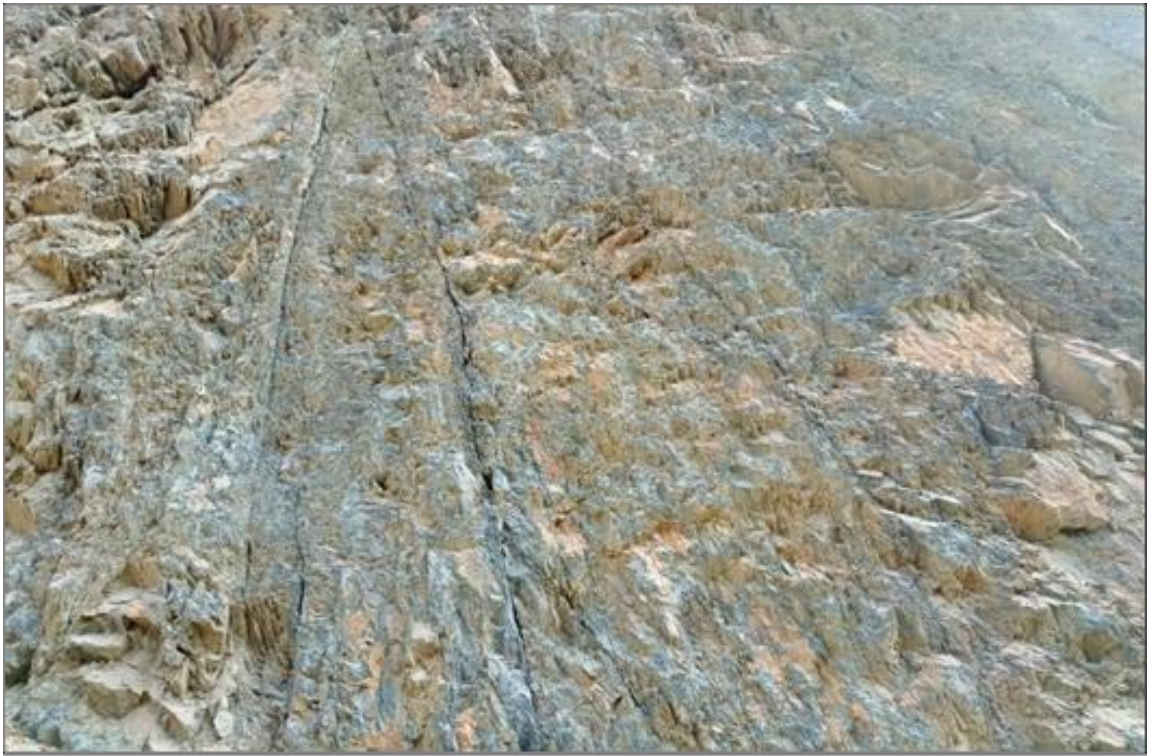
Figure 4-5: Exposure of rock mass at L3.

Location 3: RMR at the Tuin khola cut slope

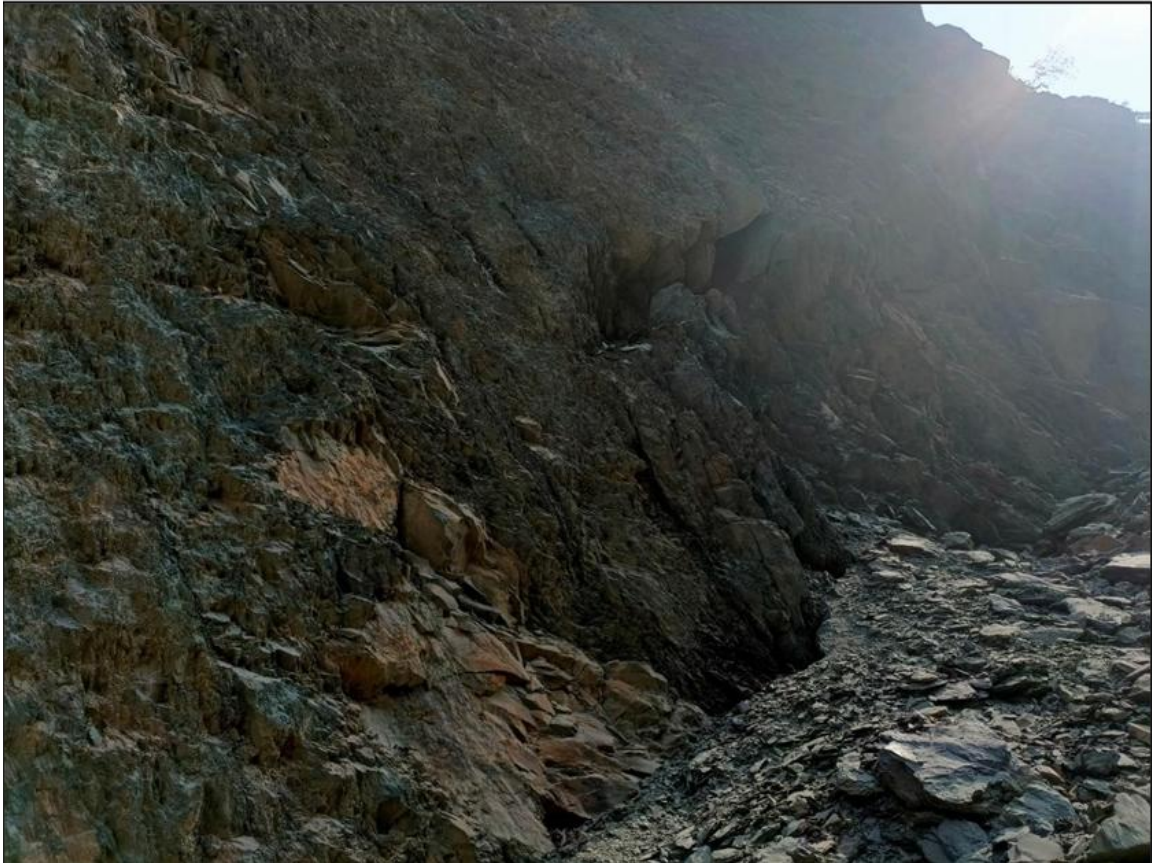
Figure 4-6: Exposure of rock mass at L4.

Location 4: RMR at the Tuin khola cut slope

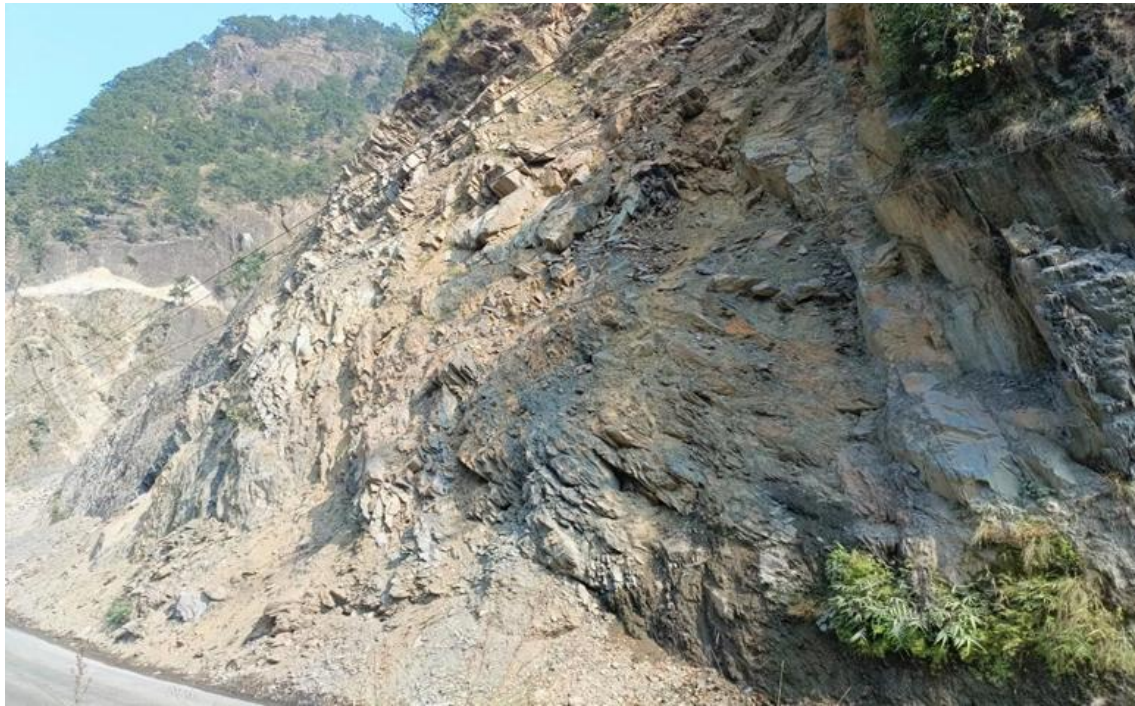
Figure 4-7: Exposure of rock mass at L5.

Location: 5: RMR at the Tuin khola cut slope

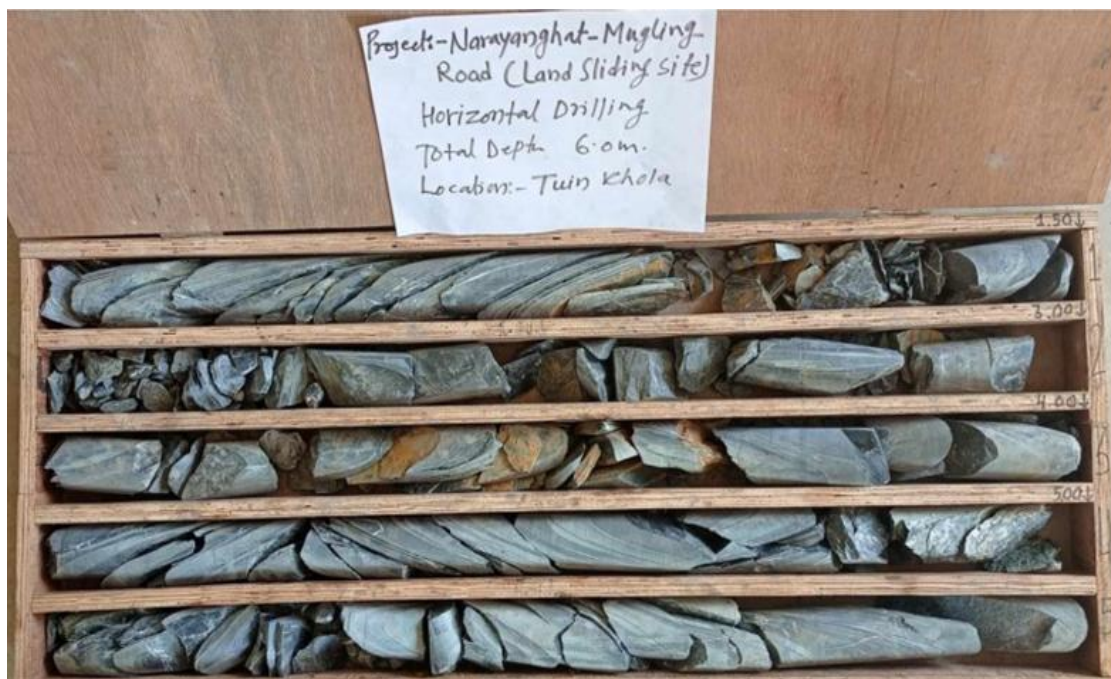
Figure 4-8: Core samples recovered at Tuin khola.

It assess internal rock mass conditions such as joints, fractures, weathered zones, and lithology, as well as groundwater behavior. It enables installation of drainage systems to lower pore water pressure, placement of reinforcement elements like rock bolts, s, or soil nails, and performance of in-situ tests including Lugeon tests, geophysical logging, and monitoring instrumentation. The drilling direction is usually oriented normal to the expected failure plane and planned considering slope geometry, mode of failure, hole diameter and length, and site accessibility.

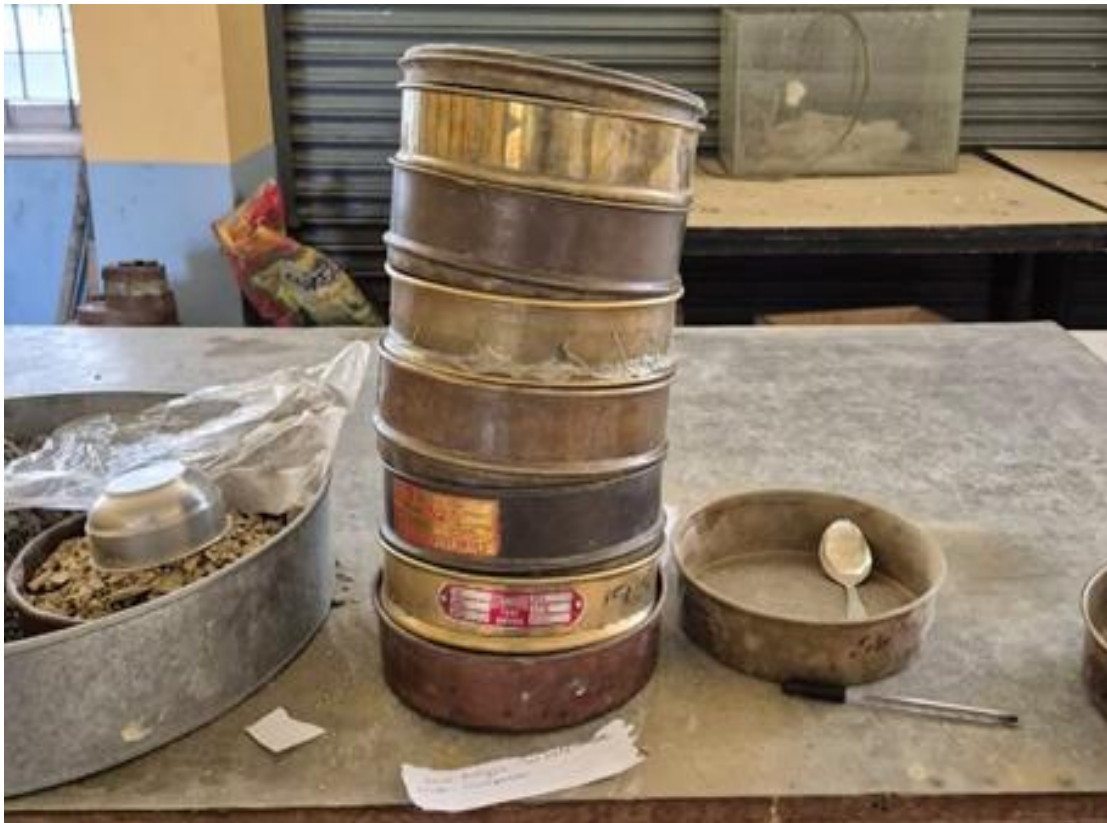
*Figure 4-9: Debris samples for sieve analysis.*

- Particle size distribution
- Specific Gravity
- Natural moisture content
- Direct shear test
- Bulk density/unit weight
- Modified / Standard Proctor Test

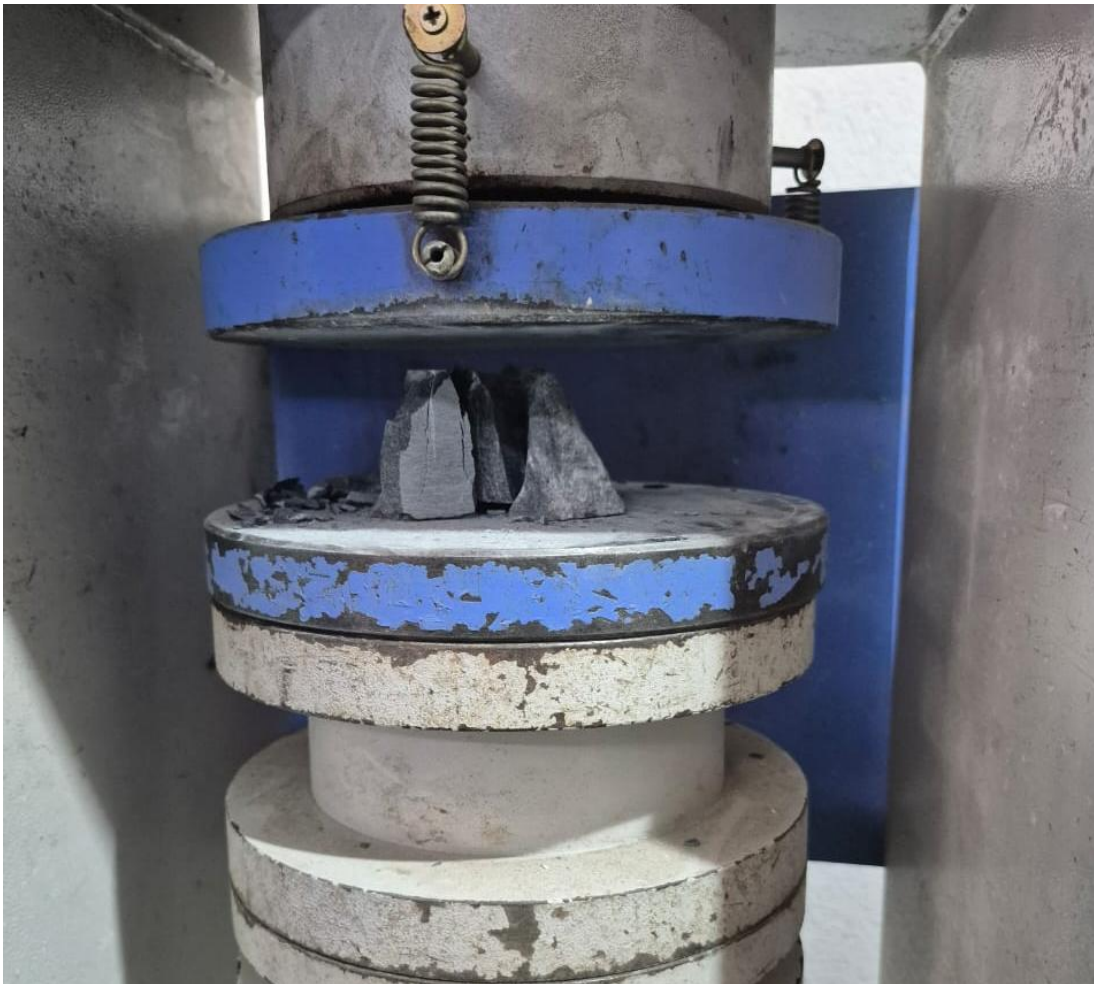
*Figure 4-10: UCS test of rock sample.*

- Uniaxial Unconfined Compressive Strength
- Point Load Index Test
- Water Absortion and Specific Gravity
- Direct Shear Test
- Bulk density/dry density

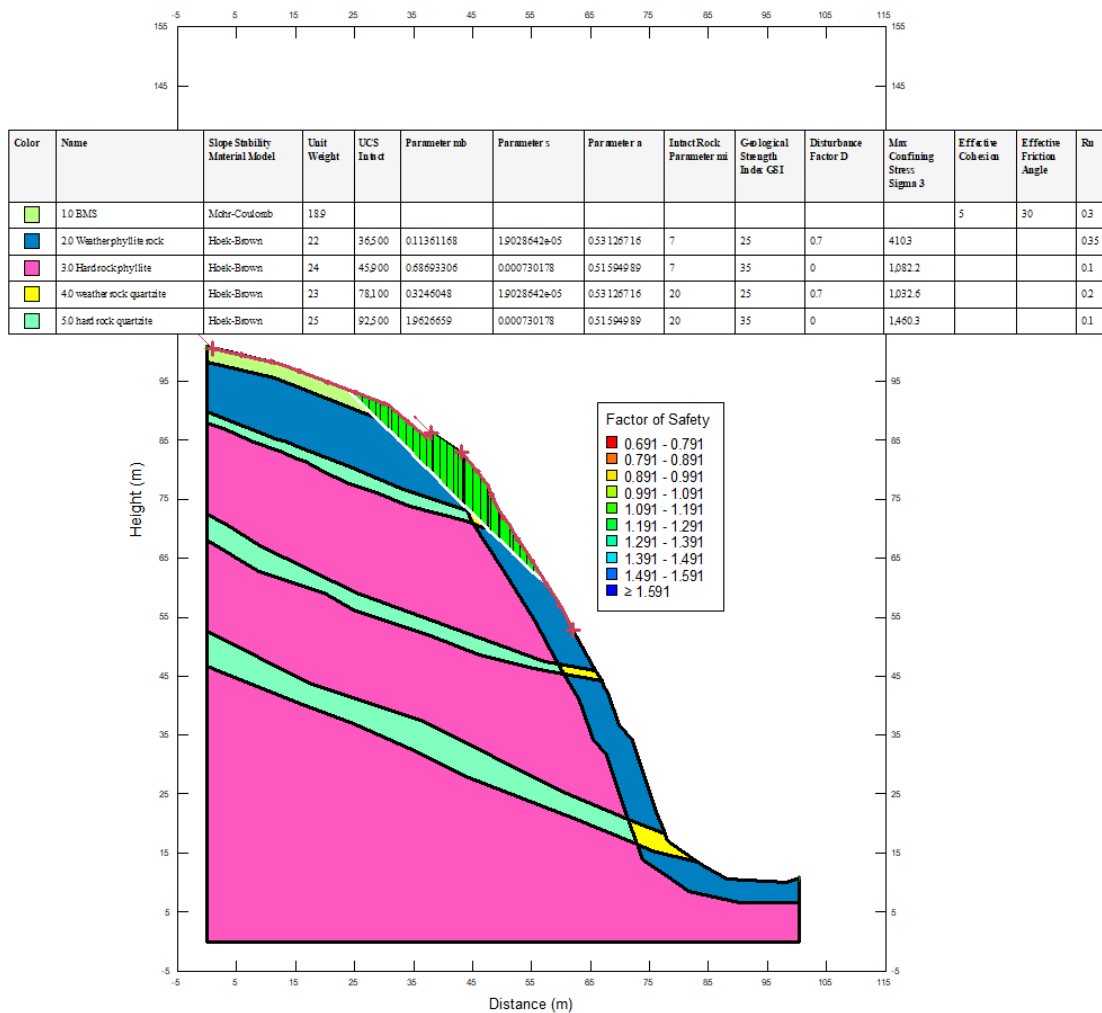
Figure 4-11: Slope stability model in Geo-studio at locations (L3).

The geotechnical analysis for the slope stability was done using the GeoStudio 2023 software (SEEP/W, SIGMA/W & SLOPE/W). The most critical sections were selected after numerous work at the field and office. The field work consists of Topographical Survey work, Geophysical testing work, Geotechnical Investigation work etc. Similarly, office work consists of finalization of level of existing landslide crown, road level and the toe area of landslide. SEEP/W was run to analyse the seepage conditions of the slope and SIGMA/W was run to know the stress and displacement of the slope mass under the pore water pressure increasing the landslide triggering force. Finally, SLOPE/W was run to calculate the FS with a proposed mitigation measure to stabilize the landslide. SIGMA/W works on the principles of finite element method and SLOPE/W runs on the principle of LEM.

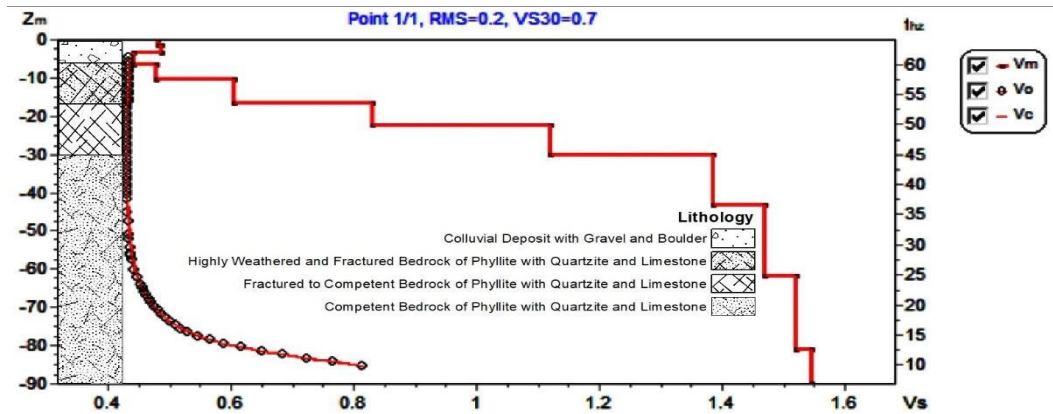
Figure 5-2: Shear wave velocity MAM test.

The shear wave velocity profile shows that the detailed analysis of landslide area.

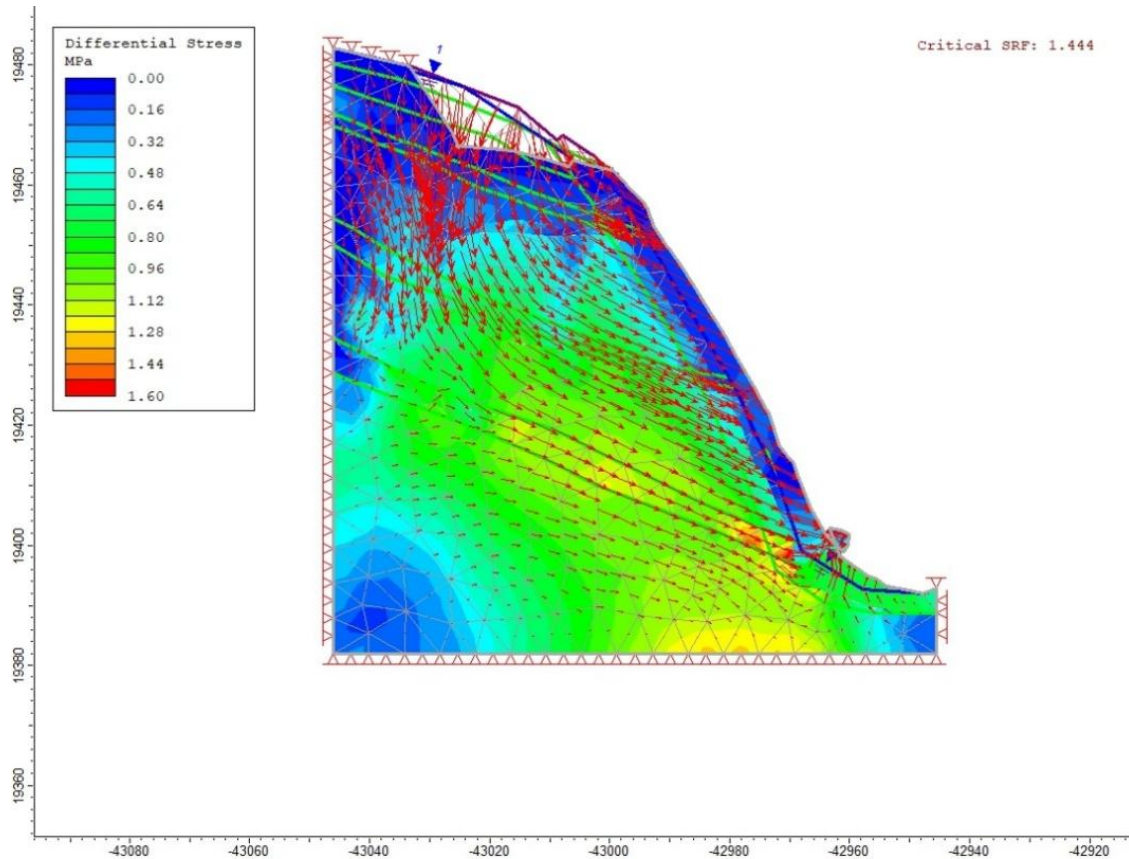
*Figure 5-6: Differential stress distribution and displacement vector.*

The slope stability analysis has been done based on the relation between the dipping of the natural hill slope and wedges formed by intersection of the foliation plane and joints. Location 3 predicted as critical and it revealed due to the occurrence of chances of wedge failure along the foliation plane. Wedges are formed by intersection of foliation (FP) and Joint (J3) is also critical because of chances of occurrence of central wedge failure. Remaining wedges seem to be stable and very less chances to occur the failure.

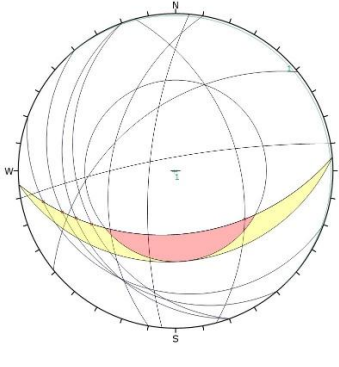
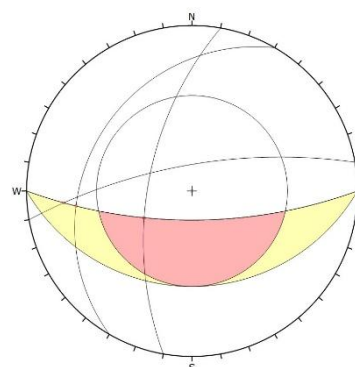
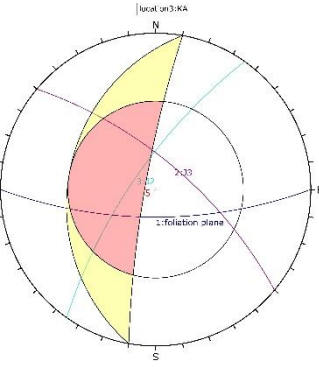
<p>KA-1: 11.31 % Wedge Failure</p>	<p>KA-2: 50.0 % Wedge Failure</p>	<p>KA-3: 67.67 % Wedge Failure</p>

Table 5-5: Stereographic projection of rock mass exposed at slide area

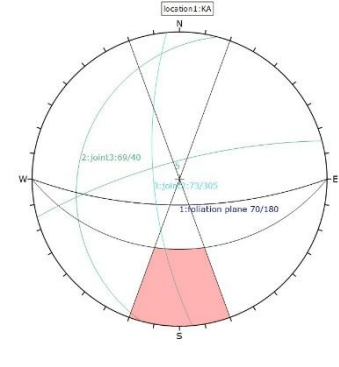
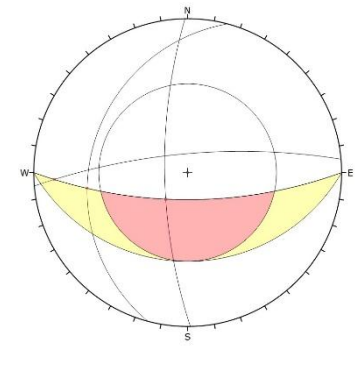
<p>KA-4: 23.33 % Flexural Toppling Failure</p>	<p>KA-5: 50.0 % Wedge Failure</p>

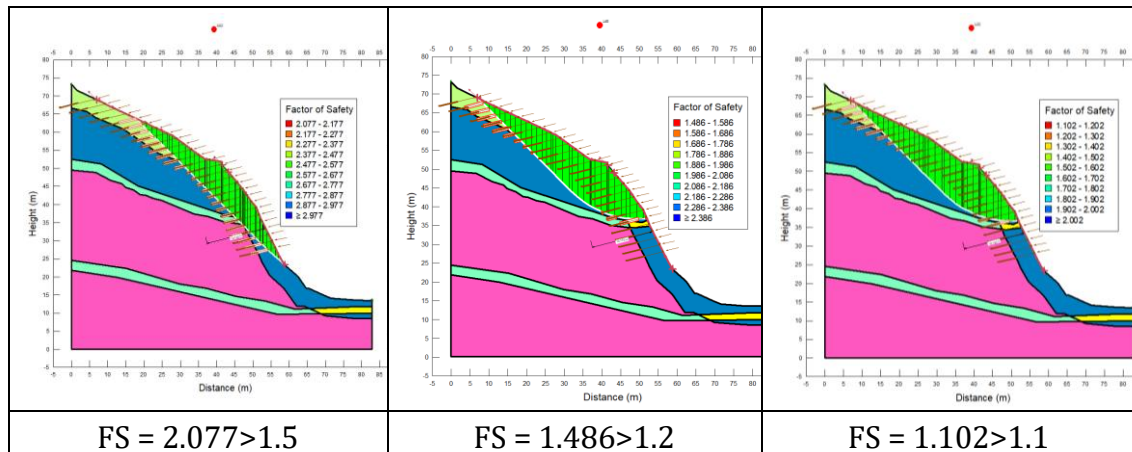
Figure 5-10: Circular failure analysis: Soil & weathered rock (Ch: 0+060).

S.No.	Case	Groundwater Conditions	FS
1	Dry Condition	No Presence of Ground water table (Static condition)	1.5
2	Wet Condition (monsoon)	Rock Slope: The saturated Gwt. within the tension crack or half depth of the slope saturated with groundwater along the active plane. Soil Slope: The Gwt. level is set at the interface of Boulder Mix Sand (BMS) and weathered Rock	1.2
3	Seismic Loading	Actual measurement or normal PGA level at the interface of most vulnerable lithologies	1.1

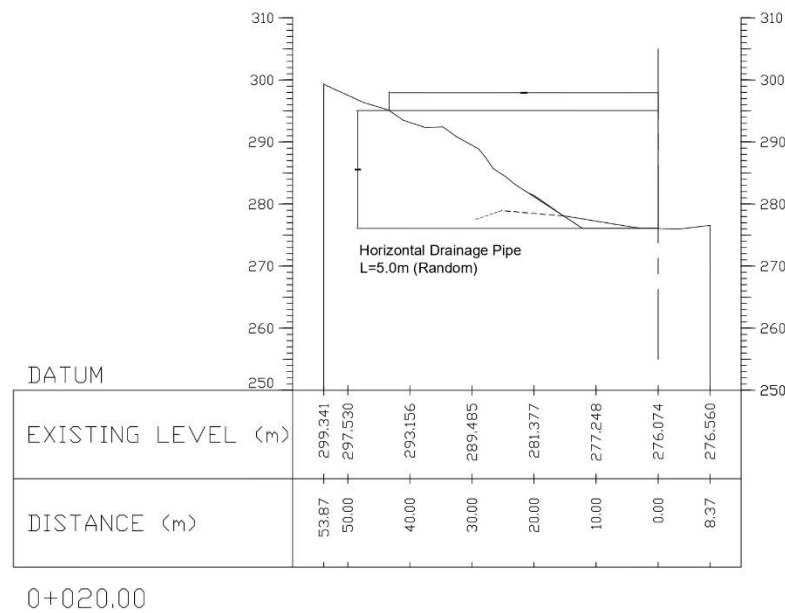
Figure 5-12: Protection of slope at Ch.: 00+020.

The effect of structural reinforcement rock bolts and subsurface drainage results in a stable slope configuration with a FS exceeding the recommended value (generally  $FS > 1.5$ ). This confirms that the proposed mitigation measures are adequate and efficient in controlling slope instability and ensuring long-term performance of the slope. Following are the design drawing.

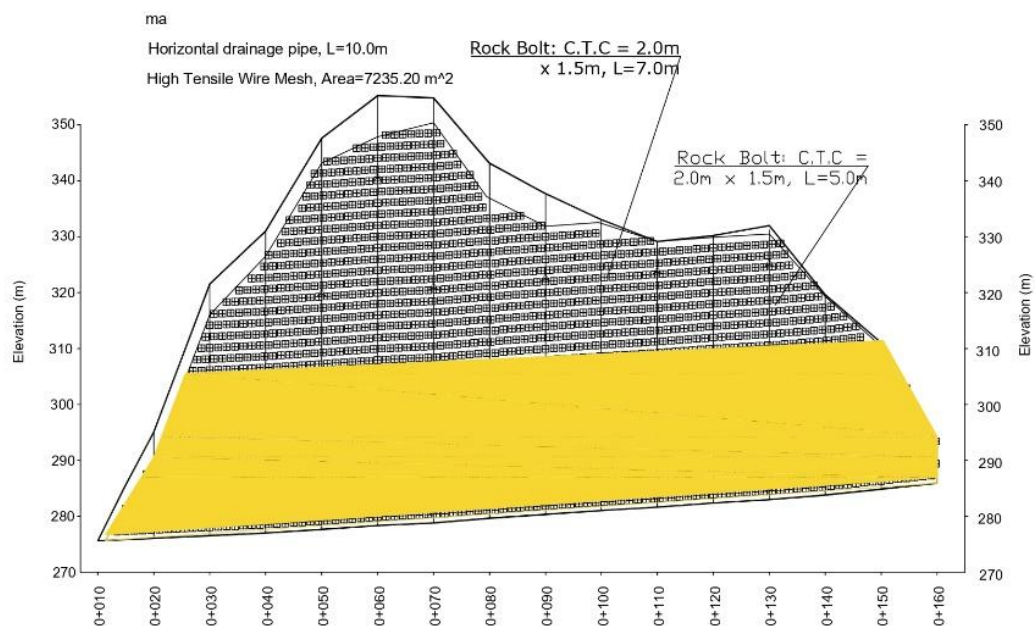
Figure 6-1: Layout of mitigate measures are recommended.

- Scaling/removing the unstable mass, boulders existing on the slope.
- Clear the sliding mass accumulated in the hillside
- Provide 3-4 m RCC cladding wall at the hillside
- Pipe drains along the road at hillside
- Install a rock bolt with plate
- Cover the slope face with high tensile wire mesh

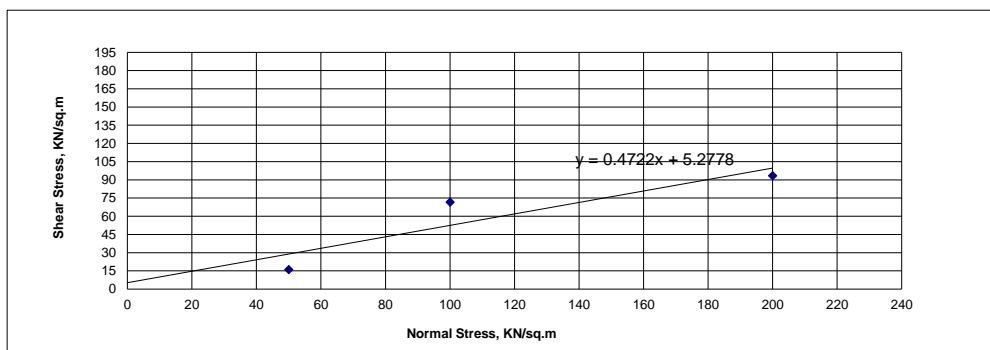
C            5.28      KN/m<sup>2</sup>  
 Φ            25.28      Degree

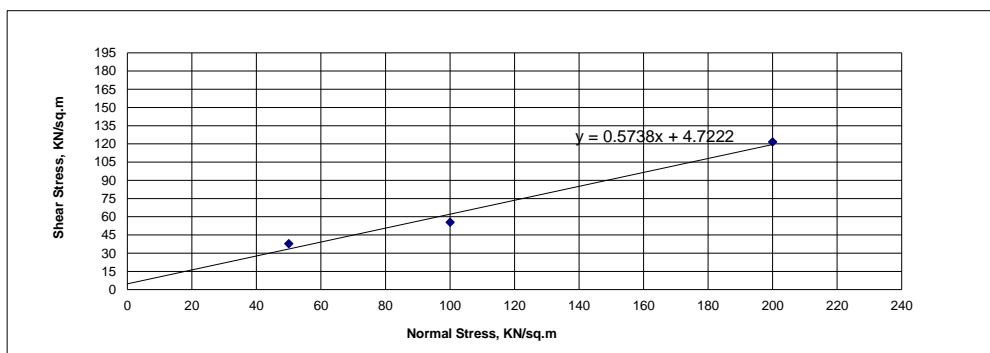
C                    4.72                    KN/m<sup>2</sup>  
 Φ                    29.85                    Degree

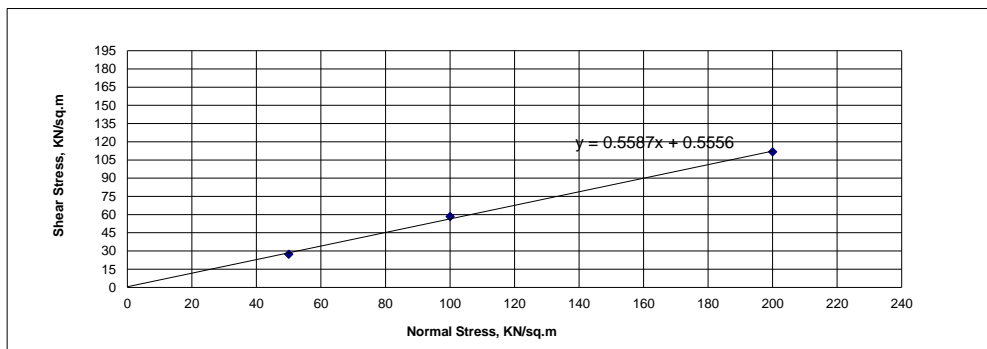
C            0.56      KN/m<sup>2</sup>  
Φ            29.19      Degree

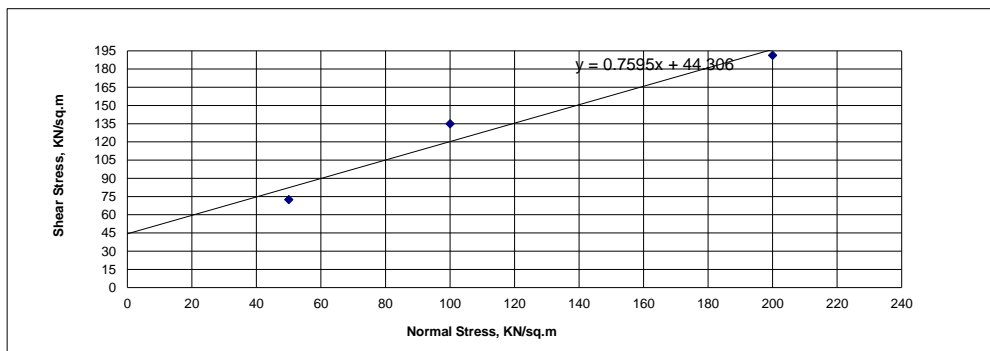
C            44.31      KN/m<sup>2</sup>  
 Φ            37.22      Degree

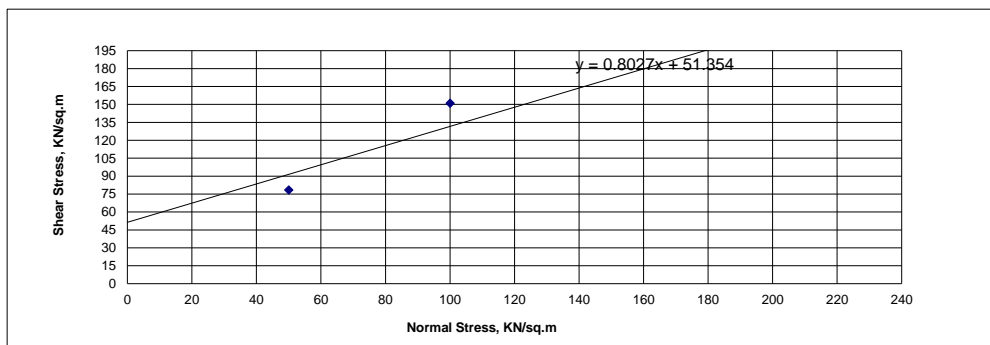
C            51.35    KN/m<sup>2</sup>  
 Φ            38.75    Degree

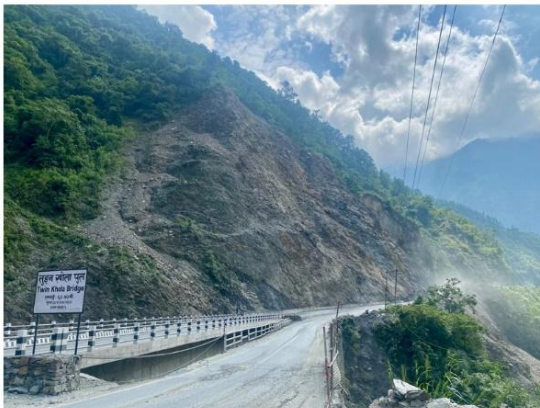
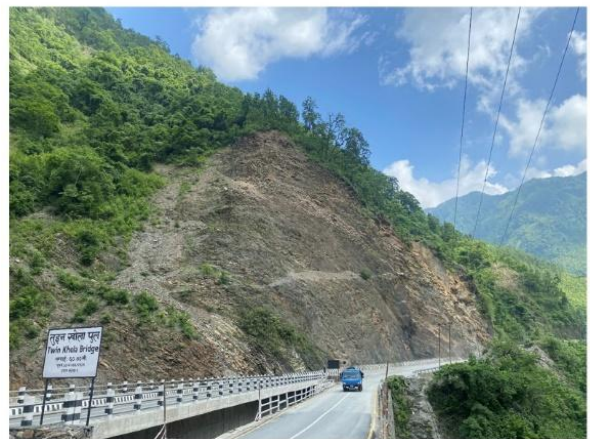
<p>Tuin khola area <b>After</b> massive landslide, pic. Date:2082-06-21</p>	<p>Tuin khola Area (CH 33+900) <b>Before</b> massive landslide, pic. Date:2082-03-08</p>

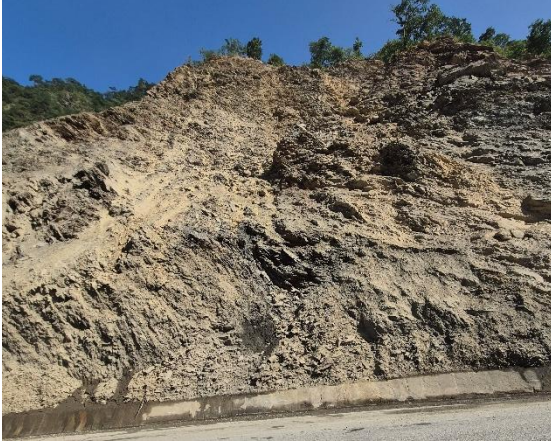
<p>Failure slope, @ center portion</p>	<p>Photos during sample collection</p>

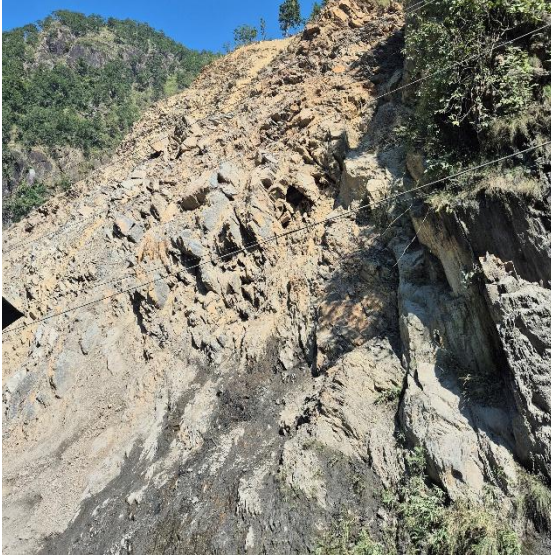
<p>Slope @ ch-00+060 Exposed weather phyllite and quartzite</p>	<p>Confirming Dimensions, and Access Points Works under Inspection</p>

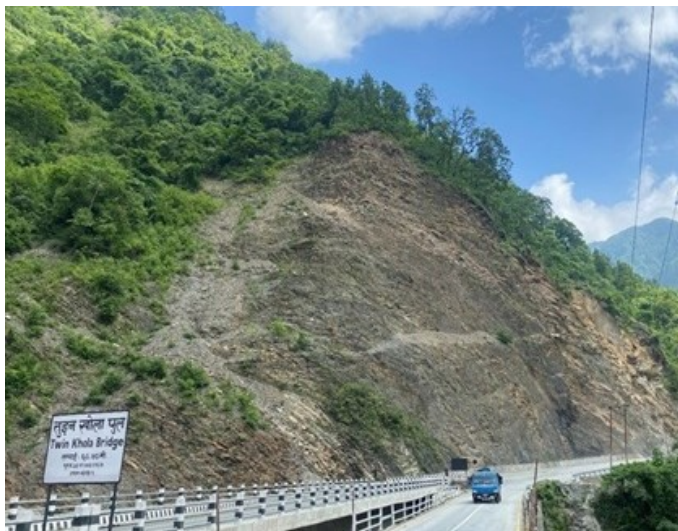
**Figure 1:** Twin khola Area (CH 33+900) Before massive landslide

location for shear zones or weak planes, black deposition is seen outside. Layer D — Foliated Rock Zone, strong presence of foliation planes / planar discontinuities. Layer E — Weak, highly weathered Rock Mass, represents shear-affected and fractured rock fabric. Layer F — Loose surface soil / debris / colluvial soil/ boulder mix sand. The

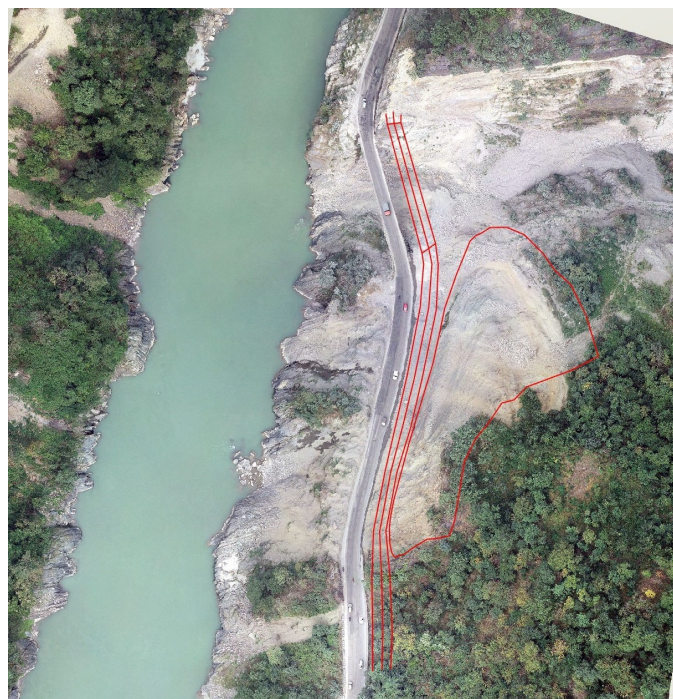
**Figure 3:** Outline of overall area of study area

The proposed site is located at Twin khola, Mugling-Narayanghat road section. The co-ordinates of this location is 27.842978, 84.558697. The aerial view site is shown in figure 3.
