THESIS NO. PUL079MSGtE003

**Stability Analysis and Mitigation Design of Excavated Slope Failure: A Case**  
**Study of Tuin Khola Landslide**

SUBMITTED TO THE DEPARTMENT OF CIVIL ENGINEERING  
IN PARTIAL FULFILLMENT OF THE REQUIREMENTS FOR THE  
DEGREE OF MASTER OF SCIENCE IN  
GEOTECHNICAL ENGINEERING

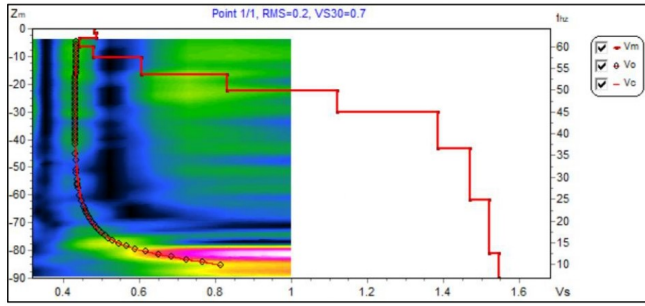
Figure 5: Dispersion curve of MAM

**Geophysical study:** The Microtremor Array Measurement (MAM) is a non-invasive geophysical test used to determine subsurface shear wave velocity profiles by recording natural ground vibrations (ambient seismic noise). The results of geological observations indicates that the landslide is structurally controlled and influenced by weakened phyllite/quartzite and saturation effects during monsoon. phyllite, metasandstone and quartzite [3]. Toe erosion by Twin Khola accelerates instability. High weathering, presence of seepage, unfavorable discontinuity orientation and low shear

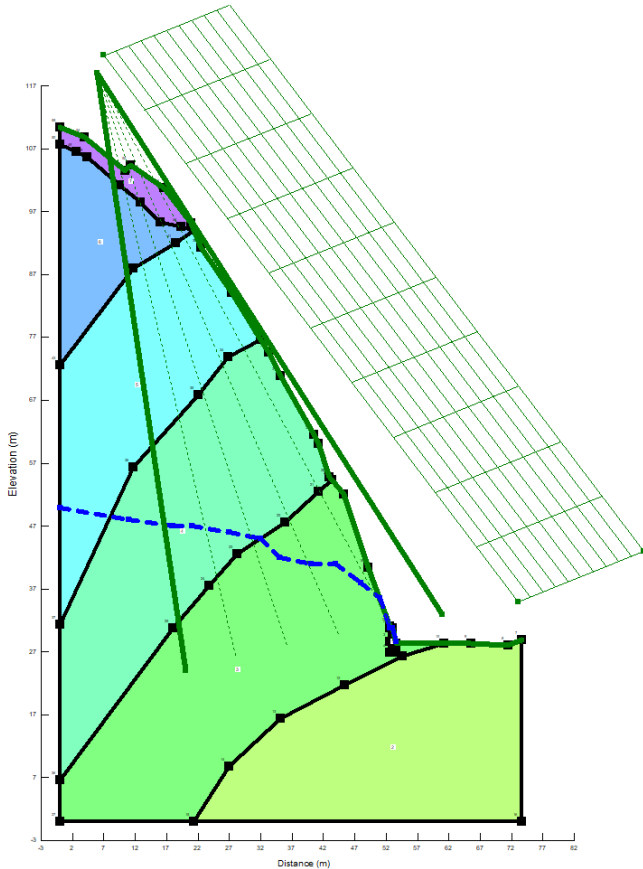
Figure 8: Interpreted Geostudio model of the slope section

- Slope protection with RCC wall rock Bolt and high tensile wire mesh during the monsoon, FS is improved up to 84.21%.
