Tribhuvan University
INSTITUTE OF ENGINEERING
PULCHOWK, LALITPUR

**Sediment Erosion in Guide Vanes of Francis
Turbine**

A DISSERTATION SUBMITTED IN FULFILLMENT OF THE
REQUIREMENTS FOR THE DEGREE OF DOCTOR OF
PHILOSOPHY IN MECHANICAL ENGINEERING

November, 2023

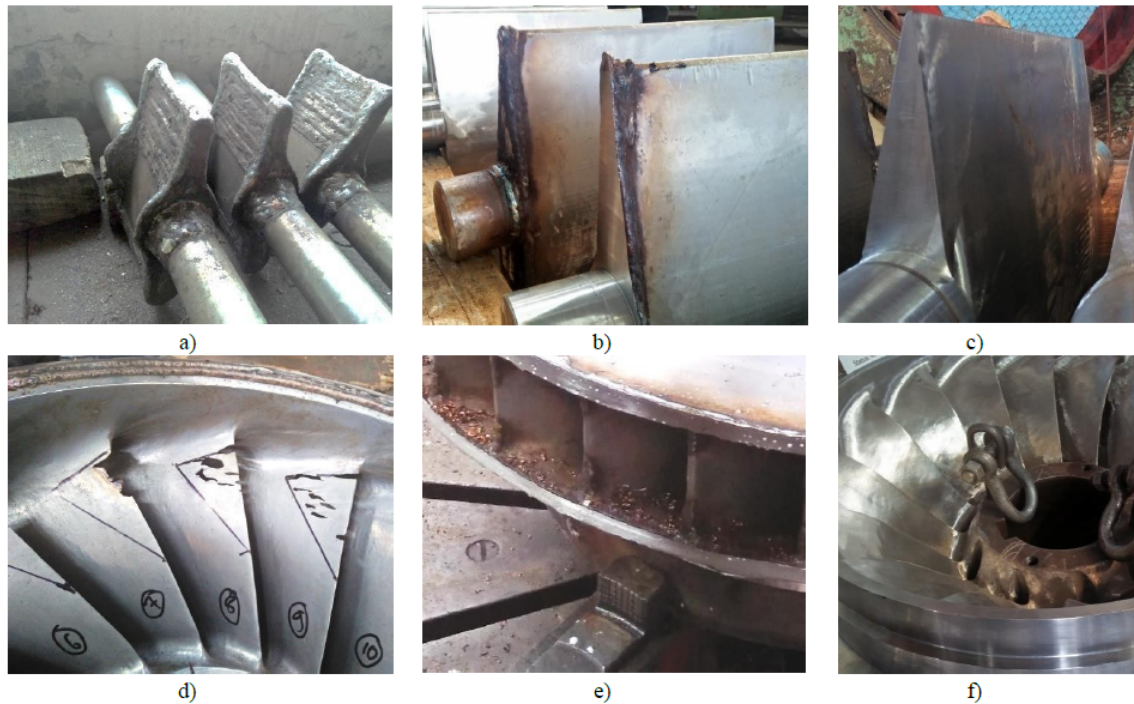
It was reported that the efficiency of the turbines in Jhimruk reduces to around 5% after erosion in the wet season [58]. Out of the total loss, the ones contributed by the leakage due to erosion of labyrinth seals were found to be between 2-4%. However, the turbines undergo repair and maintenance in the dry season so plant's loss is retained. The change in the efficiency of the turbines after each repair has not been reported yet, but since the hydraulic profile of the blades are maintained with high-quality machining, the change in the efficiency of the runner for each successive repaired turbines can be considered marginal. Repair and maintenance of the electro-mechanical components are the part of the annual routine of the power plant. The normal repairing period for the runner, GVs, and upper and lower rings is 150 to 180 days. Various processes involved in the repairing and maintaining of these components are shown in Figure 2.3. In the case of GVs, the repair work includes welding, machining and grinding. The base material of the guide vane, i.e. 13.4Ni5Cr is used as the weld material. After filling the eroded sections, the GVs are machined according to the reference design, with 97 mm span height and 180 mm chord length. Final finishing is done by grinding, which brings the GVs into their original shape. Repairing of the runner involves similar processes. However, the outlet eroded section undergoes cutting of a V-shaped section as shown in Figure 2.3 (d) before welding. According to the reference design, this cut-out section is replaced with a new section. The eroded area at the runner's inlet is repaired using the same technique as the GV but with the base material of 16Cr5Ni.

Figure 2.3: Different processes of repairing eroded GVs (a, b, c) and runner (d, e, f)

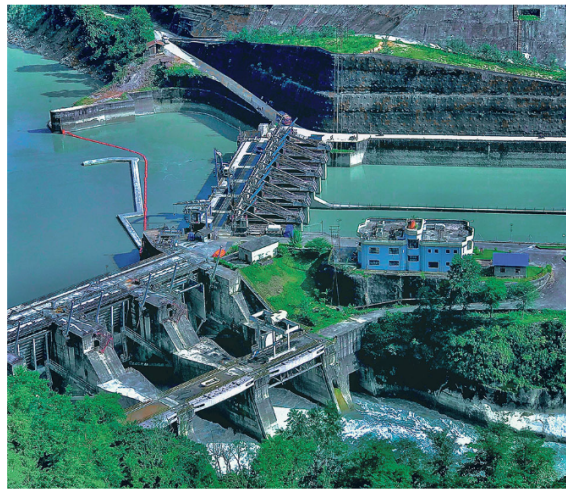
from the Sidhartha highway, access road leads to the dam and reservoir source, with a side road leading to a power plant site. Figure 3.4 shows the dam, intake (bottom), spillway (top) and the Kaligandaki 'A' hydro-power plant.

Figure 3.4: The dam, intake (bottom), spillway (top), Kaligandaki 'A' hydro-power plant

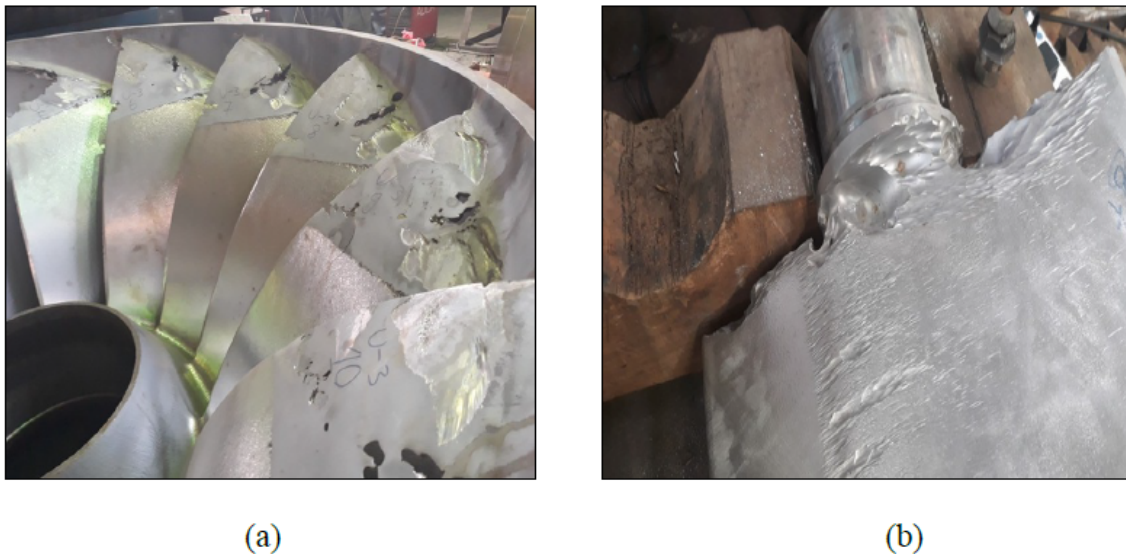
By its nature the Kaligandaki 'A' River flows through the Himalayas and carries a lot of silt generating a suspended sediment load of 43 Mt/yr, with sand accounting for around 25% of it. This sand contains a high concentration of angular quartz, which is very abrasive. The monsoon provides approximately 95% of this suspended sediment load, which is sufficient to fill the reservoir in a single monsoon season, which lasts from late May to late September. When the concentration of suspended sand increases in the river and fed to the turbines rapidly in early June the reservoir level is reduced on these days, allowing sand to be moved. As the reservoir level increases to the impounding level, the sand concentration falls, decreasing flow velocity and sand transport rate. Sluicing has substantially stabilized reservoir capacity, resulting in reservoir sediment balance. Figure 3.5 shows the eroded runner and GVs of Kaligandaki 'A' hydro-power plant.

Figure 3.5: (a) Eroded runner blades (b) Eroded GV of Kaligandaki 'A' hydro-power plant

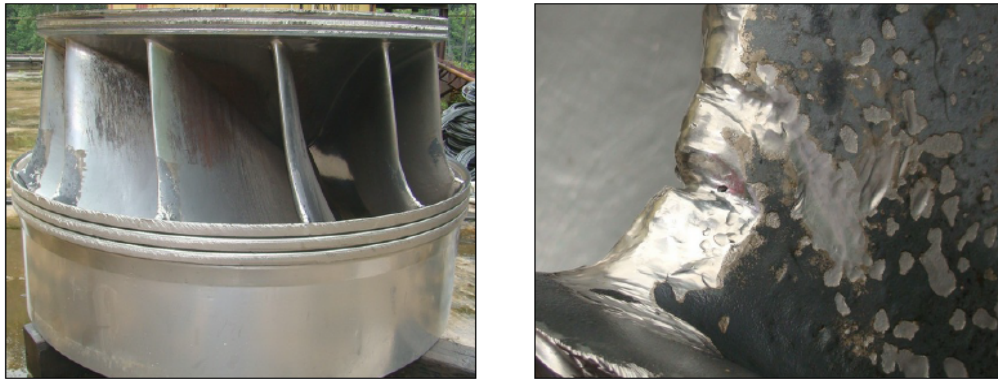
If the particle is hard and solid, it will be possible that a process similar to abrasive wear will occur, Lower Marsyangdi hydro-power plant head works samples were taken and sieve size varied as 125-200 μm , 200-300 μm and 300-600 μm . After the test observation, the weights were noted and erosion rate were calculated. From analysis, it is observed that the erosion rate varies with size of the sediments. The erosion rate increases with the increase in the size of the sediments keeping all other parameters constant. The higher the particle size, the higher the sediment erosion occurs. Erosion tests were performed keeping the size constant as 125-200 μm for all three samples. From analysis of Lower Marsyangdi hydro-power plant, it is found that erosion rate decreases in going from head works to tail-race keeping size 125-200 μm . The erosion is reduced while going from head-works to tail race [70]. Figure 3.10 shows the eroded runner blades of Lower Marsyangdi hydro-power plant.

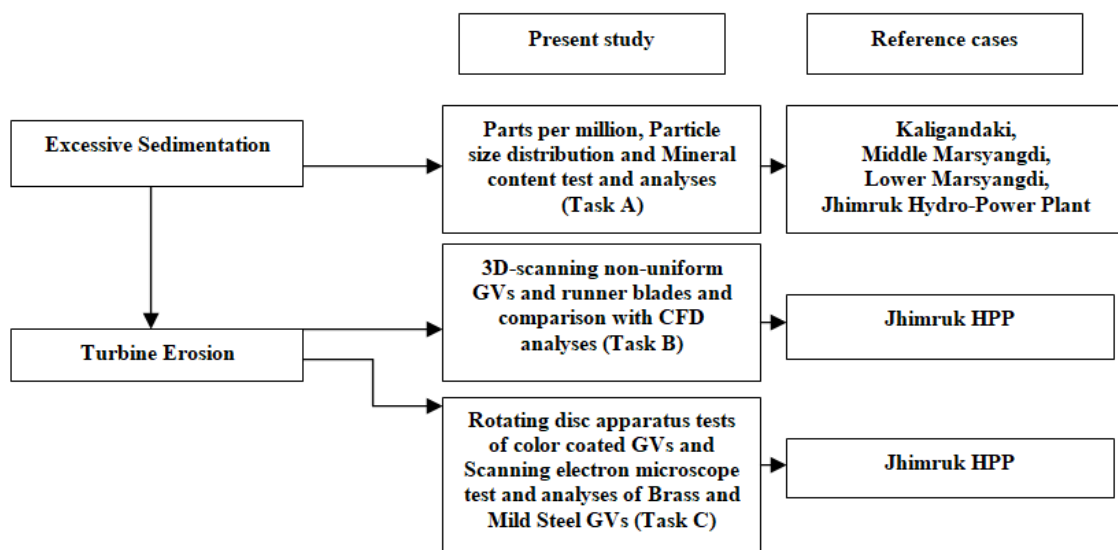
1. Task A, investigation of concentration, particle size distribution and mineral content test and analysis
2. Task B, monitoring of 3D-scanned eroded GVs and runner blades and comparison with CFD analysis
3. Task C, evaluation of erosion of GVs tested at RDA and SEM analysis

Figure 4.1: Methodology adopted in this study

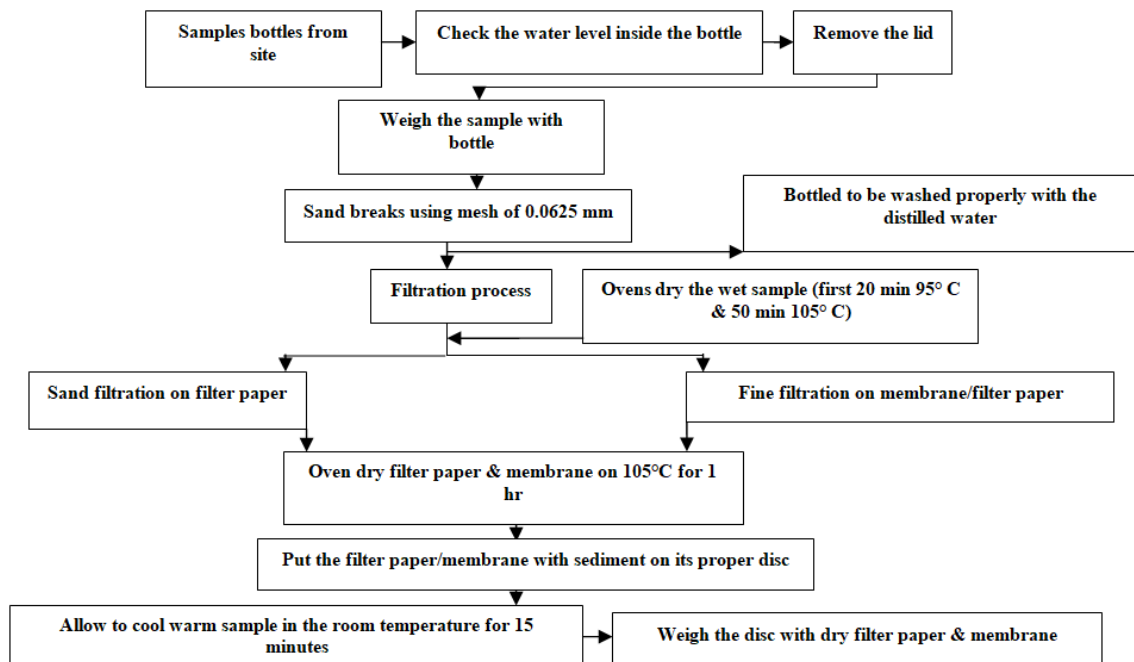
begins, a sufficient supply of clean (distilled) water must be provided in the filtration lab. It was ensured that all of the wash bottles were filled with clean water. To prevent leakage, samples were transferred from the collection location to the Sediment Lab in a dedicated container under tight observation. Each bottle was branded in accordance with the Tab supplied by Hydro Lab. The oven's temperature was set at 95°C. To confirm that no water has seeped out during transit, the water level in the bottle was measured and compared to the water level seen at the location. The appropriate filter paper was placed on top of the filter funnel's screen, and the filter tunnel and container were clamped together. The vacuum pump was started, pouring the upper layer of clean water from the sample container into the filtering unit without jostling it. The filter device was filled with the water sample. The sample bottle and the upper half of the filtering unit were flushed with distilled water. The vacuum pump was turned off and the filter unit's upper section (container) was removed. The filter was placed in the appropriate dish with care. The dish was put in the oven separately. The sink was filled with the water from the filter flask. The distilled water was used. The filter flask and filtration machine was cleaned. After cleaning and drying, the sample vials were placed in the designated containers. Another bottle was chosen and the procedure was repeated until the oven was full or all samples collected from the location have been evaluated (Source: hydro lab Nepal). Figure 4.2 shows the process of sediment concentration analysis.

Figure 4.2: Process of sediment concentration analysis (source: hydro lab Nepal)

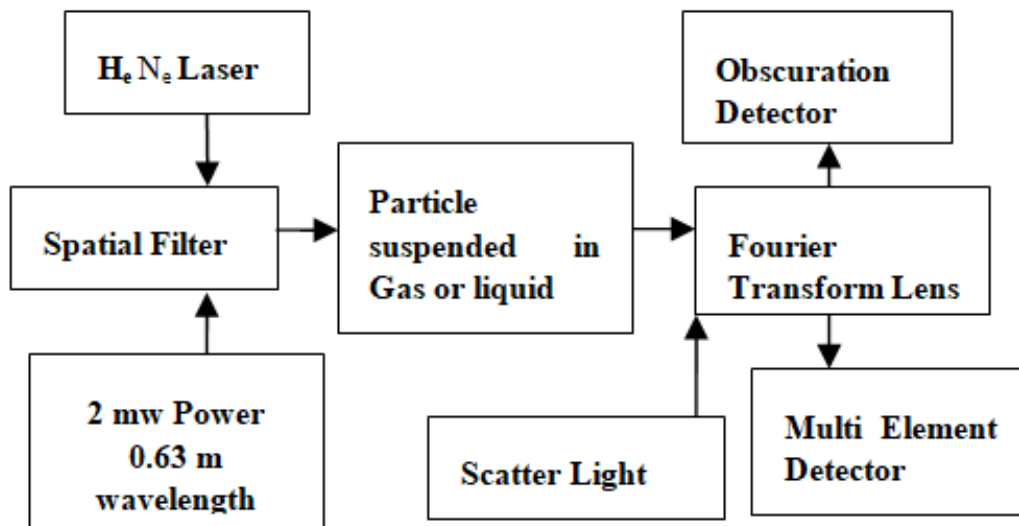
Figure 4.3 shows the working principle of the laser diffraction system. The suspended sediment concentration was then analyzed using a Laser diffraction particle size analyzer ranging in size from 10^{-4} to 10 mm to determine the particle size distribution. The test was carried out by adding up to 8% to a maximum of 18% of the sample each time.

Figure 4.3: Working principle of laser diffraction system (source: hydro lab Nepal)

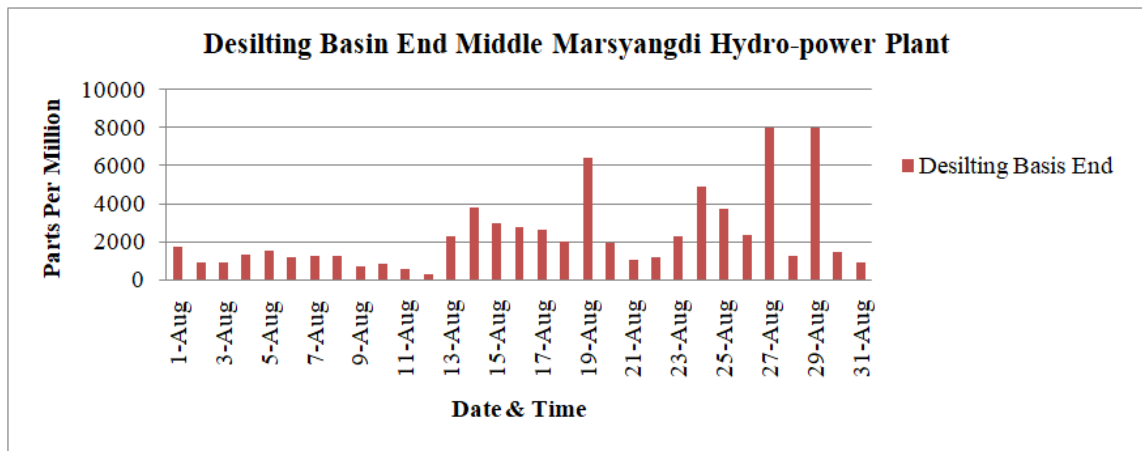
The highest and lowest sediment concentrations were observed throughout the Middle Marsyangdi hydro-power plant sample period at desilting basin end from the 1st to 31st of August 2019 at different time tables, as shown in the graph at Figure 5.4. The part per million concentration is displayed vertically on the graph, while the date and time are displayed horizontally. As seen in the graph, the highest part per million concentration is around 8000 on 27th and 29th August and the lowest concentration is around 500 on 12th August 2019.

Figure 5.4: Parts per million analysis, Middle Marsyangdi hydro-power plant

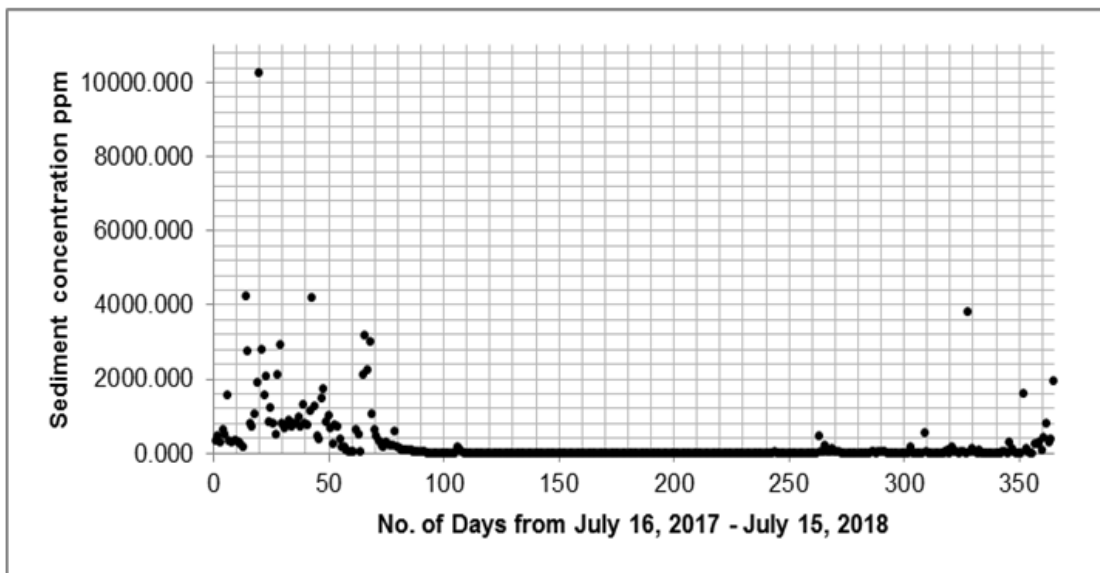
Figure 5.11: One year Sediment concentration at Jhimruk hydro-power plant

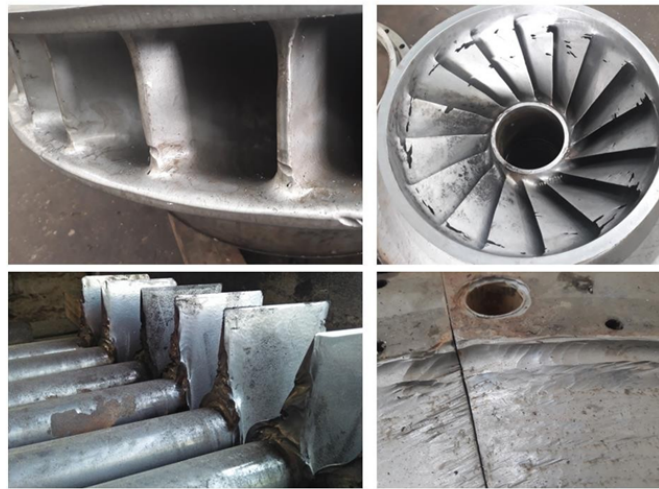
The excessive concentration of hard minerals causes erosive and abrasive wear in the turbine components as shown in Figure 5.15. At the inlet of the runner, erosive grooves are found to have occurred near the edges. These grooves make certain angle from the edge and have similar patterns for all the blades. The erosion on the trailing edge of the blade is concentrated at the edge of the shroud. On the guide vanes, the ends of the vanes, or the space between the facing plate and the guide vane were found to be severely eroded.

Figure 5.15: Erosion in the runner and guide vanes of the plant

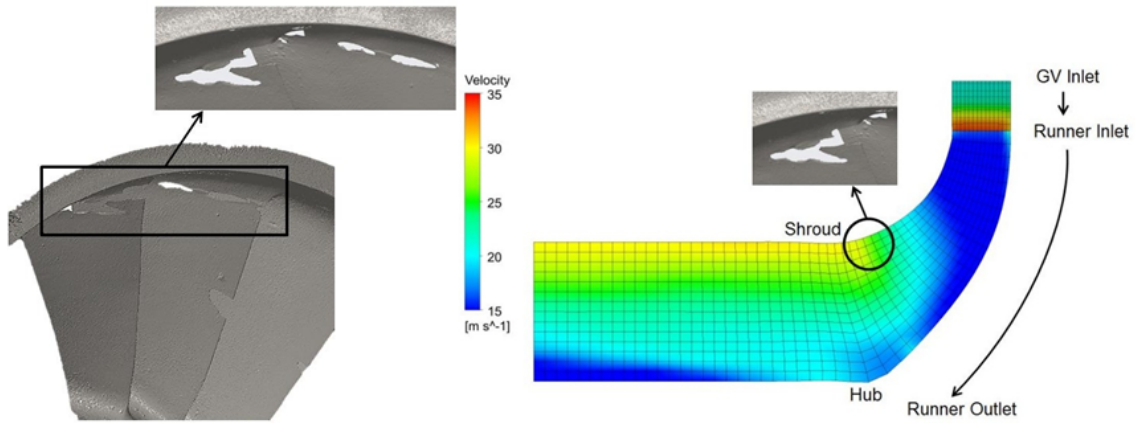
Figure 5.21: Illustration of the runner outlet erosion (type iii) due to high relative velocity

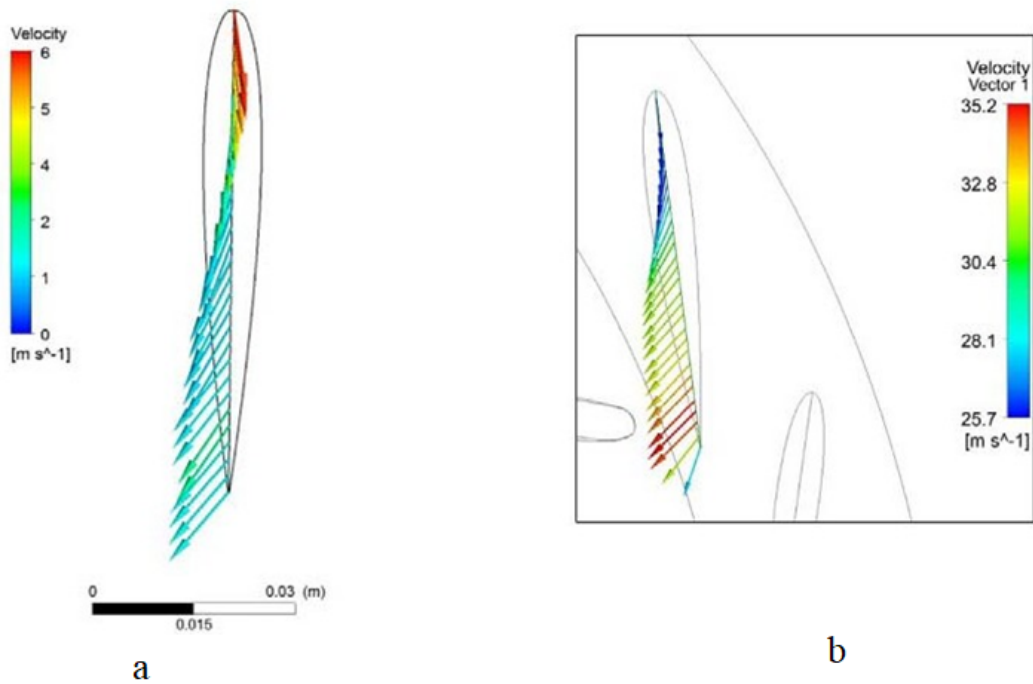
Figure 5.24: Leakage flow through the tip of the GV a) in RDA (from present study) and b) in actual turbine

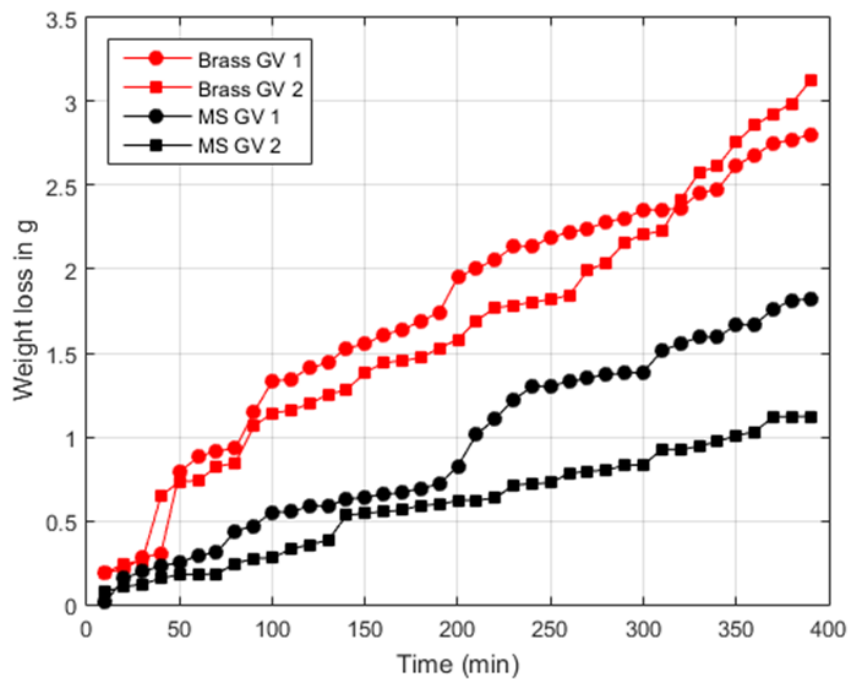
Figure 5.28: Trend of weight loss in GVs with increasing time
