**SEISMIC VULNERABILITY OF BUILDING**  
**A CASE STUDY OF ILAM MUNICIPALITY**

**A DISSERTATION**

Submitted to the Central Department of Geography, Faculty of  
Humanities and Social Sciences in Partial Fulfillment of  
Requirement for the Master's Degree in Geography

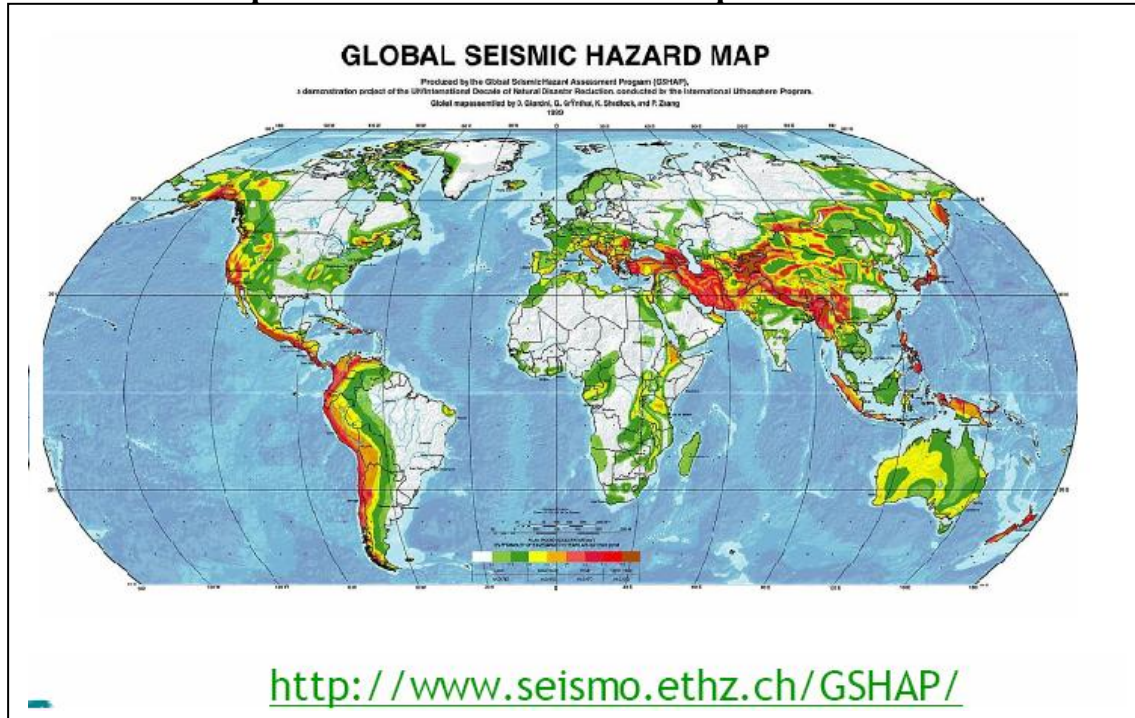
**Map1.2: Global seismic hazard map**

Map 2 shows the seismic hazard area of the world. South west and south east Asia, western part of North and South America are highly probable area of earthquake

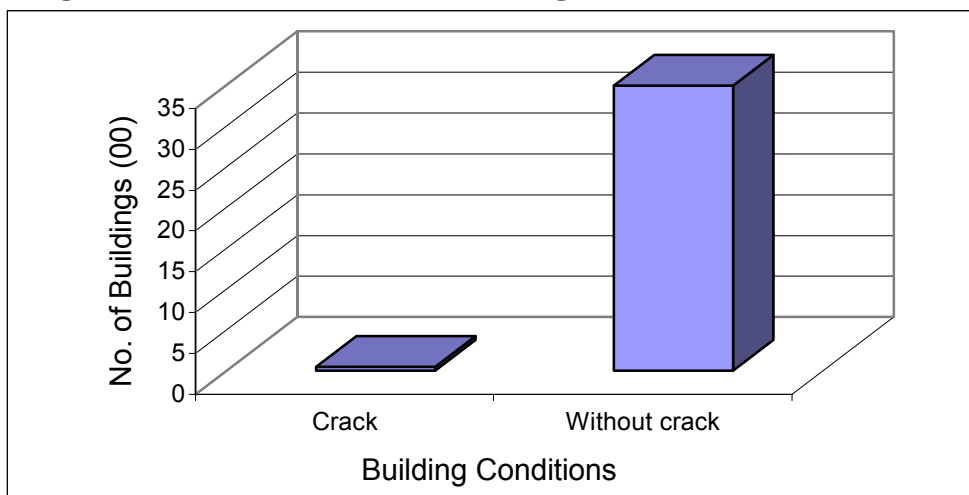
**Figure 5.5: Condition of the buildings**

In the earthquake period, poor condition (weak construction material, crack etc.) of the building are more vulnerable don't need large shaking than the buildings without cracks. Wall cracks are more dangerous for the building damage in the period of earthquake. Therefore the study tries to find out the visible crack of the building to assess the damage probability of buildings.

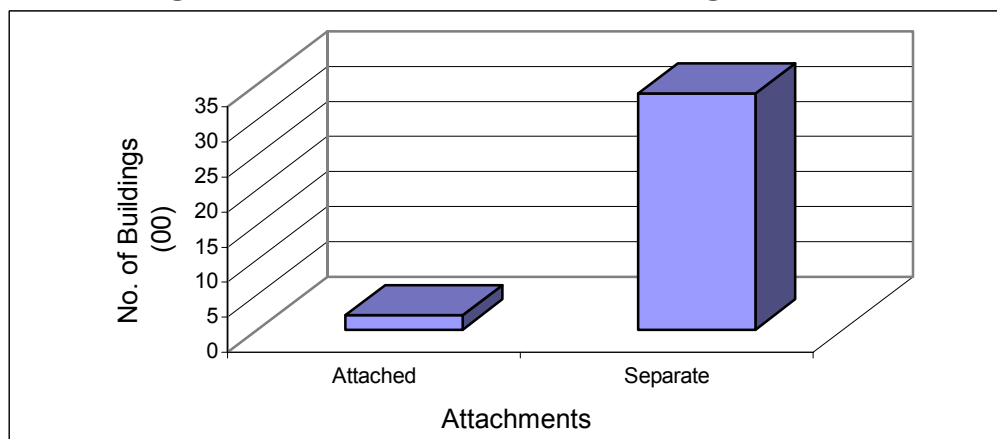
**Figure 5.6: Attachments of the buildings**

Building attachment and separation also play important role for the vulnerability of the building because attached buildings are more vulnerable than separate building. In the study area, it was found that, 6 percent of the total buildings were attached with the other nearest building and about 94 percent were found separate building. (Table 5.7).

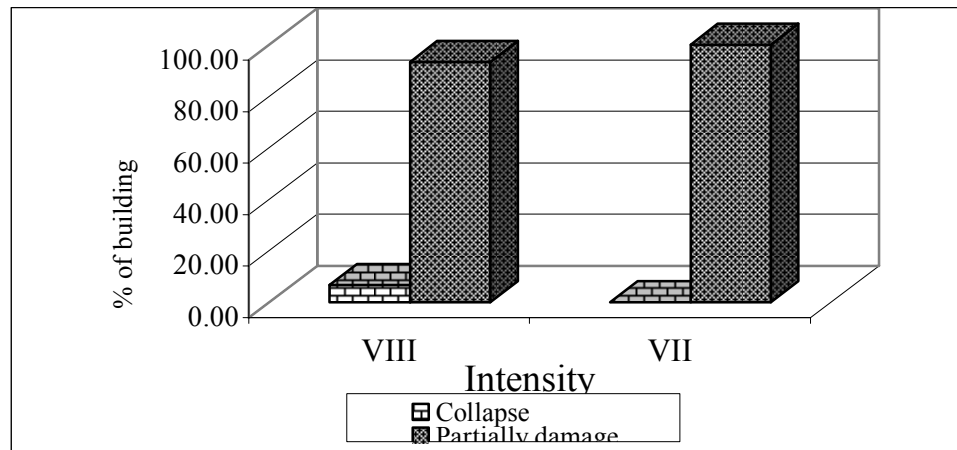
**Figure 6.2: Collapse and damage Probability in different intensity**

To classify the total building of the study area according to collapse and partially damage, it is found that under the intensity of VIII, 212 of the total building (6.66 percent) are found in completely collapse probability category and 2971 buildings (93.34 percent) are found in partially damage probability category.

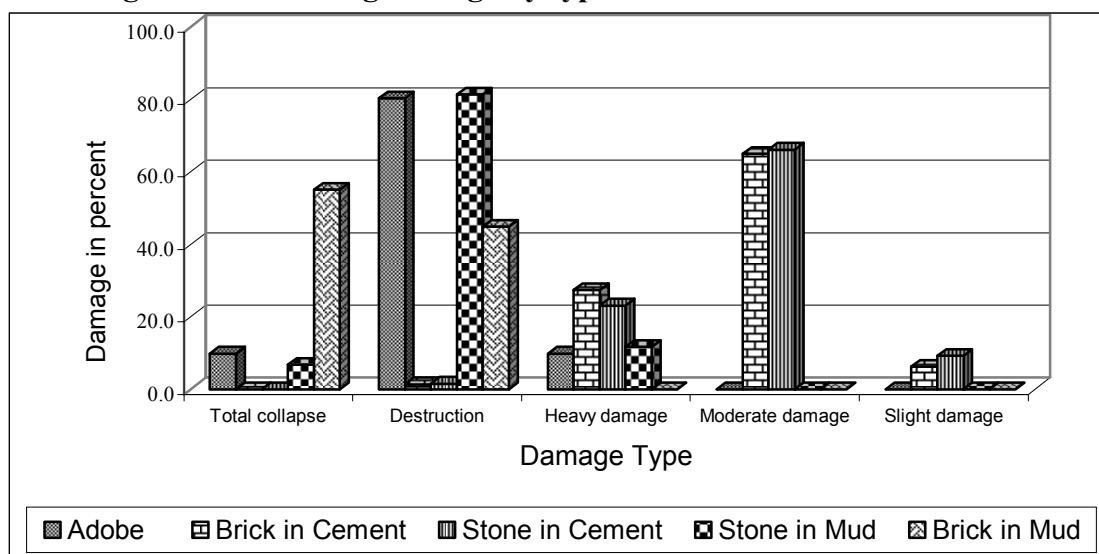
**Figure 6.3: Building damage by types**

The damage of building according to their construction material or typology was calculated from the damage grade. Under the magnitude of VII and VIII earthquake, 9.82 percent of the Adobe, 6.80 percent of Stone in Mud, 55.10 will completely collapse (DG 5). 80.36 percent of Adobe buildings 1.40 percent Brick in Cement 1.54 percent of Stone in Cement, 81.44 percent of Stone in mud and 44.90 percent of Brick in Mud will partially damage (destruction, DG 4) and 9.82 percent of Adobe, 27.39 percent of Brick in Cement, 23.8 percent of Stone in Cement, 11.75 percent of Stone in Mud building are under the heavy damage or DG 3. Like this, 64.97 percent of Brick in Cement, 66.15 percent of Stone in Cement are suffered in moderate damage as shown in table 6.10.

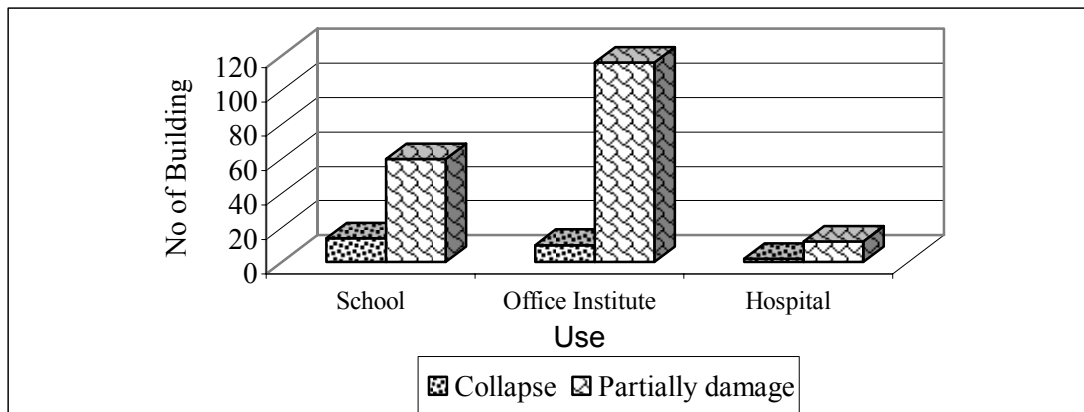
**Figure 6.4: Damage probability of school, hospital and office institute.**

School is the social concentration center of the rural and urban area. School can provide more awareness programme to the community. Management of the public schools is largely depending on the responsibility of the local community. Usually very low budget is available with the school management. On the other hand, school can be a shelter for the deliverance in the earthquake period. But most public schools in Nepal have been built up of stone in mud and abode without engineering design. So, they have more chance to damage and collapse in the period of earthquake. Similarly, office and institute are the social service center of the country, but it has been also constructed without engineering judgments. So they have a great chance to damage and collapse in the earthquake period. Like this hospital is an important center for treatment of injured and patient. It is more important to preserve the public life at the time of earthquake, so it must be well constructed.

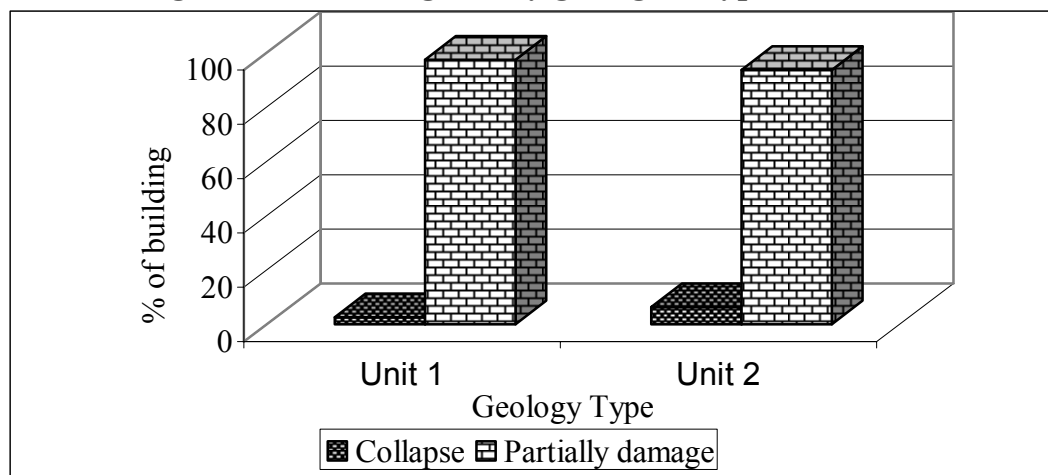
**Figure 6.5: Building loss by geological type**

To calculate the collapse and partially damage probability of building in the study area, unit 2 (garnet kyanite sillimanite gnesis, orthogenesis and white colored, course grained, fractured quartzite) type of geological condition has high probability of buildings collapse then the unit 1 (Garnet-kyanite, sillimanite gnesis and gray quartzite) type of geological condition. 6.36 percent of the total buildings are under the collapse probability in unit 2 and 2.51 percent of the total buildings has high probability of collapse in unit 1, are shown in table 6.12 below.
