Conservation and Management of Mahalaxmi Temple at Balambu

A THESIS

**SUBMITTED TO THE DEPARTMENT OF ARCHITECTURE
IN PARTIAL FULFILLMENT OF THE REQUIREMENTS FOR
THE DEGREE OF MASTERS IN ARCHITECTURE (M. Arch.)**

September, 2022

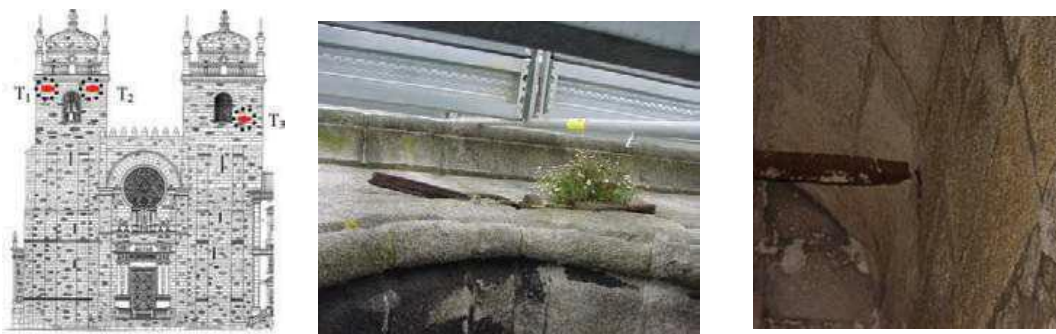
The towers show considerable out-of-plane motions and dispersed cracks. Three iron ties were just added because to the damage that has already occurred (date unknown). The anchorage of tie T1 is substantially distorted, and tie T3 is damaged and corroded. After tie T3 was broken, the divide between the East and West façades of the South tower persisted. Due to the application of a significant point load, the masonry walls next to the anchorages have likewise undergone the anticipated deformation. With extensive cracks and out-of-plumb walls, the South tower is worse off than the North tower. The longitudinal cracking seen in the majority of the apertures, with a maximum width of a few millimeters, confirms separation between the internal and external leaves of the walls.

Figure 7 Tower ties with deformed anchorage T1 and broken tie T3

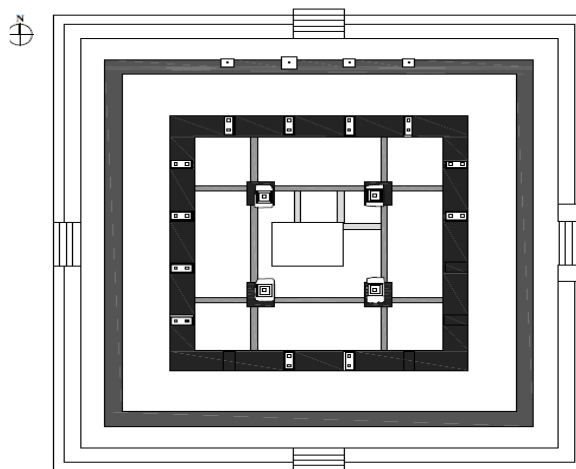
Collection and distribution of load through posts and walls to the foundations. It is a strip foundation in brick-in-mud-mortar for both the colonnaded perimeter enclosure and the sanctum square. Saddle stone under each post which rested on brick pier each 2m deep (Davis, et al., 2020) The central brick piers were abutted by cross walls also made of brick.

Figure 17 Foundation plan showing three groupings of columns on the ground floor (Tiwari, 2019)

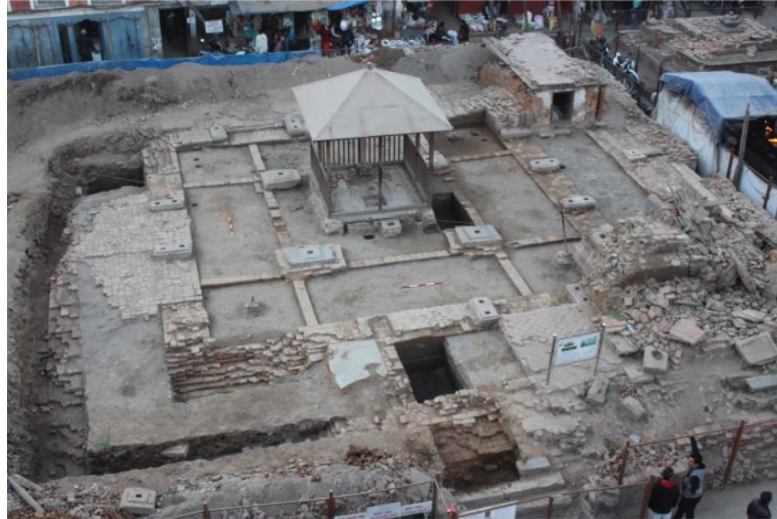
It is built over a set of nine-pit ritual foundations dating to 7th and 9th centuries AD (Tiwari, 2019). The sanctum square had been provided with a set of 1 brick thick and 35 courses deep cross-walls that ran in both directions making a *navakunda* configuration.

Figure 18 Nine-celled mandala formed through brick-piers, foundation wall and cross-walls uncovered during archaeological assessments at the Kasthamandap

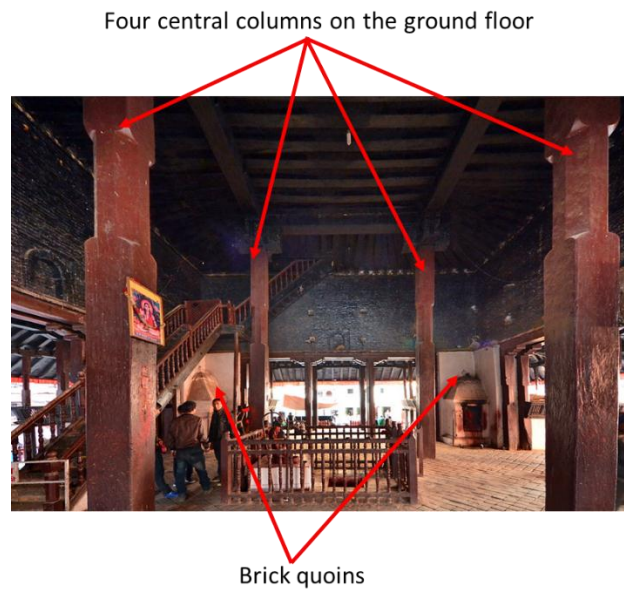
Brick quoins of the ground and first floor provide structural support. The core of the ground floor consists of four massive 7m high wooden posts on which the four posts of the first floor rest. In the second floor a square of twenty posts forms the structure

Figure 19 Ground floor of Kasthamandapa

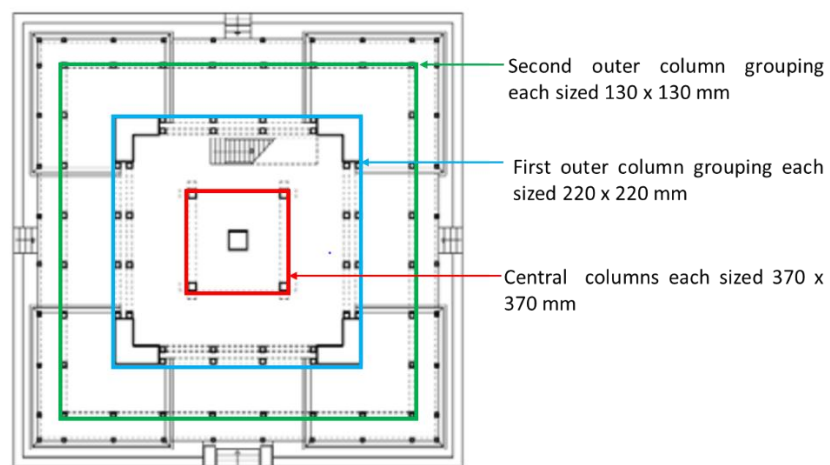
Both first and ground floors have different groupings of columns around the central four. The wooden posts support wooden beams upon which wooden floor boards are placed.

Figure 20 Ground floor column grouping

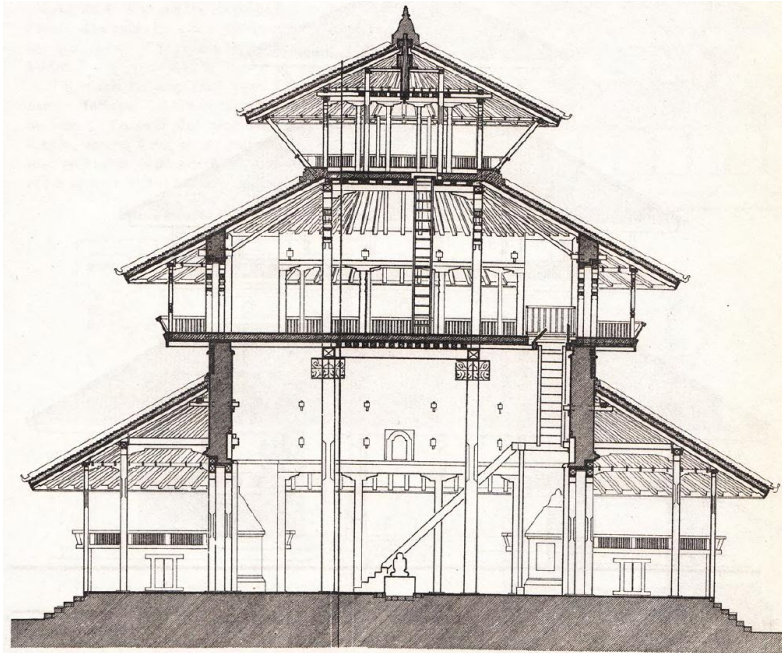
Both first and ground floors have different groupings of columns around the central four set to bear the two wide overhanging roofs on both these floors. The second floor roof is supported by the arrangements of 20 timber posts. The central four column arrangement ends at the first floor and does not extend to the second floor.

Figure 21 North- south Section showing arrangement of columns and roof support

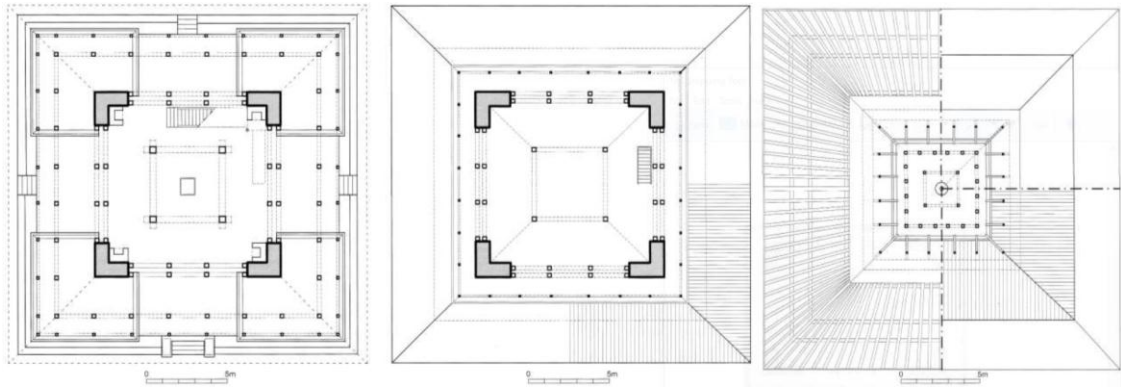
Based on the necessity, few things has been modified from the old one e.g. Railings, copper tie in footing, metal nails in few places.

Figure 22 plans for reconstruction of kasthamandpa

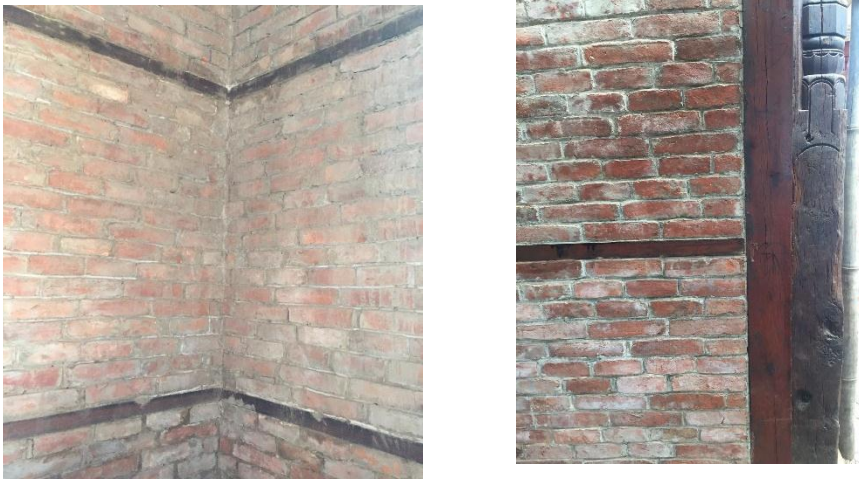
Size of posts were not changed but corner posts were added. Wall ties were used in in form of timber bands at 1.2m interval heights internally and 1.8 m interval externally. Timber posts were added in corners of brick walls.

Figure 25 Corner post first floor

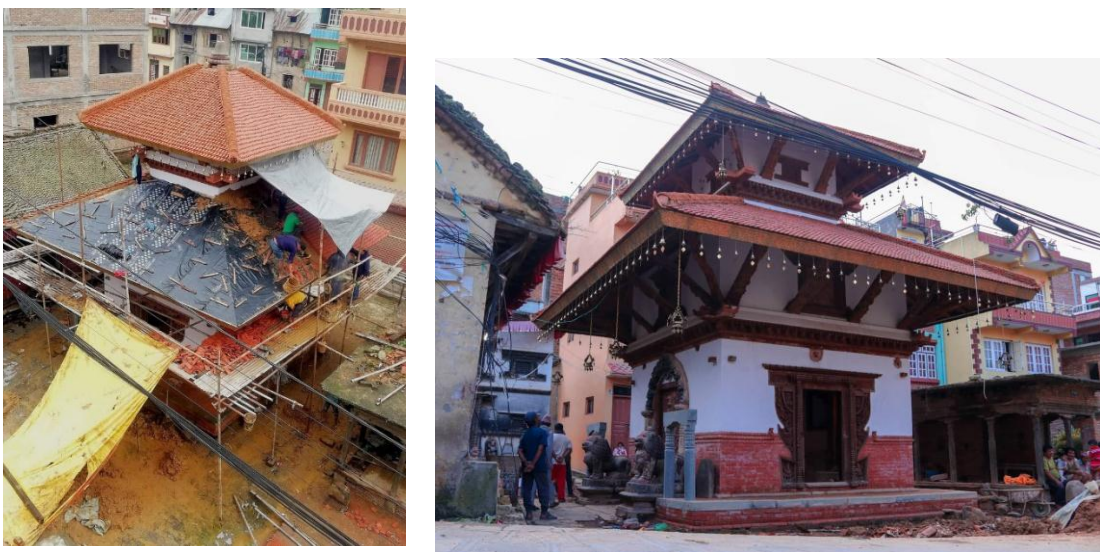
After the 1949 renovation, the latest major act of conservation was the reconstruction of temple after the 2015 earthquake. According to Kathmandu Valley Temples (2020) the two Roof Temple (Pagoda Style) of Mahalakshmi was partially damaged 2015 by earthquake. After the 2015 earthquake, meetings were called among the locals that included members from Mahalaxmi guthis, political parties and other local members to discuss the earthquake damage and conservation needed for the heritage in Balambu. From the initial meetings, it was determined that the reconstruction of the Mahalaxmi temple was desired as other reconstruction projects were also going on after the earthquake. A committee called '*Mahalaxmi Purnanirman Samiti*' consisting of seven members was established and they began efforts for the reconstruction of the temple in coordination with the local authority (ward no. 12 office of Chandragiri Municipality). Initially, the plan was to gather fund locally and the reconstruction of the temple to be overseen by the committee. After learning of the requirement of Department of Archaeology involvement in conservation of old temples, the committee and ward office approached the department with initiation through senior archaeology officer Jayram Shrestha. The department of Archaeology after initial check recommended the reconstruction of temple as the structure was damaged after the earthquake. Cracks were seen in the interior of the upper floor and in addition to this the timber was rotten due to leaks on the roof. The reconstruction project started in 2076 B.S.

Figure 64 Mahalaxmi temple during and after reconstruction

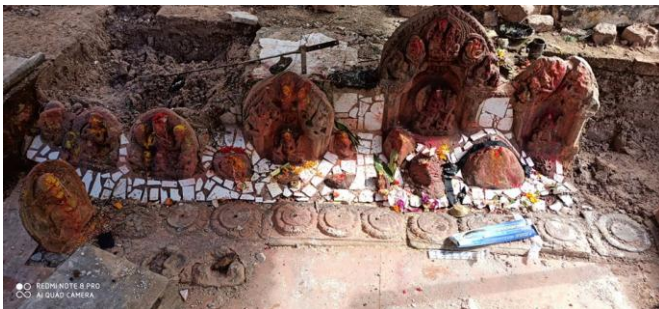
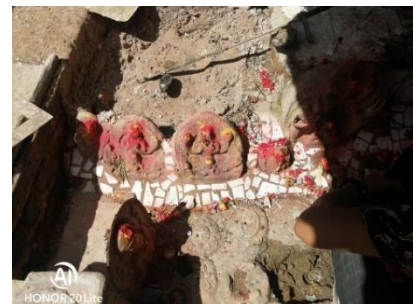
Inside the temple, stone statues and stones representing deities are placed in a linear manner. The statues are surrounded by raised stone platform. The stone statue of Mahalaxmi is placed at the center.

Figure 72 stone idols before (left) and in the process of removal for new column placement (right)

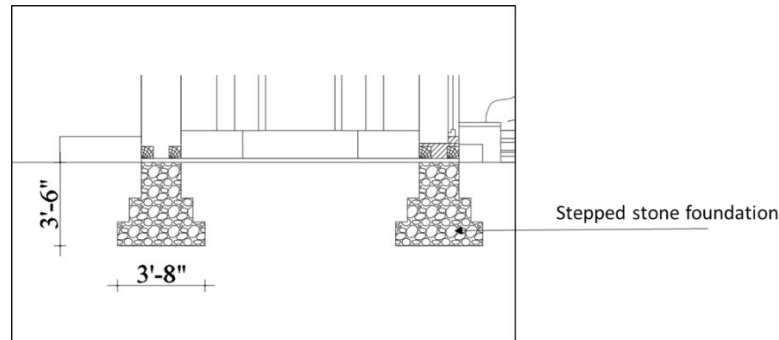
The foundation is not exposed. The original foundation was stone in mud mortar of 12” depth. For the new construction, the foundation was increased to 3.5’ and lime concrete in 1:2:4 lime, sand and aggregate was used.

Figure 73 foundation detail new

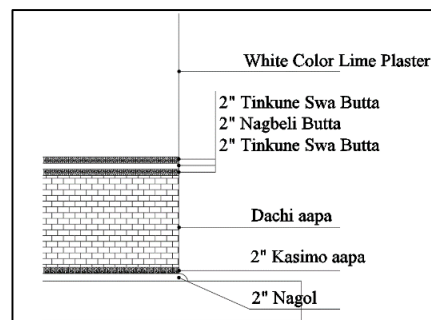
Figure 75 Ground floor wall detail new

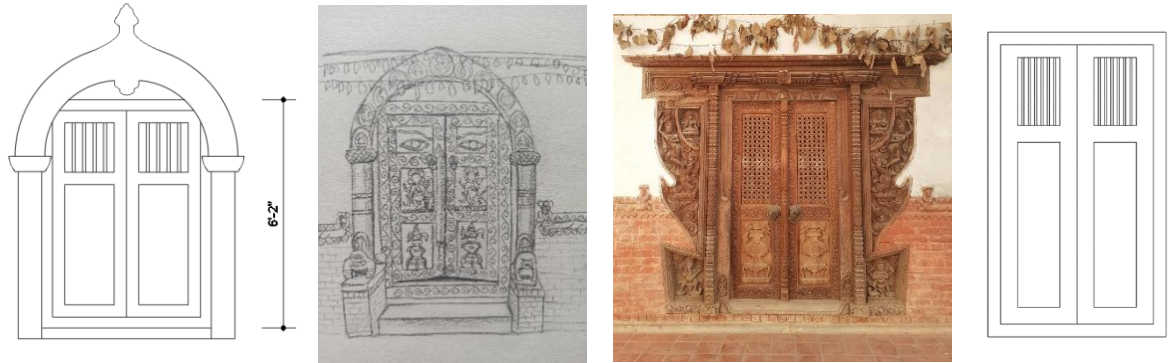
added to them. Devi ko and bhaila ko are added to the sides and carvings of astamangal and lattice are added to the shutters. For the main door, shutters and most of the frame are reused but copper plated. The copper plated design adds design of astamangal to the shutters. In the front entrance, the stone toran and two sets of lion statues are reused.

Figure 90 Main door old (left) and new (right)

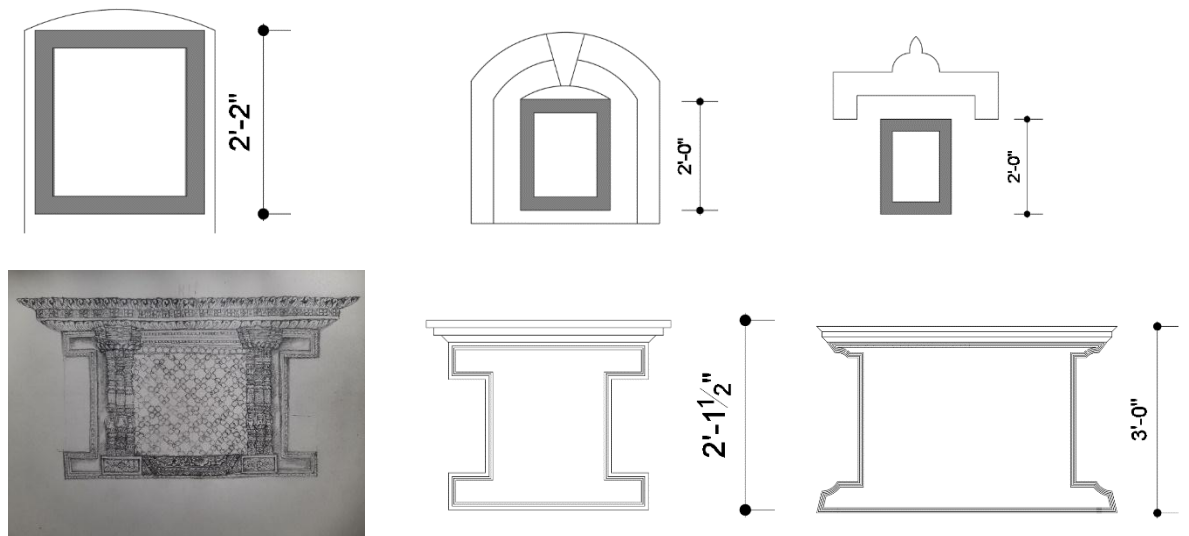
Windows in the old structure were plain wooden ones. For the new structure, the windows are made more elaborate in design with carvings and multi leafed.

Figure 91 Windows old design (upper row) and new (lower row)
Ground floor (left), first floor (middle) and top floor (right)

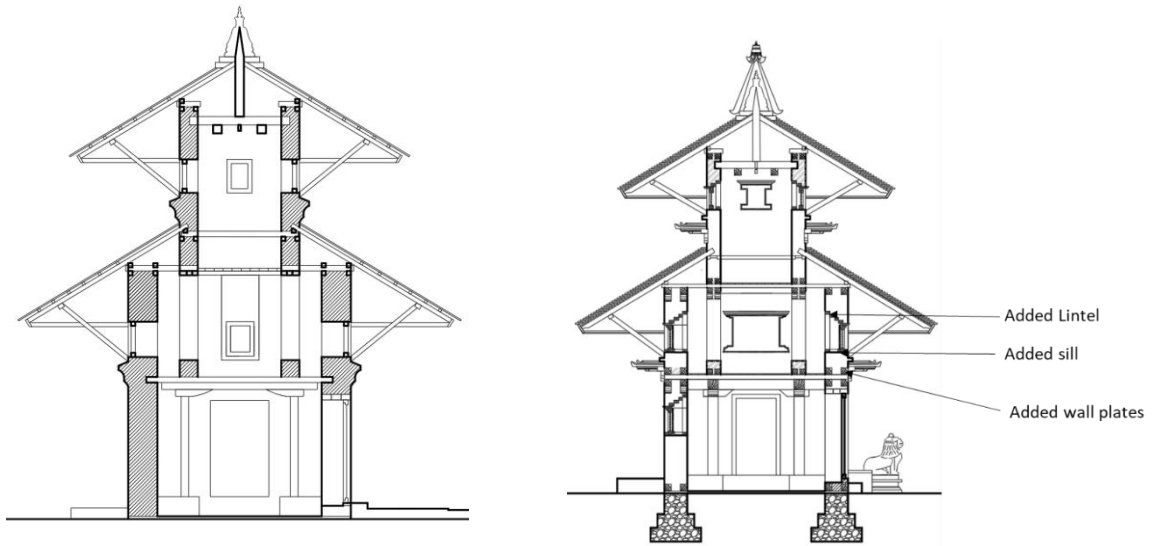
Wall plates were added in three heights in each wall which also acted as sill and lintel bands for the openings. Since the columns are new, the timber from previous columns were used for wall plates.

Figure 92 Section at A-A old (left) and new (right)

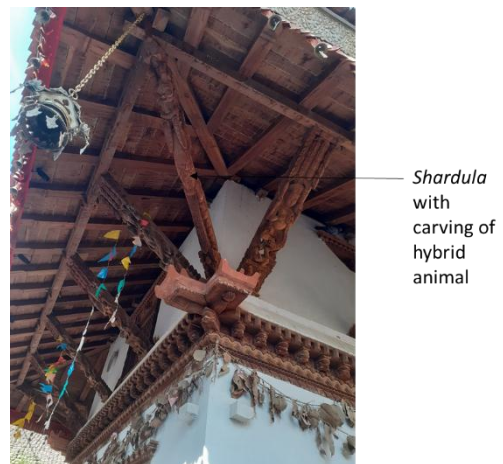
Figure 93 struts south eastern corner lower roof new

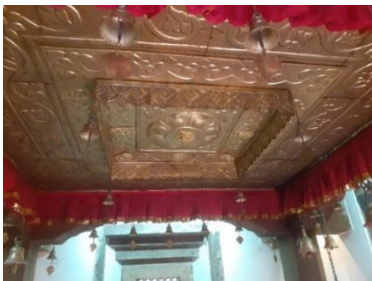
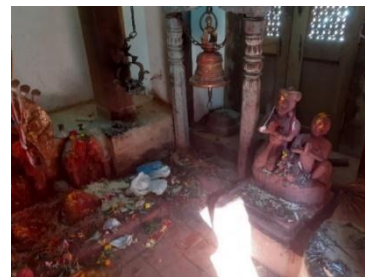
Illhan (metal decorative ceiling) was added to the ground floor interior. The temple previously had a gold plated *illhan* which was stolen and then replaced with a fabric one. Stone post for bell was added.

Figure 96 metal decorative ceiling in the temple

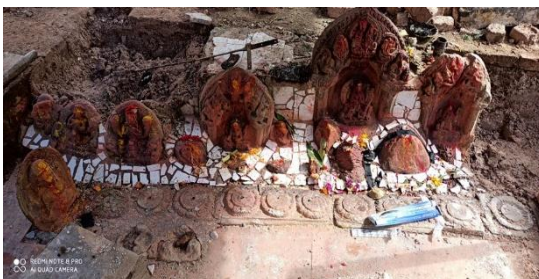
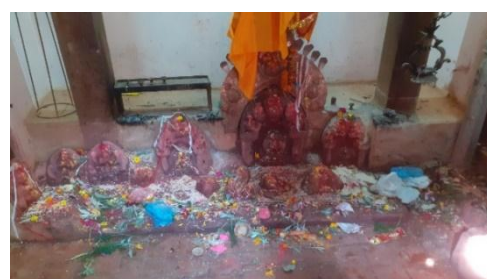
Figure 97 Stone idols placement before and after reconstruction

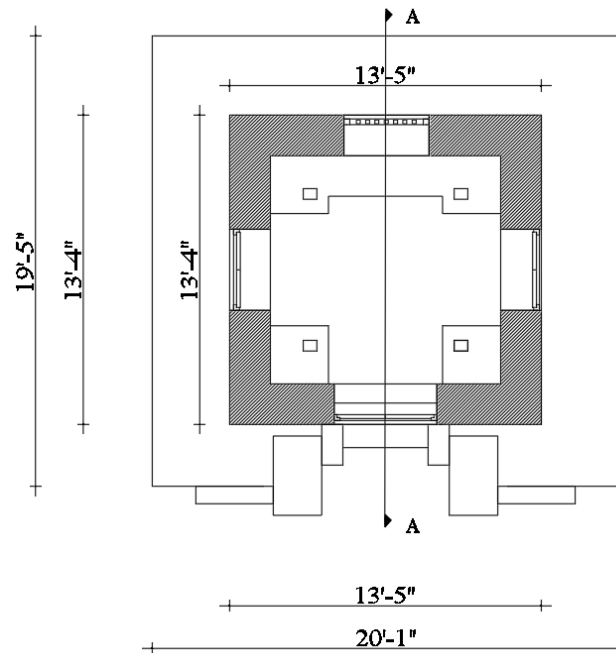
Figure 101 Ground floor (plan at level 1)

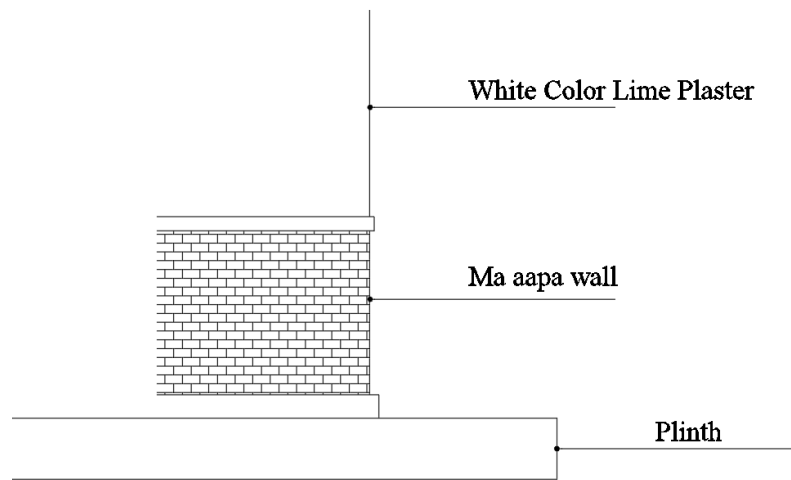
Figure 109 Ground floor exterior wall

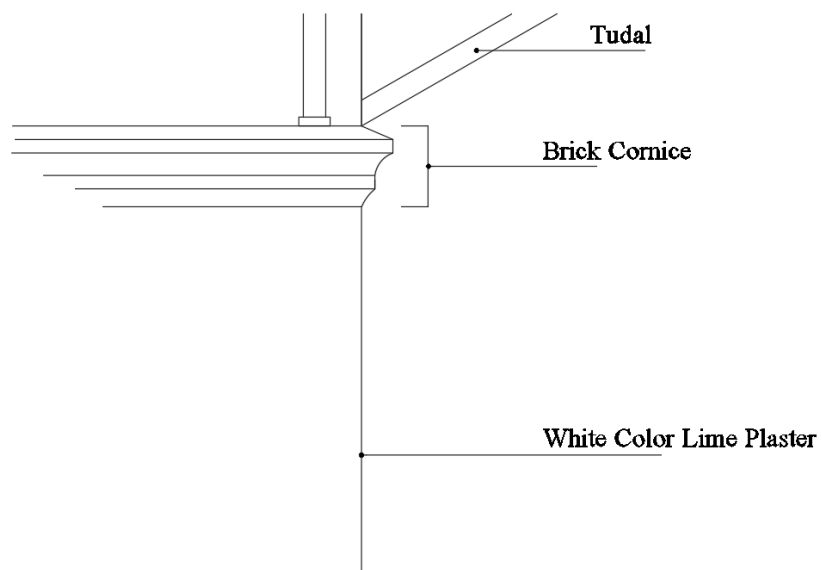
Figure 110 Cornice details

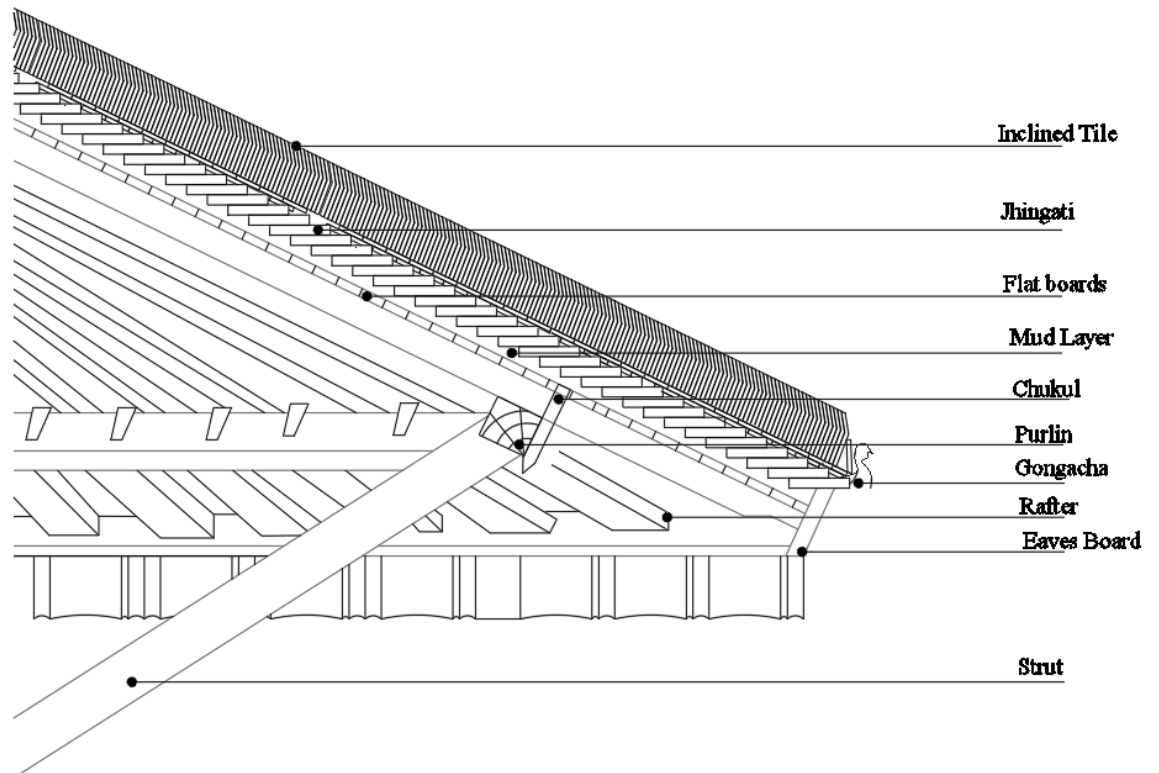
Figure 111 Roof details

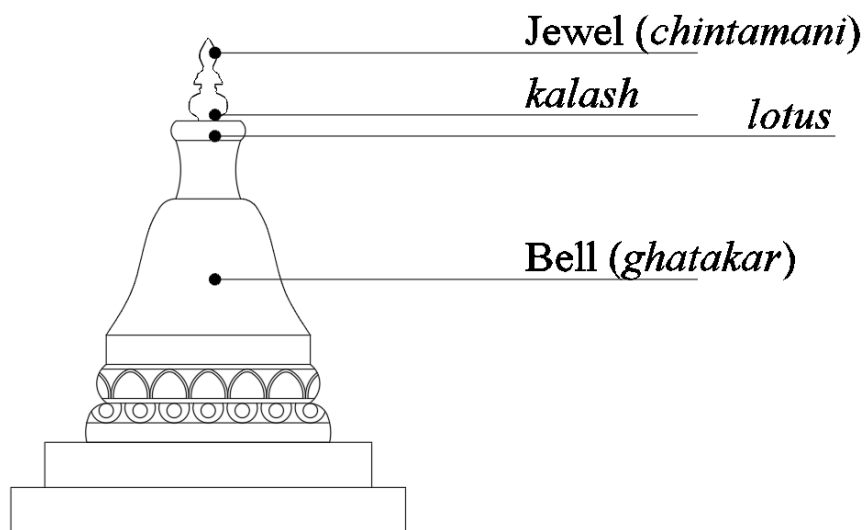
Figure 112 Gajur details

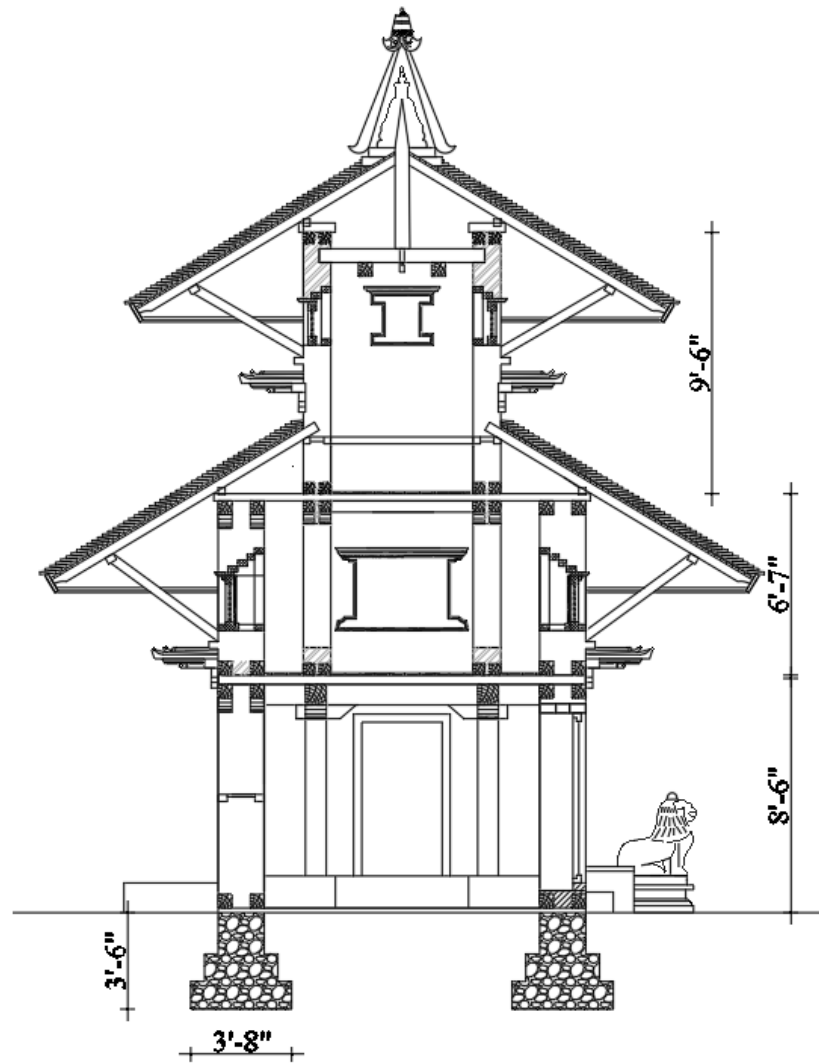
Figure 119 Section at A-A

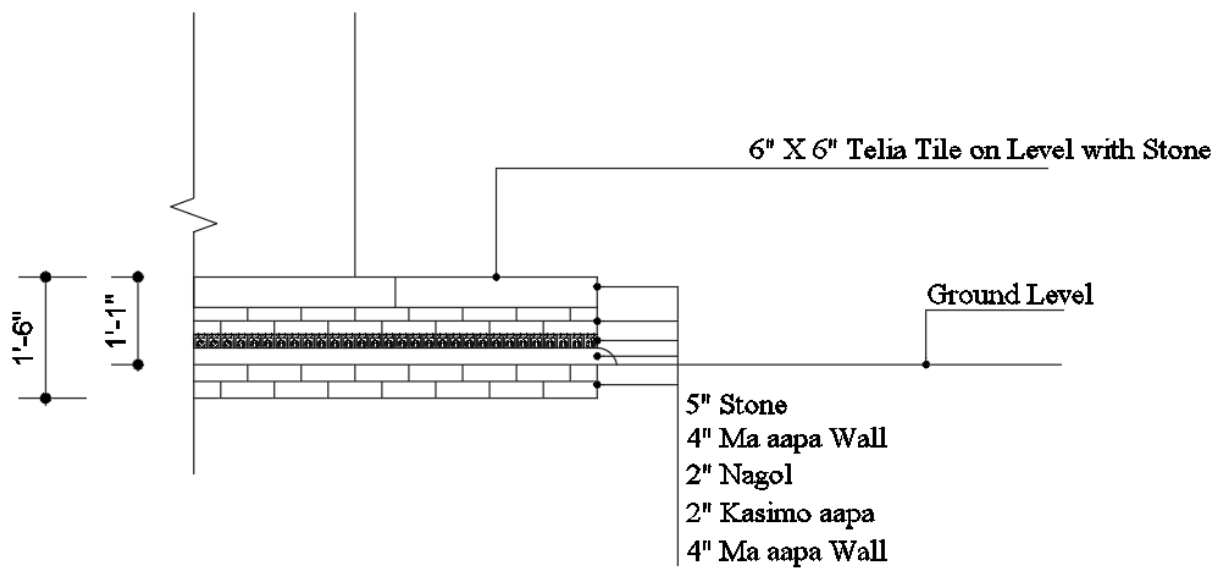
Figure 123 Plinth details

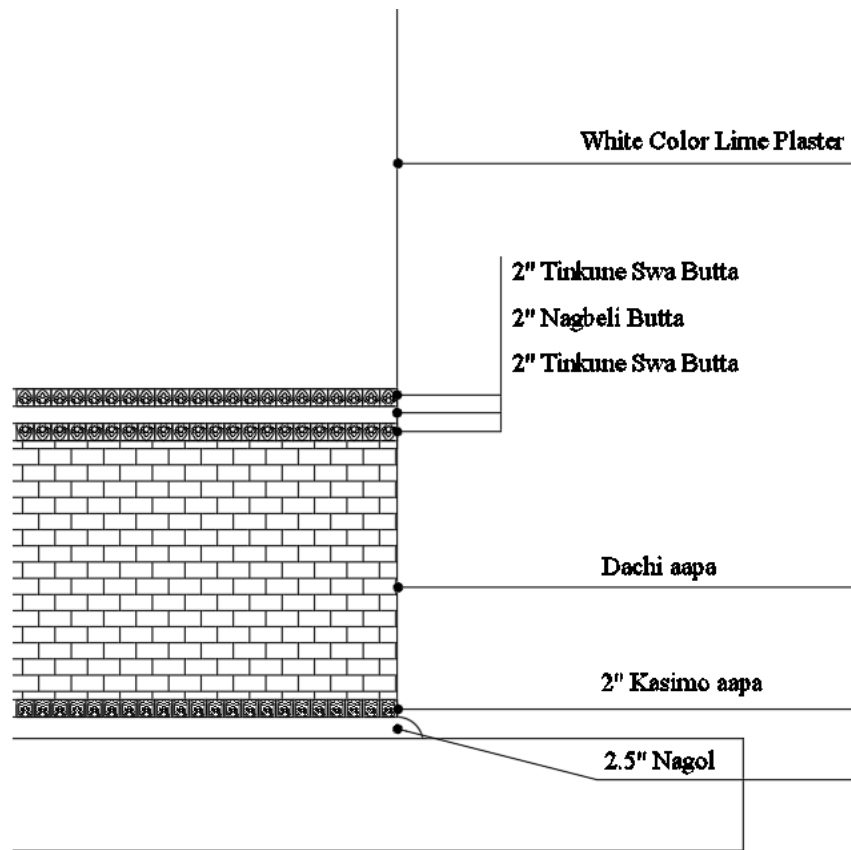
Figure 124 Ground floor wall exterior

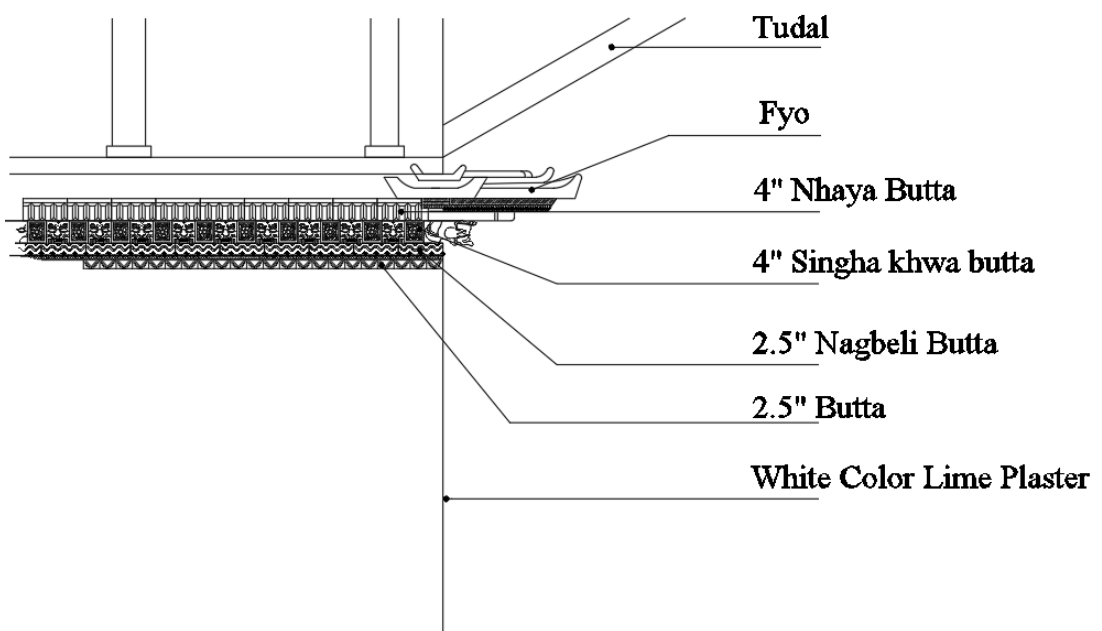
Figure 125 Cornice details

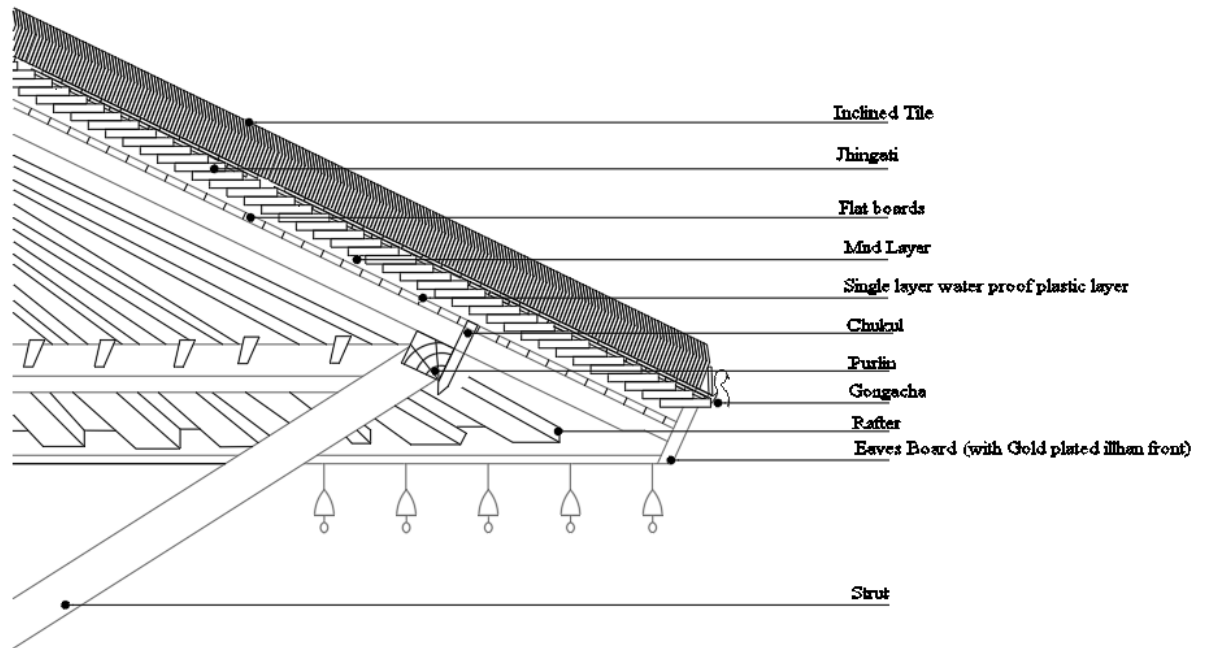
Figure 126 Roof details

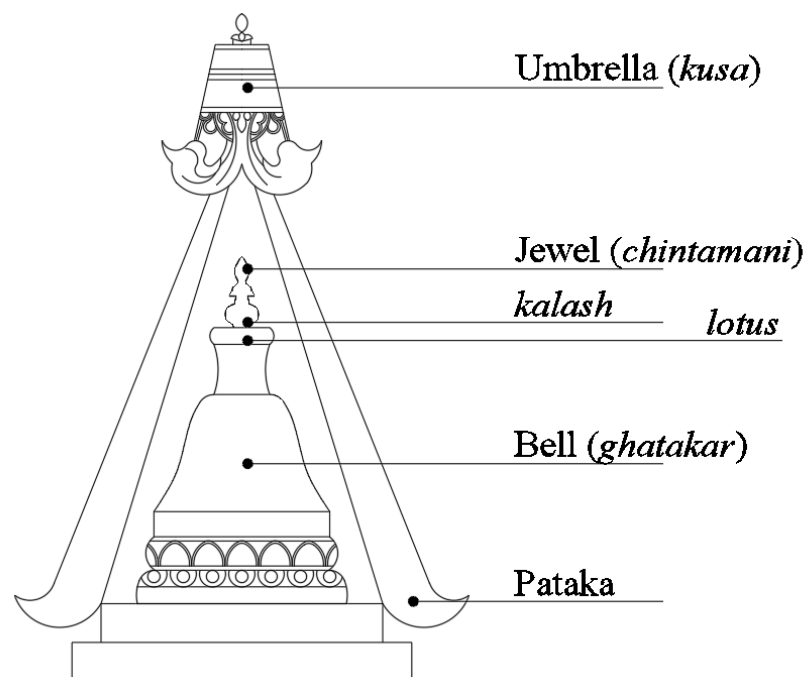
Figure 127 Gajur details
