**TRIBHUVAN UNIVERSITY
INSTITUTE OF ENGINEERING
PULCHOWK CAMPUS**

**Seismic Vulnerability Assessment and Retrofitting Techniques for
MRT Compliant RCC Buildings**

**SUBMITTED TO THE DEPARTMENT OF CIVIL ENGINEERING
IN PARTIAL FULFILLMENT OF THE REQUIREMENTS FOR THE
DEGREE OF MASTER OF SCIENCE IN ENGINEERING IN
DISASTER RISK MANAGEMENT**

SEPTEMBER, 2022

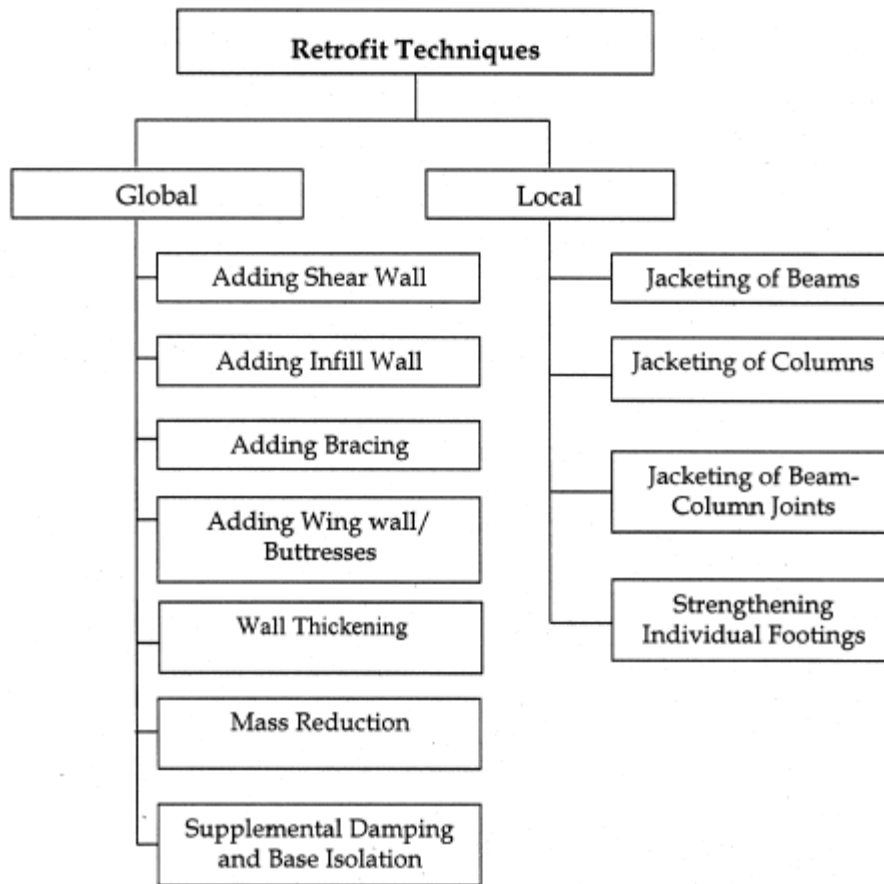
Figure 4 Retrofitting Techniques

longitudinal reinforcement and to increase shear strength. The jacketing can be of columns, beams, foundation, shear wall.

1. RC jacketing of Columns

RC Jacketing is a technique for reinforcing and improving structural components. When the structural design is changed, it is used to enhance bearing load capacity. When a structural member fails, it is utilized to restore the integrity of the design (DUDBC 2016). It can be used on beams, columns and wall. The jacketing consists of added concrete with reinforcement in longitudinal and direction with stirrups covering the original column. The column's structural analysis determines the jacketing thickness as well as the quantity and diameter of the rebar used in the jacketing procedure. It enhances the column's ductility and flexibility. The column's ductility and shear strength are increased by the closely spaced reinforcement stirrups given in the jacket. It increases a building's ability to withstand lateral loads and prevents stiffness concentration, as is the case with shear walls.

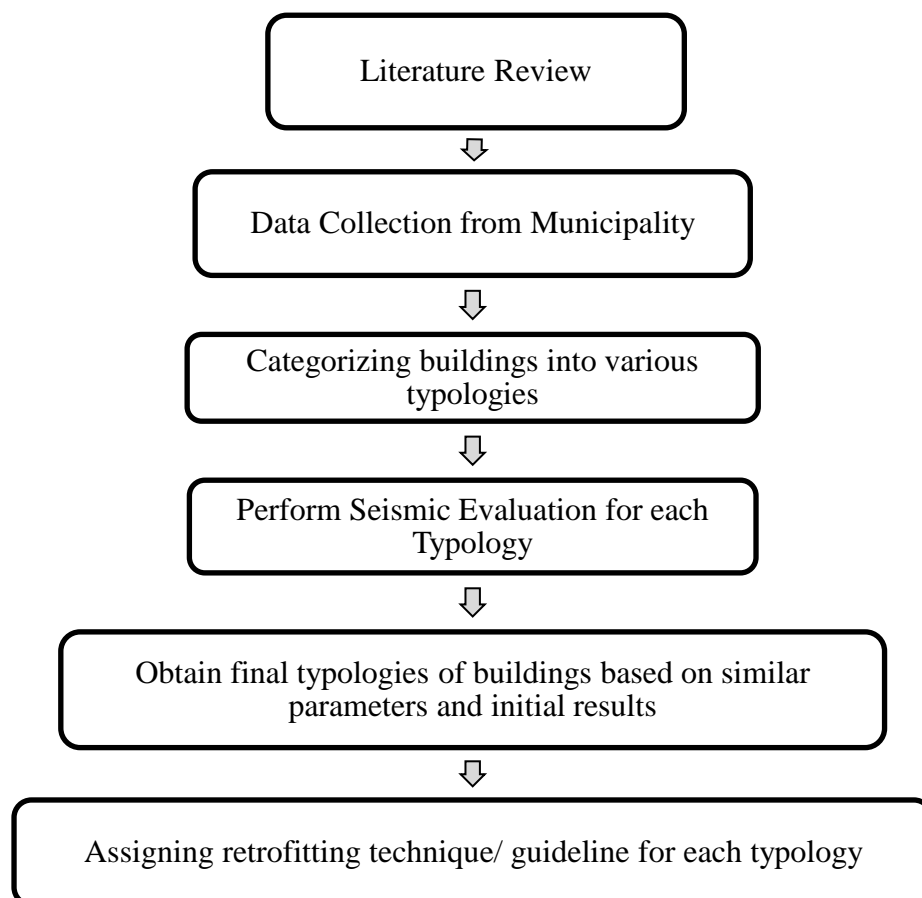
Figure 5: Research Framework

A research framework is a conceptual illustration of the study's purpose. It covers the necessary steps required in order to accomplish the research's objective. A sequence of steps taken to accomplish the study objectives are utilized to construct the research framework. Figure 5 shows flowchart of the research framework.

Data collection (approved building drawings) was done from municipality office. The buildings were categorized into various typologies based on sizes of frame, span, number of storeys, building and floor height, number of bays, dimension of structural components, grade of concrete.

The analysis and design was carried out using finite element software ETABS. The structural deficiencies for each typology were assessed and the ones requiring similar upgrading of structural components were generalized into final typology. The seismic performance level of buildings was evaluated by performing pushover analysis by FEMA 440/ATC 40's capacity spectrum method. The strength and deformation requirements of the structural system were used to estimate its performance, and these requirements were then compared to the capabilities available at the desired performance level.

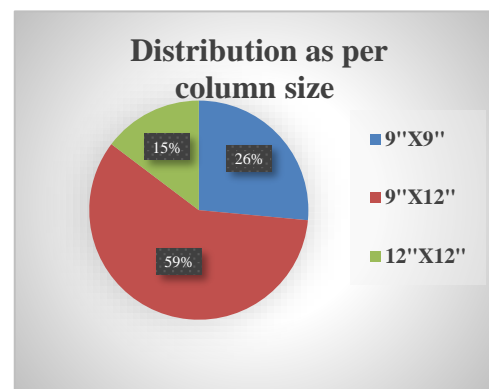
Figure 8 Distribution of MRT compliant buildings as per column size

More than half (59%) of MRT compliant buildings had column size of 9"X12". Seventy one percent of MRT compliant buildings followed NBC 205:1994. Similarly, prevalence of two storey and two and half storey with/without staircase cover was observed.

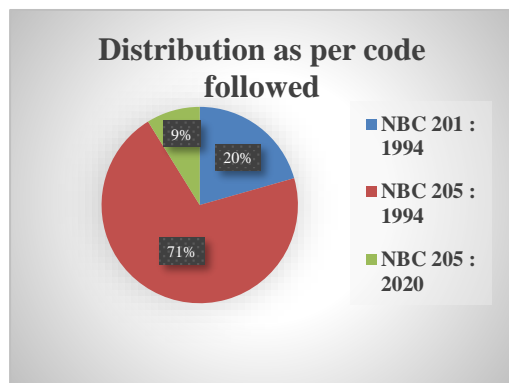
Figure 9 Distribution of MRT compliant buildings as per Code Followed

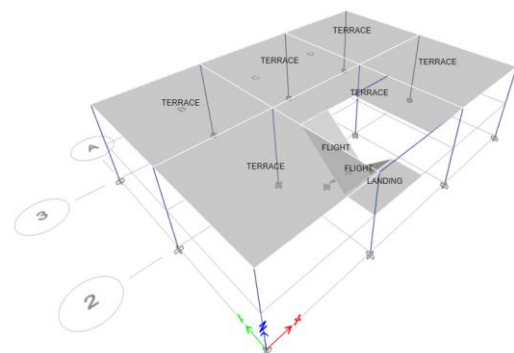
Figure 11: (a) Floor Plan of Typology A (b) 3D Model of Typology A

The building showed maximum drift of 0.001, which is less than allowable 0.00625, and maximum displacement of 2.5mm and 2.6mm in EQx and EQy direction respectively. Maximum allowable displacement is $0.00625 \times$ height of the building which is 23.75 mm in this case. Torsional irregularity was found at A3 and D3 under EQx loading. Hence, those columns must be revised.

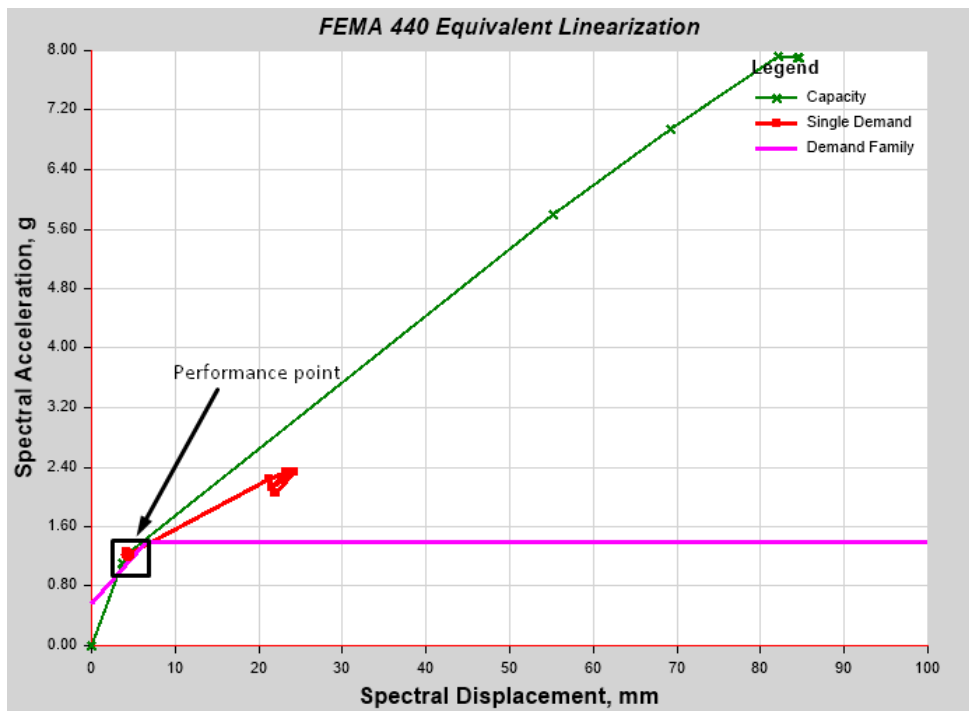
Figure 15 Performance point of retrofitted structure

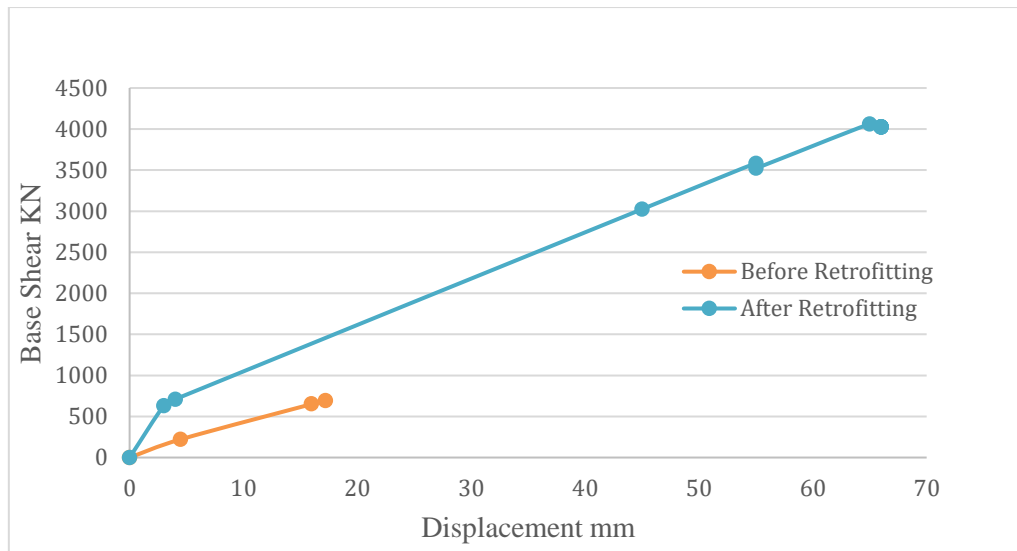
Graph 1 Pushover curve before and after retrofitting for typology A

The above graph 1 shows the pushover curve of the building before and after retrofitting from which it can be interpreted that the performance (capacity) of building has improved after the application of assigned retrofitting strategy.

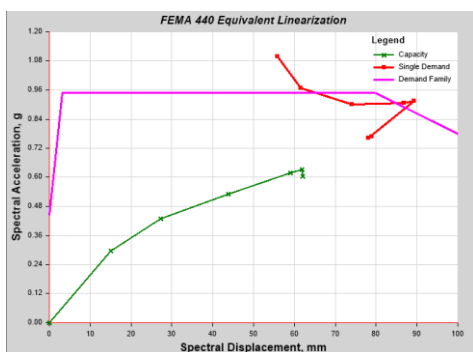
Figure 24 Demand Capacity Curve Before Retrofitting

Here, the performance point was not obtained for the building in its original condition but after retrofitting the performance point was obtained with desirable drift i.e. performance level.

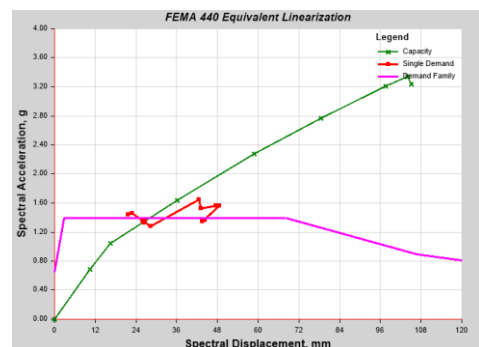
Figure 25 Demand Capacity Curve After Retrofitting

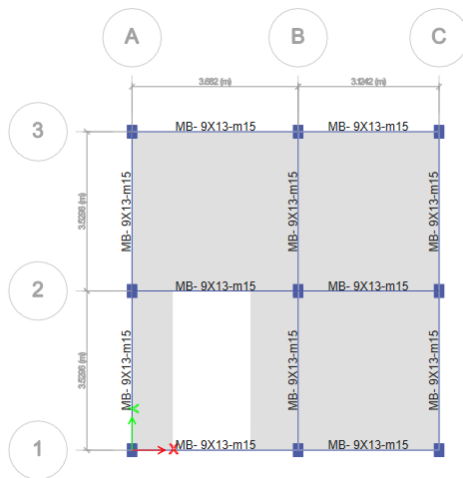
Figure 32: Plan of Typology D

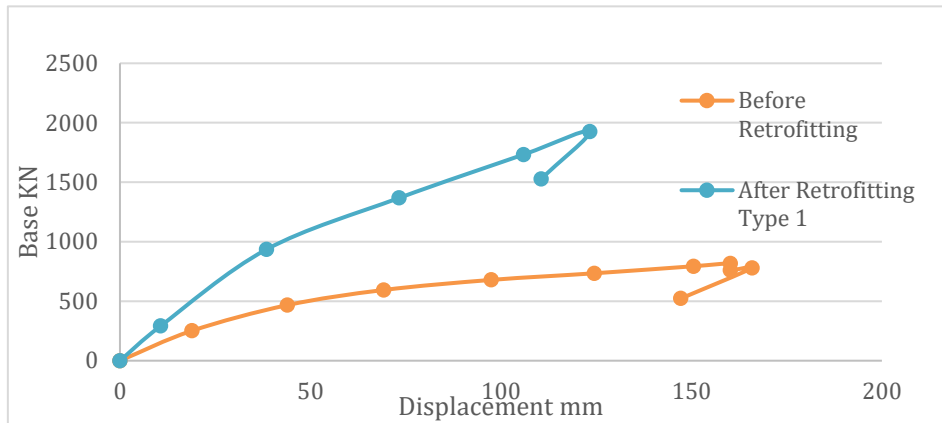
Graph 4 Pushover curve before and after retrofitting for typology D

The above graph shows the pushover curve of the building before and after retrofitting from which it can be interpreted that the performance (capacity) of building has improved after the application of assigned retrofitting strategy.

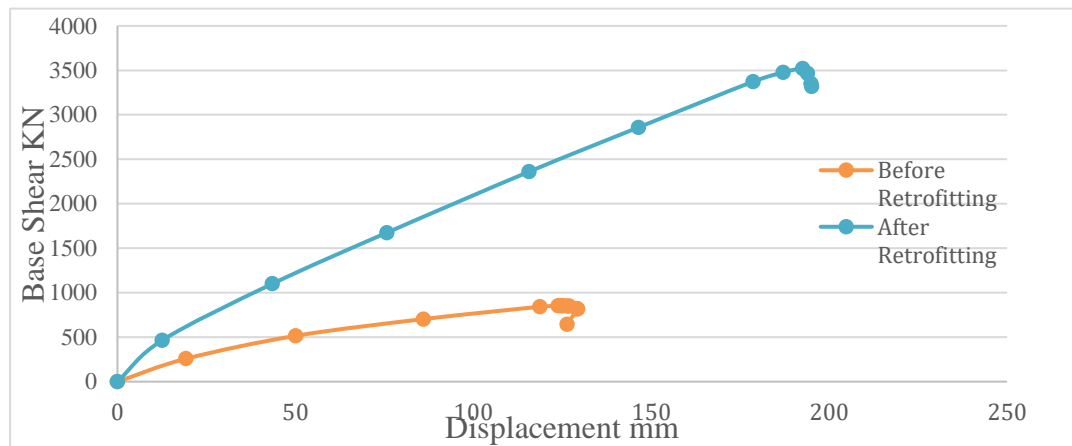
Graph 6 Pushover curve before and after retrofitting for typology F

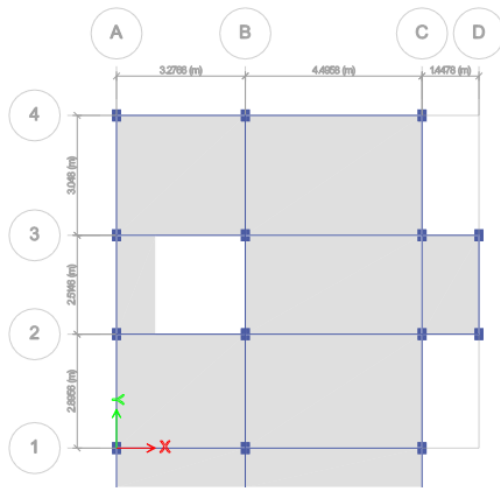
Figure 57: Plan of the Building

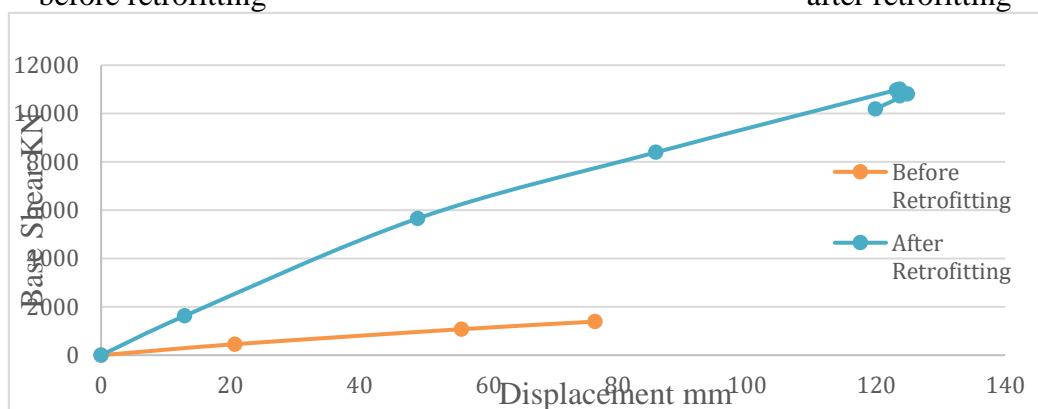
Graph 8 Pushover curve before and after retrofitting for typology H

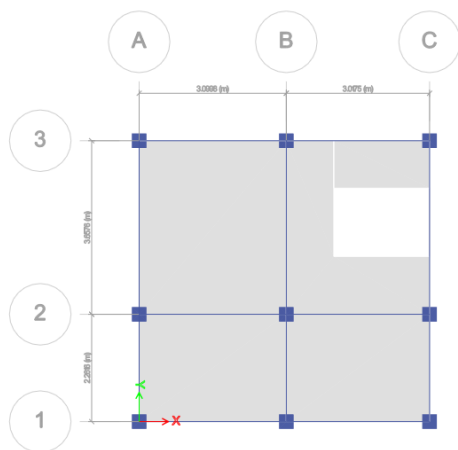
Figure 61: 3D Model of the Building
