Thesis No.: G011/075

Study of Stability of Slope Failure-The Case of Singati Landslide, Dolakha

SUBMITTED TO THE DEPARTMENT OF CIVIL ENGINEERING
IN PARTIAL FULFILLMENT OF THE REQUIREMENTS FOR THE
DEGREE OF MASTERS OF SCIENCE IN GEOTECHNICAL ENGINEERING

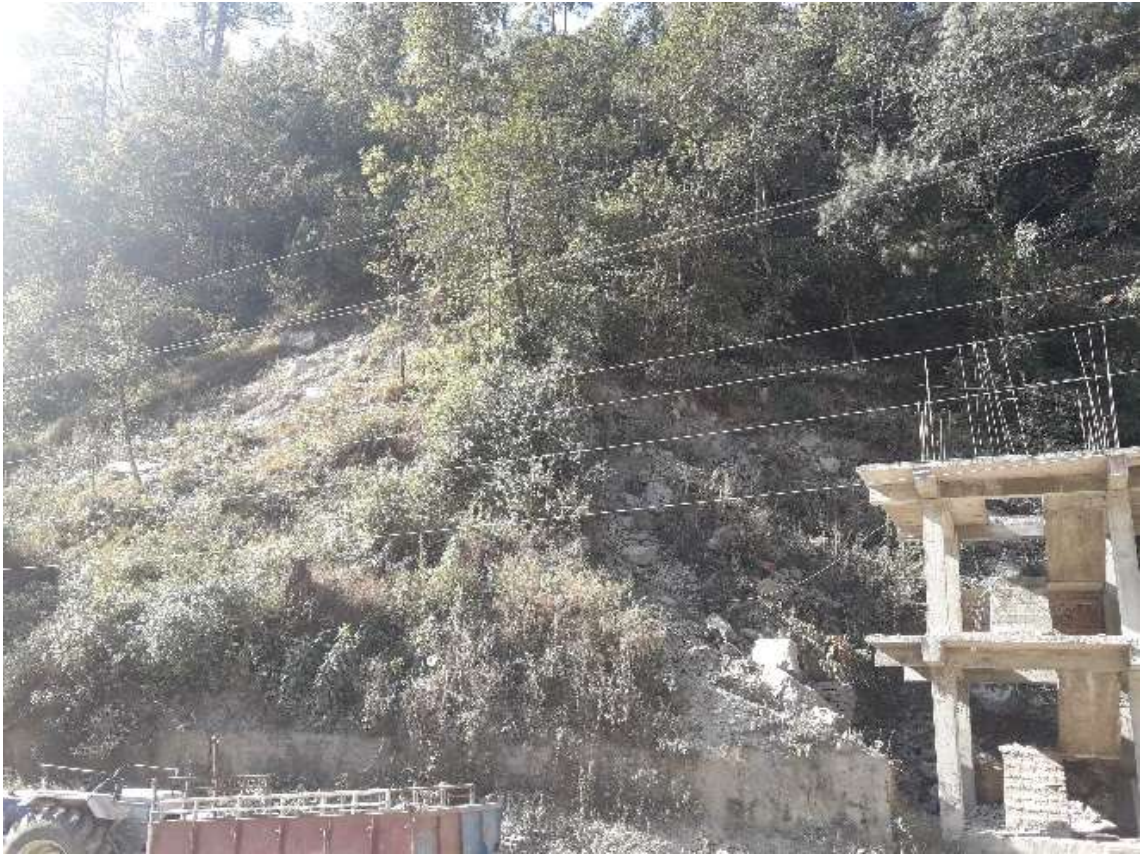
Figure 1. 2: Under Construction building damaged by landslide.

building which is under construction is damaged as seen in Figure 1.2. The infrastructures like road, bridge over Singati River are subjected to risk. The transmission tower which was constructed on the landslide zone by damaged by this landslide phenomenon.

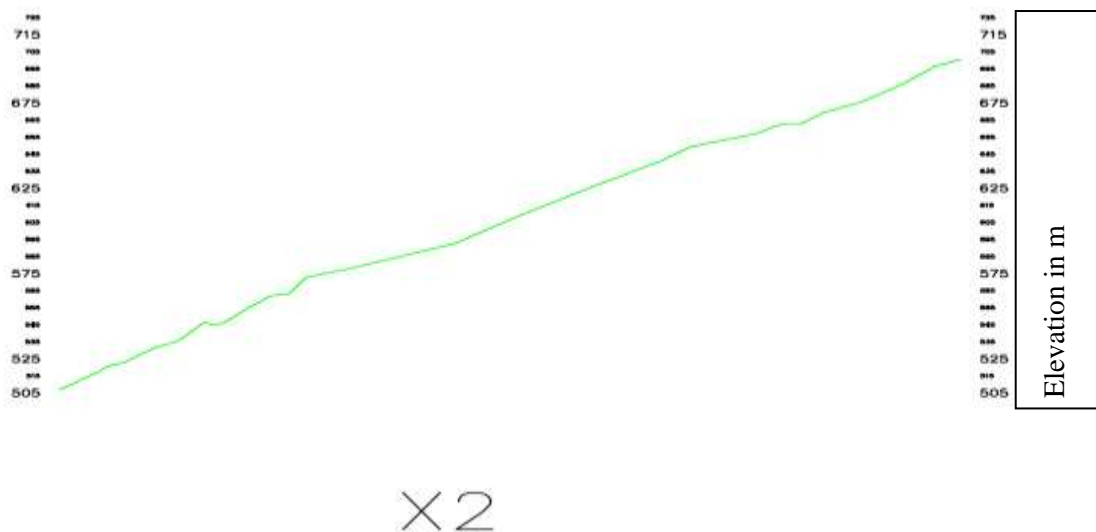
Figure 3. 3: Cross section of the studied slope (Source: NEA Engineering Co. Ltd.)

The survey work reports are collected from NEA engineering company limited. In order to perform back analysis, the cross section of the critical slope is needed. The sketch of cross section were provided by the NEA engineering company limited.

Cross section X2 as shown in Figure 3.3 is used for the back analysis using deformation data as this slope represent the more number of pillars i.e. Pillar 1, Pillar 2, Pillar 3, Pillar 4, Pillar 5, Pillar 6 and Pillar 16.

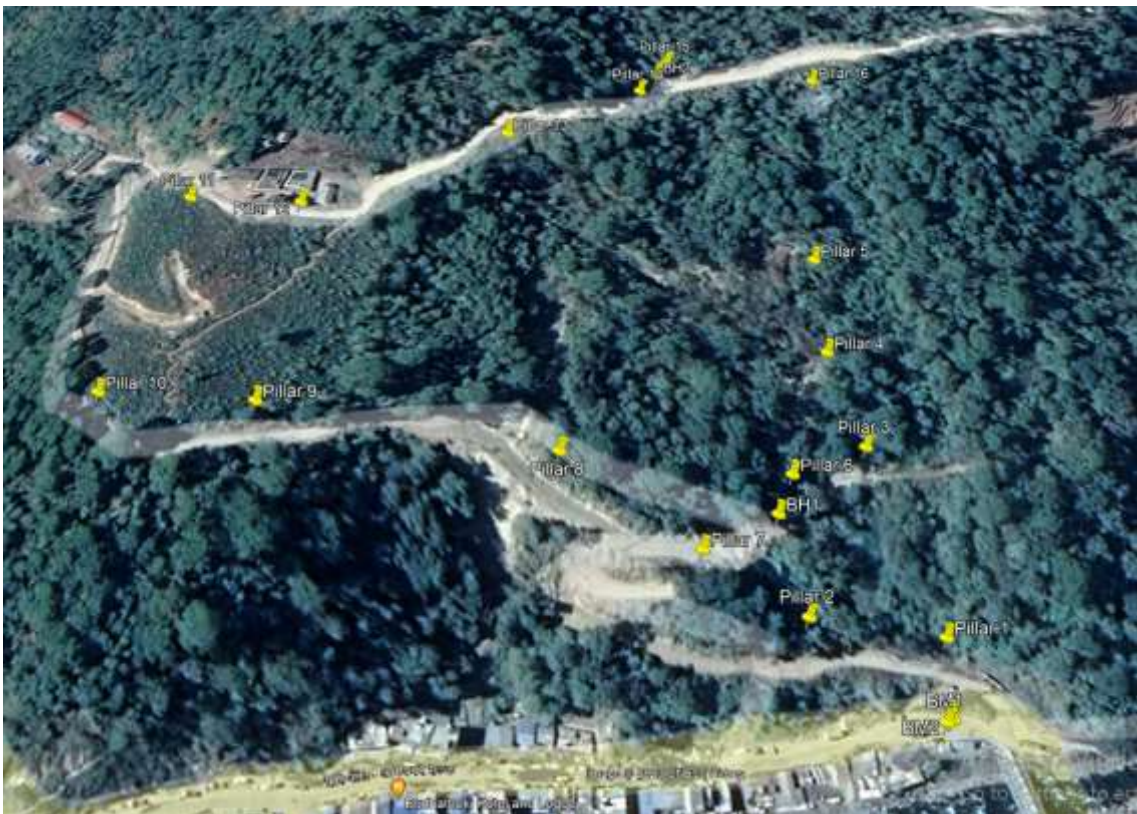
Figure 4.1: Location of Installed Pillars in the study area (Source: Google Earth)

The concrete pillars are installed in the different location in the study area as shown in Figure 4.1. The deformation in the various months are measured by using total station surveying equipment. The measured deformation are compared with the data of the first pillar installed month. The co-ordinates of the installed pillars are recorded after installation with respect to the fixed position benchmark BM2 and BM1. The Co-ordinates of the installed pillars in the month of Falgun is tabulated below in Table 4.1.

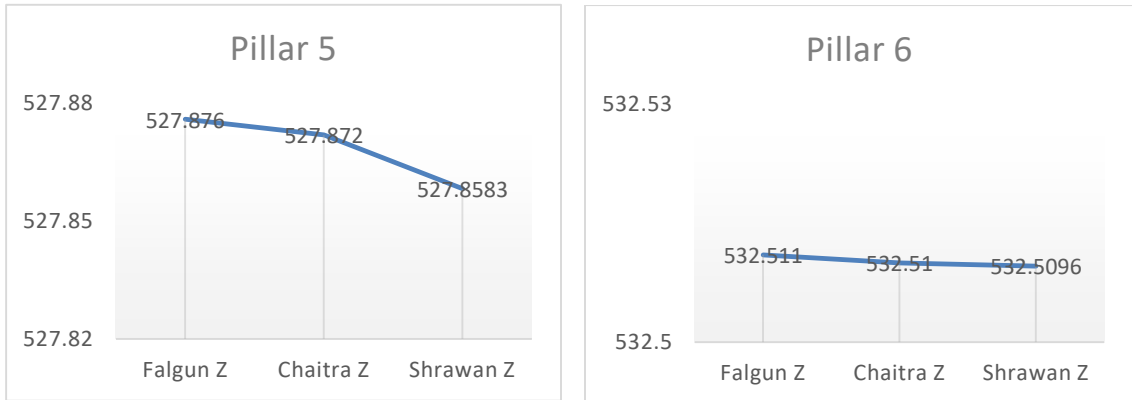
The X, Y and Z co-ordinates for the month of Falgun, Chaitra and Shrawan are recorded and the deformation seen in the vertical direction in various months with relative to Falgun are calculated and presented in the next sections. The deformation in the Y direction i.e. in the vertical direction which can be seen by plotting the Z co-ordinates measured during various months are presented in the below figures for each Pillar data.

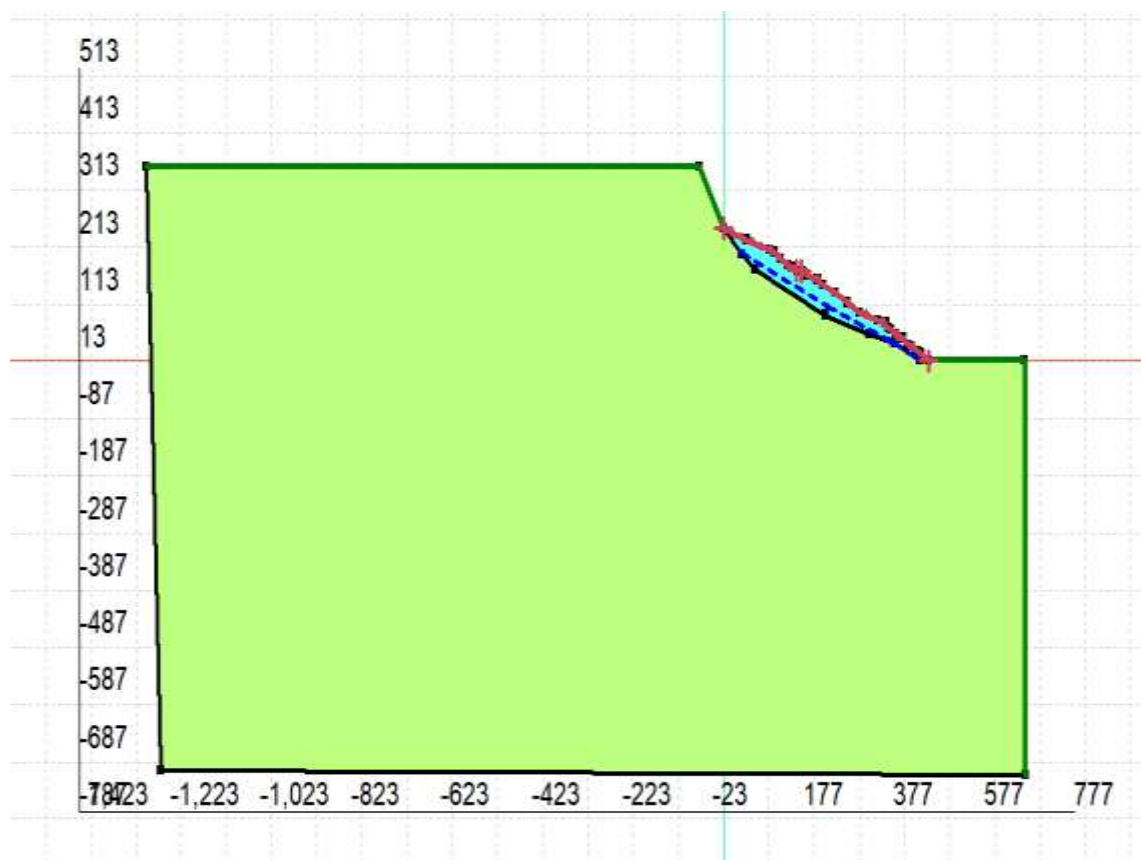
Figure 5. 13: Model in LEM.

Figure 5.13 shows the geological model prepared in LEM and the data shown in the figure are taken from the back analysis by FEM.

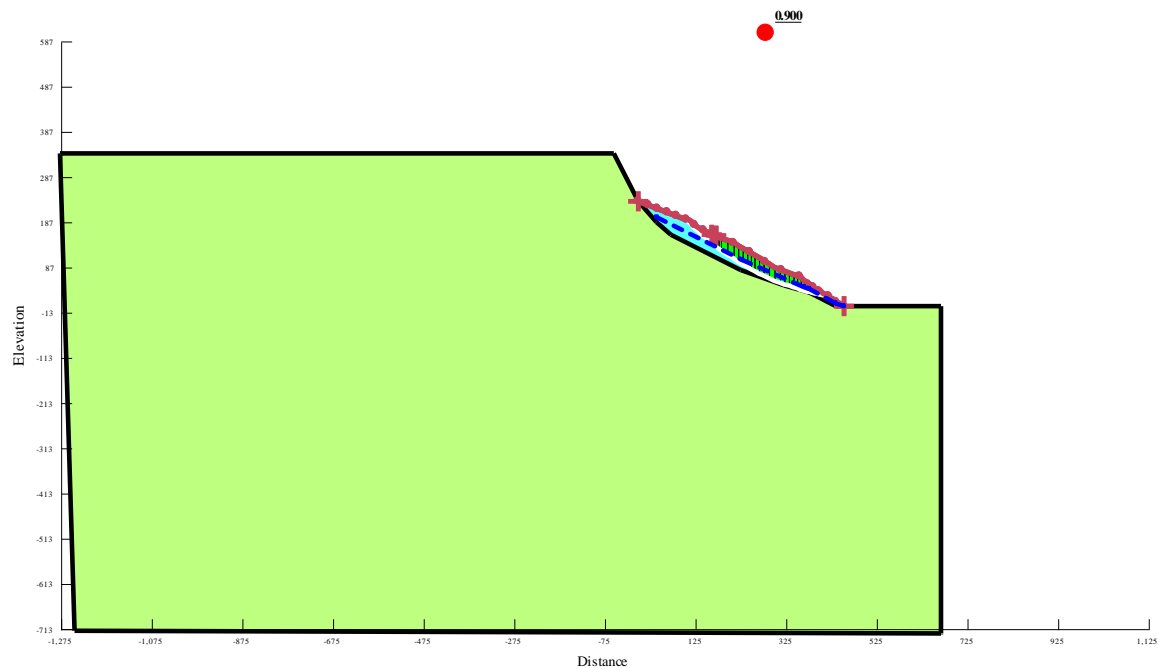
The material properties are assigned to each layer, entry and exit method is used to represent failure surface. The water table surface at 8m from the original water table is drawn and the analysis is carried out.

Color	Name	Model	Unit Weight (kN/m ³)	Cohesion' (kPa)	Phi' (°)	Phi-B (°)	Piezometric Line
■	Rock Layer	Mohr-Coulomb	24	85	30	0	1
■	Top Layer	Mohr-Coulomb	18	5	28	0	1

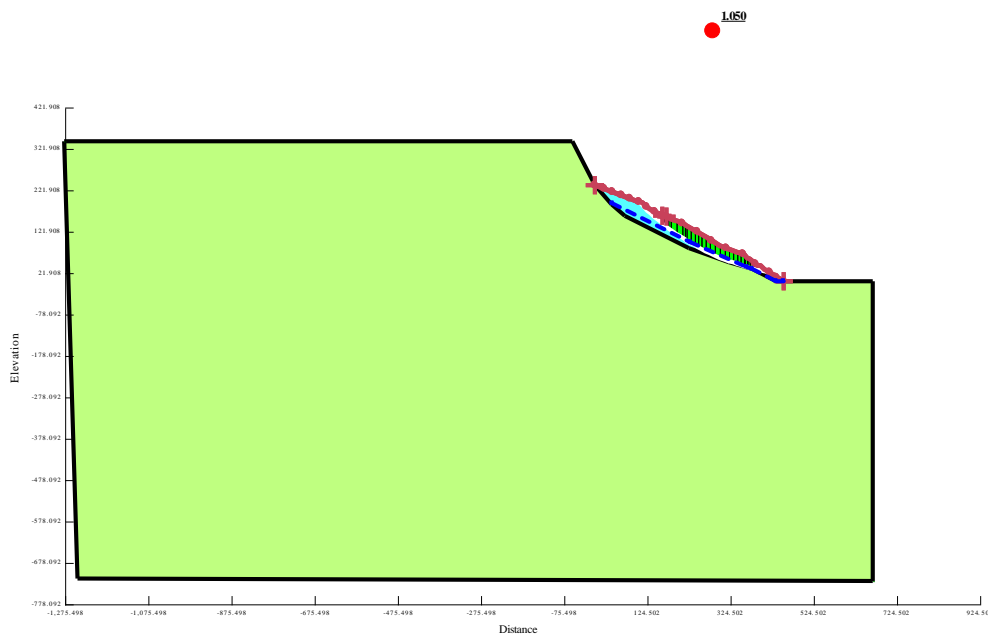
The mitigation model for the slope was prepared by carrying out the trails by further decreasing the water table and checking the Factor of Safety of the slope. After decreasing the water table to the original ground water table measured in Magh month, Factor of Safety value of 1.05 is achieved which is presented in the Figure 6.1.

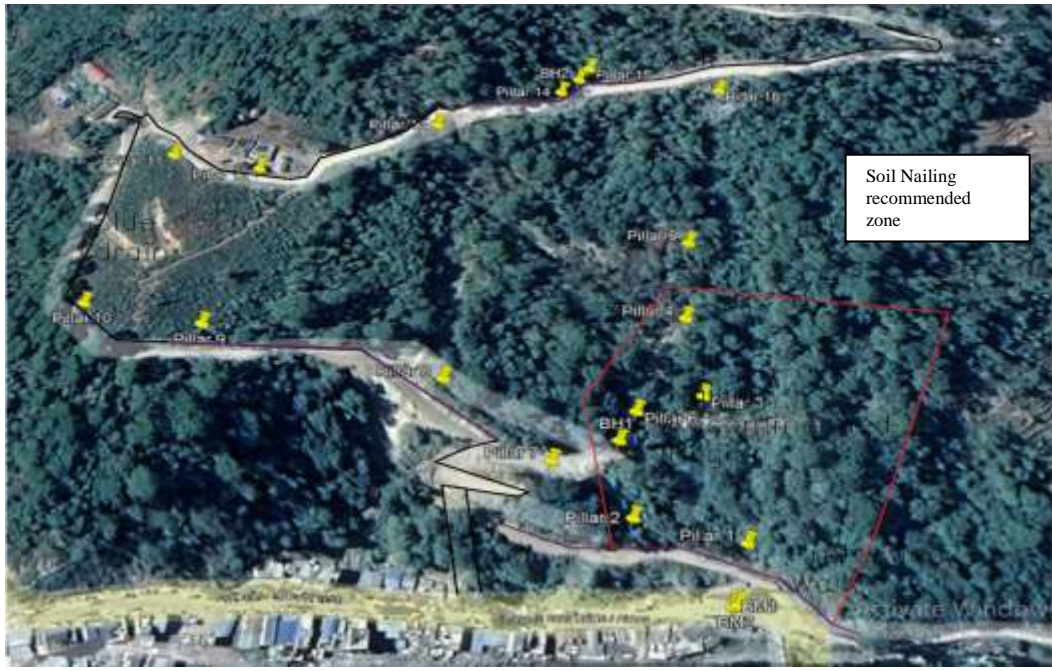
Figure 6. 3: Recommended Protection measures.

After the decrease in water table showed the increased stability of the slope, the basic recommendation for mitigation measures such as surface and subsurface drainage, protection walls in the road sides and soil nailing in the toe area of the slope are recommended as shown in the Figure 6.3 which shall be verified and designed by the experts.
