**TRIBHUVAN UNIVERSITY
INSTITUTE OF ENGINEERING
PULCHOWK CAMPUS**

THESIS NO: M-129-MSTIM-2013/2023

**Corrosion on welded joints of buried head race pipe
A case study of Daraudi Khola A Hydropower Project**

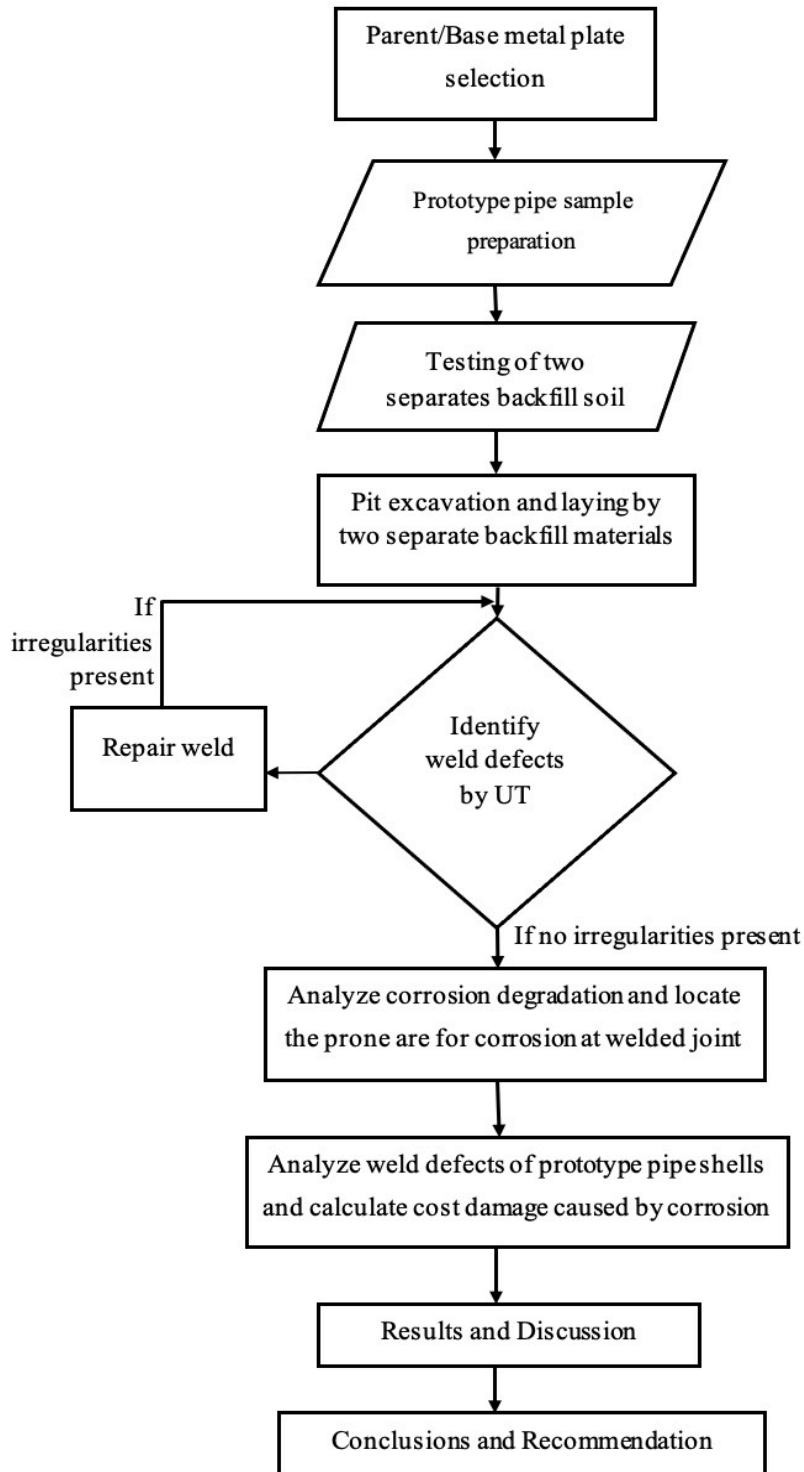
Figure 3.1: Research methodology

Research methodology was done based on Figure 3.1. It is divided into three sections and consists of specimen preparation, soil sample test and weld quality test on prototype pipe shell.

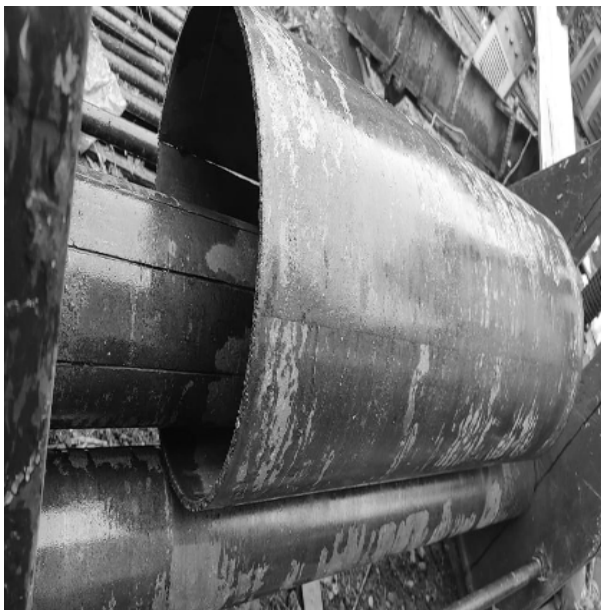
Figure 3.3: Metal plate forming

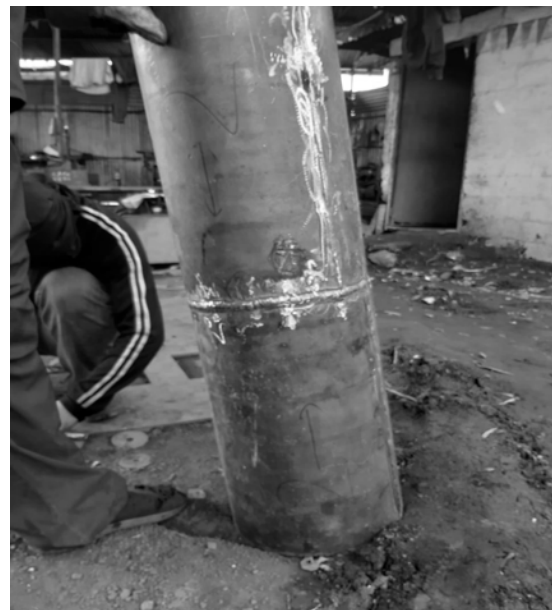
Figure 3.4: Welded prototype pipe shell

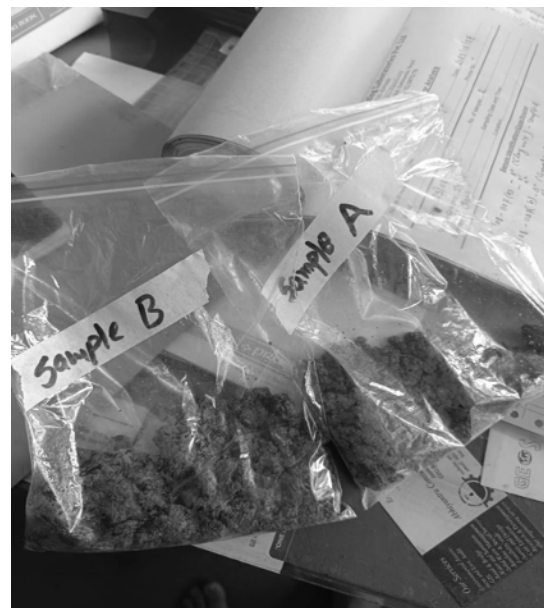
Figure 3.5: Soil samples

Figure 3.6: Soil samples

Soil samples at the level of the existing water pipe from seven locations at the test site were collected and analyzed. Porosity, moisture contents, sulphides, chlorides, pH, and acidity in soil were also evaluated. Samples of soils are shown in Figure 3.5 and Figure 3.6.

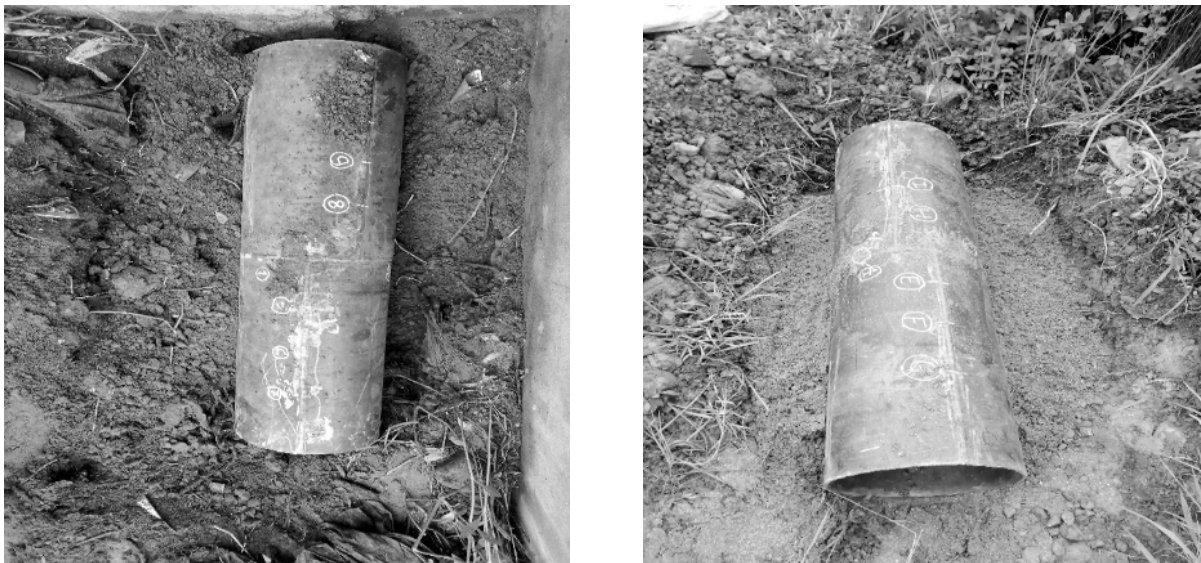
Figure 3.7: Mark identification

Prototype pipe shells were completely rolled and laid on the two separate excavated pits. Before laying, the welded joints were marked with alphabet letters on the longitudinal and girth joints so that these points can be analyzed to support the study. In order to meet the specific objectives the prototype pipe shells were marked after fabrication as shown in Figure 3.7.

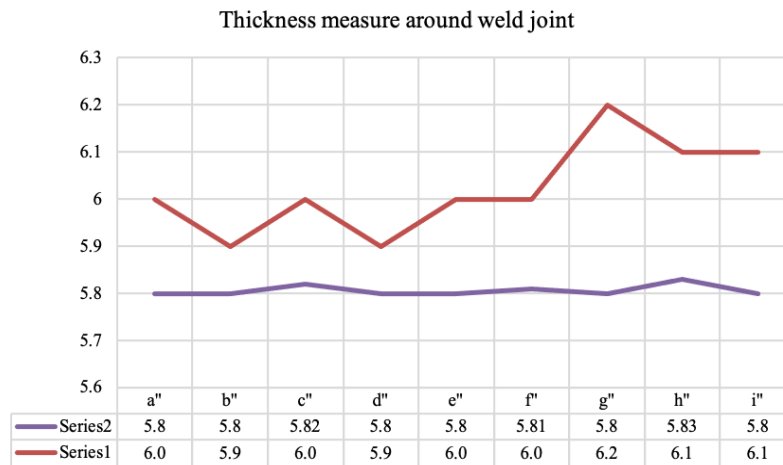
Figure 4.1: Corrosion degradation in the weld joint

In the graph, the upper band shows the thickness measured was 6.00mm using the ultrasonic machine at the marked points where pipe shells were buried by sand mixed pebbles. Similarly, lower bands show the thickness measured on average was 5.80mm on pipe shells buried by loose soil with clay. Metal loss is 0.2mm in thickness. The loss may be due to rust developed on the pipe shell surface. It is assumed that with loose soil clay the metal loss was 0.2mm on average. Since prototype pipe shells were supposed to be buried for almost 3 months. The results show that metal loss per year is 0.80mm. The remaining life of the pipe shell when being buried in loose soil with clay last only for 7.50 years without considering corrosion allowance. However, metal loss with sand mix pebbles were insignificant.

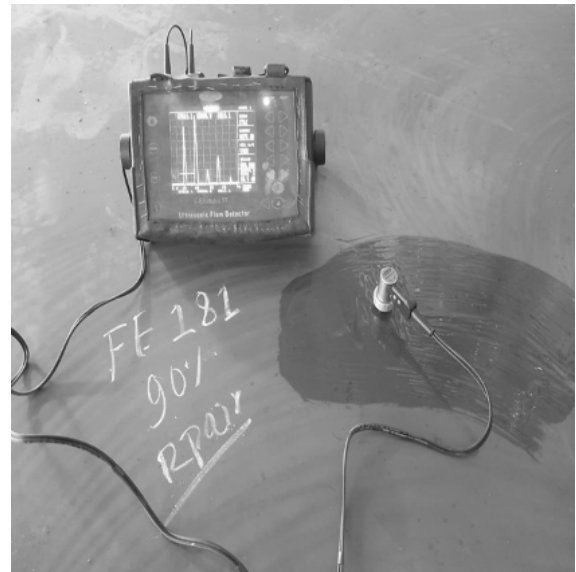
Figure 4.6: Weld joint to be repaired

In this experimental study UT machine was used to detecting the thickness of the test piece and depth of irregularities. UT is carried out since the metal plate thickness is 6mm and ASME recommends UT to measure the thickness of a minimum of 6mm. Flaws or irregularities like porosity, slag inclusions, lack of root penetration, and undercuts are the defects UT used to measure on welded joints of test specimens.

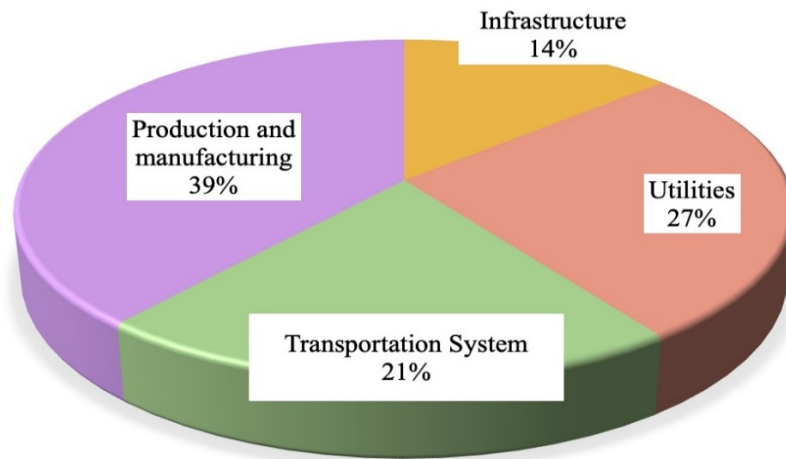
Figure 4.9: Cost of damage due to corrosion

All subsequent research demonstrates that, in highly developed nations, corrosion represents a consistent cost to a country's gross national product. The cost of corrosion-related damages is calculated by adding together both direct and indirect costs. However, this term has not been given any distinction in Nepal. By excluding indirect costs only direct cost is adopted, to study and try to calculate the overall costs related to corroding components in Nepal. Neglecting the expected indirect cost. The pie chart shown in Figure 4.9 illustrates the cost of damage brought on by corrosion in the hydropower and water sector utilities.
