**BEHAVIOUR OF CFRP  
(CARBON FIBER REINFORCED POLYMER)  
STRENGTHENED RC PIER UNDER LATERAL LOAD**

**A thesis submitted by  
ANUP KUMAR SUBEDI**

**MASTER OF SCIENCE  
IN STRUCTURAL ENGINEERING**

**FEBRUARY- 2010**

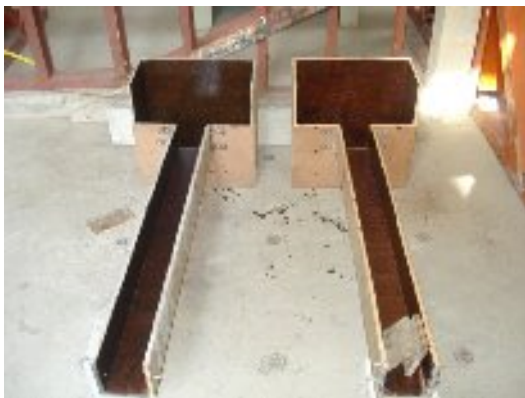
**Fig.2, Plywood Form.**

For the preparation of column-footing assembly, strong form of 12mm thick plywood was prepared in the lab ref fig.2. Reinforcement cage was fabricated according to detailing of reinforcement and then it was placed inside the form. The clear covers for each specimen were 10mm. After placing the rebar cage, form was clamped with bracket in order to restrict the bulging. Ref. fig.3

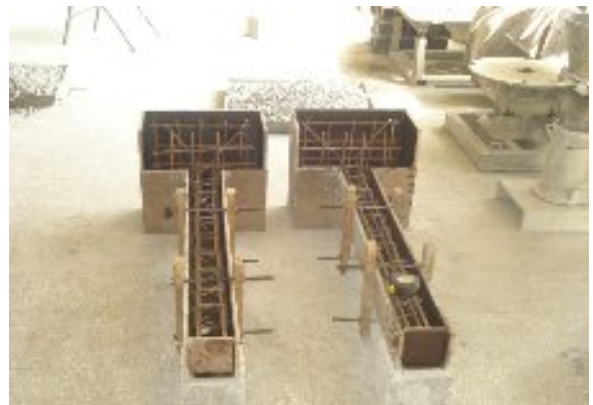
**Fig.3, Rebar cage inside Form and clamping of form**

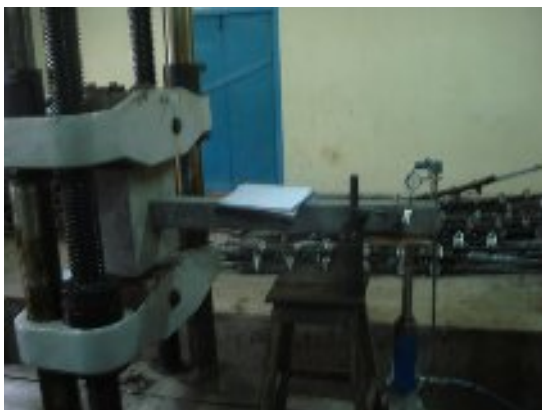
**Fig.6. Test set up.**

The test set up is displayed in fig.6. Footing was properly fixed and lateral load was applied with the help of hydraulic actuator. The columns were tested in a horizontal position. Load was applied at the free end of column i.e. 95cm from column-footing interface. The entire specimens were tested after 28 days.

**Load applied by actuator**

Load was applied vertically with the hydraulic actuator of capacity 200 KN. Load was applied in the average incremental of 1.58KN which was measured by load dial gauge and corresponding deflections were measured with the help of deflection dial gauge, however load and deflections were also measured when cracks were observed.

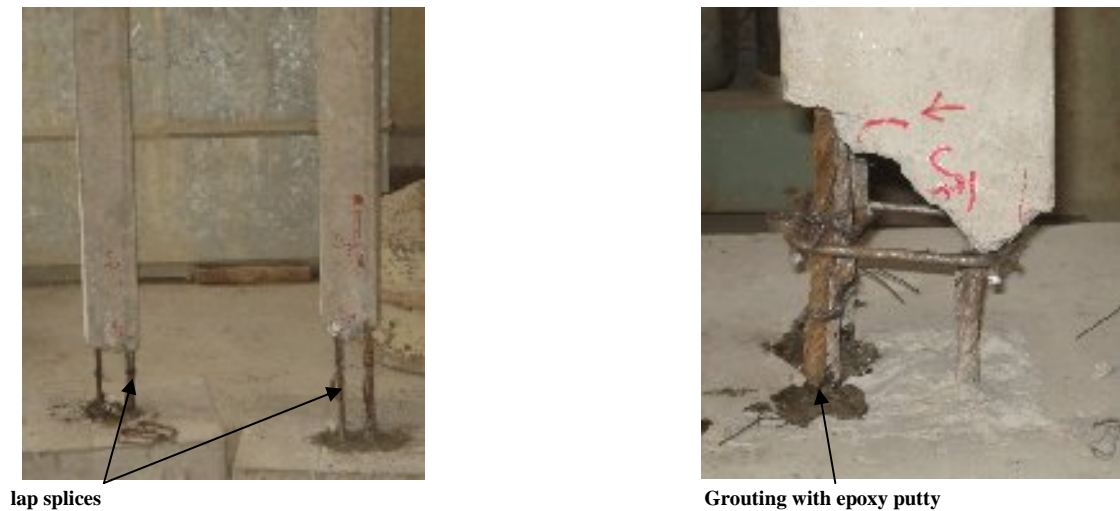
**Fig. 7.1**

1. Loose concrete were removed and damaged area were cleaned thoroughly with water and completely dried. Lap splices were fixed where the rebars were fractured and buckling were serious. Ref. Fig.7.1.

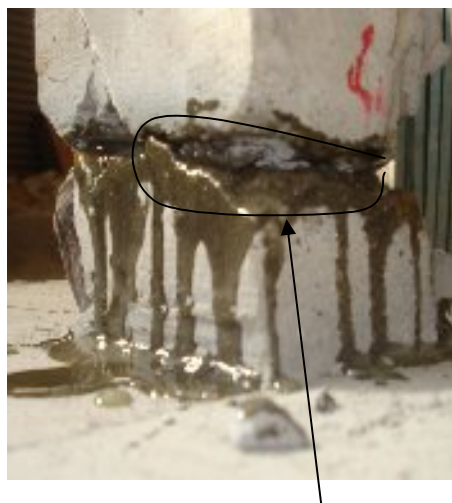
2. Grouting was done by injecting epoxy resins wherever necessitated and possible. Ref. Fig.7.2. it was kept for 48 hours for hardening purpose.

**Fig. 7.2.** Epoxy grouting in cracks

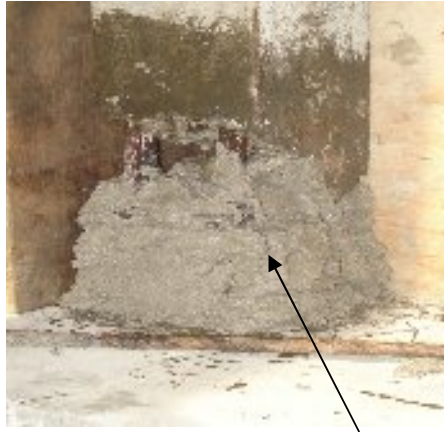
**Fig 7.3**

3. After completion of grouting, voids were filled properly with high strength filler materials having good bonding strength ref fig.7.3. (Filler materials or epoxy putty was prepared in lab by mixing epoxy resin with dry and clean silica sand. The mixing proportion was 1: 18 by weight i.e. 1 part of epoxy resin with 18 parts of silica sand. The average compressive strength of epoxy putty was 30Mpa in 48hrs and 50Mpa in 7 days as measured in lab by testing the cubes of size 5cm x 5cm.) It was kept for 10 days to ensure that full strength was obtained.

Gaps filled with Filler

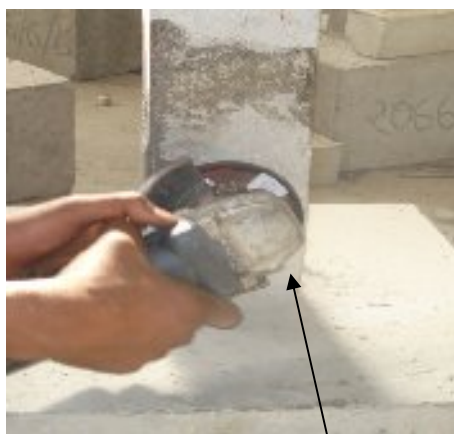
**Fig. 7.4**

4. The surface was smoothed and cleaned and corners of columns were rounded in order to prevent stress concentrations which may cause premature failure of CFRP. Ref. fig.7.4.

surface smoothing with grinder

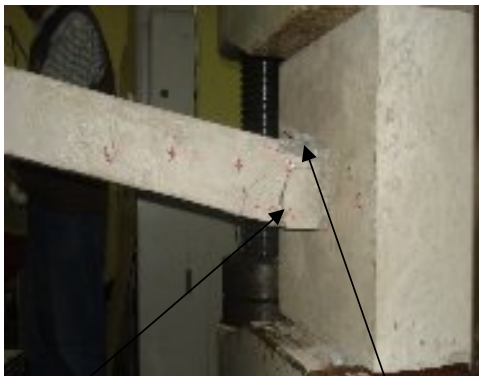
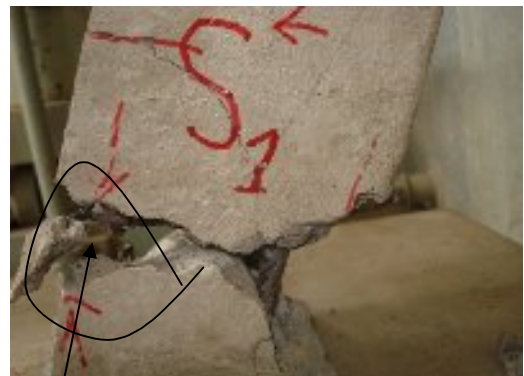
**Fig. 8.1, specimen, S1**

In specimen S1 early flexural cracks were seen at 14cm, 7cm and 20cm from footing top at a load of 3.11KN and 1.19% of lateral drift ratio(lateral deflection/column height). After further increment of load these early cracks (specifically cracks at 7cm and 14cm) were increased significantly. Some flexural cracks were also seen nearly up to the mid span but these cracks width and depth were not increased significantly. The crushing of concrete on compression side was also seen near column-footing interface and concrete spalling took place at this zone at yield load 8.78KN at lateral drift ratio of 6.26%. After degradation of load carrying capacity of column, the steels were ruptured at 35% drift ratio. The steels were ruptured at 10cm from footing top. Ref fig, 8.1.

Distinct flexural crack and crushing  
Of concrete on compression side.

Rupture of reinforcement

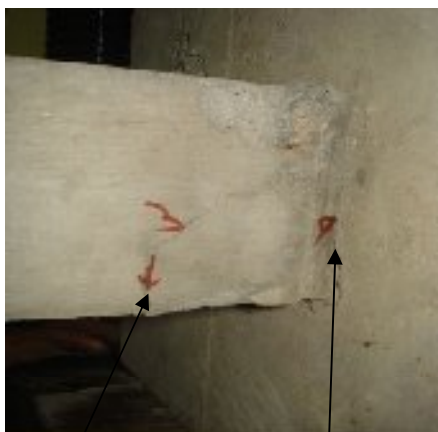
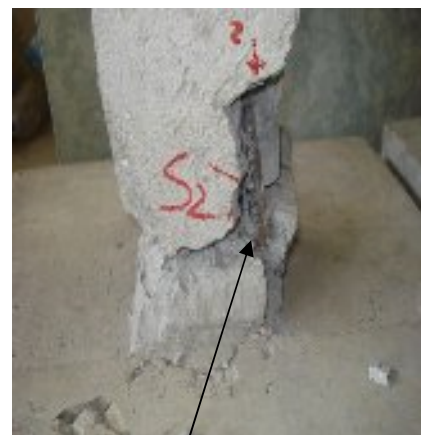
**Fig 8.2a**

Similarly, in other specimens also the pattern and propagation of cracks were similar to that of S1 which is explained above but the damages seen were different. In specimens S2 and S3 only one longitudinal reinforcement was ruptured and damage was less serious than S1, the location of rupture was 7cm and 10cm from column-footing joint and corresponding drift ratio was 21% and 20.3% respectively. Ref. fig. 8.2.

Progression of Flexural crack. **Specimen, S2**      Crack at joint.

Damage seen after rupture of Reinforcement. **Specimen. S2**

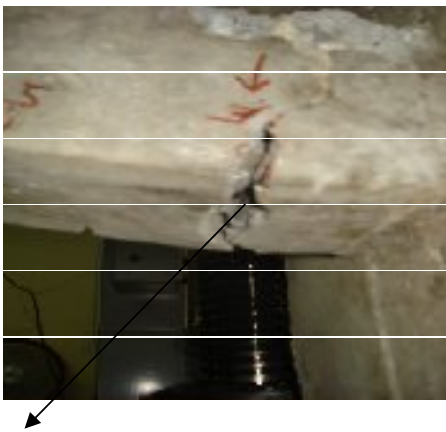
**Fig, 8.2c**

Flexural crack near interface and  
Concrete spalling at top.  
**Specimen, S3**

rupture of reinforcement and  
Spalling of concrete cover.  
**Specimen, S3**

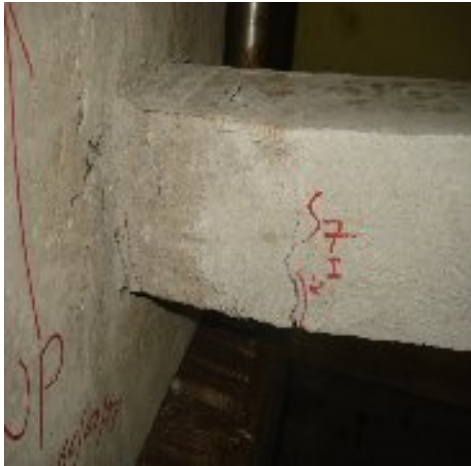
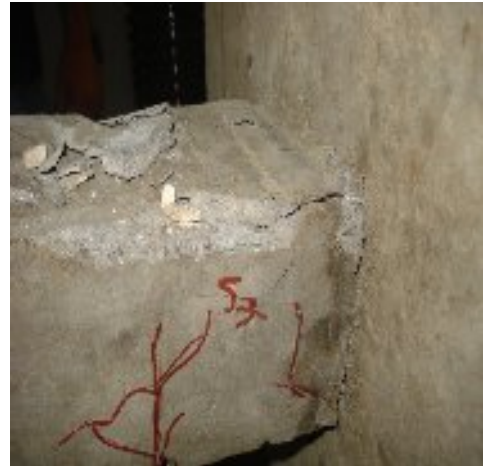
**Fig, 8.4c**

Progression of flexural crack  
**Specimen, S7**

Crushing and spalling of concrete  
 at corner and joint crack.  
**Specimen, S7**

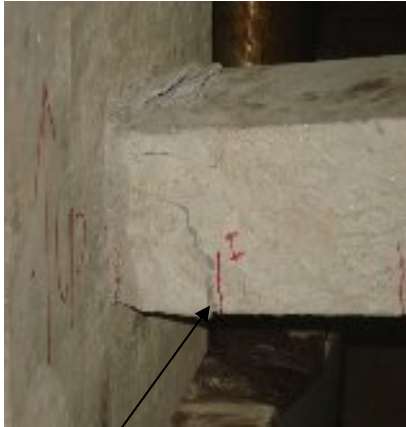
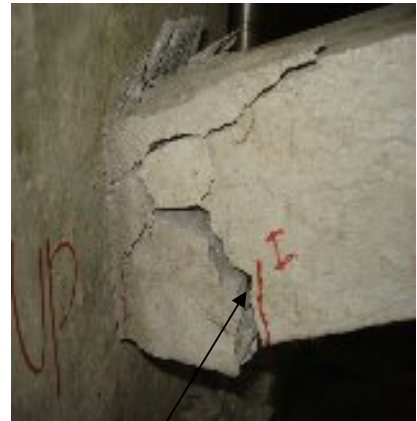
Fig.8.4e

Widening of flexural crack  
Specimen, S8

Development of plastic hinge  
Crushing and spalling of  
Concrete at corner.  
Specimen, S8

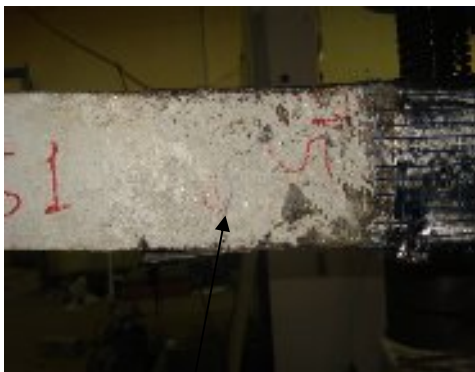
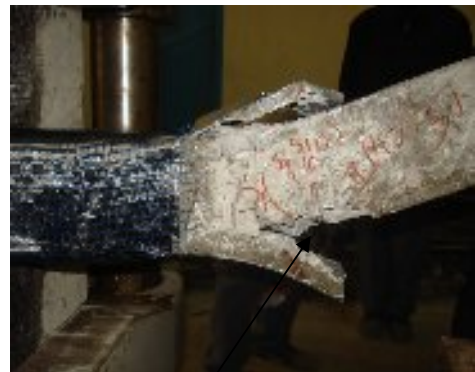
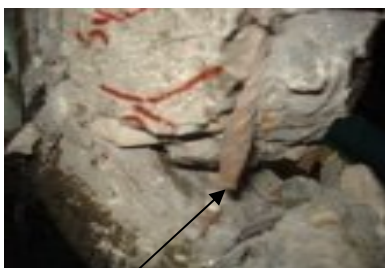
**Fig. 10a**

Initial flexural cracks were seen just at the end of FRP wrap and at mid-span at a load of 3.11KN and lateral drift ratio of 1.17%. After further increment of load the crack at the end of FRP wrap begun to propagate rapidly towards footing side, however others cracks also appeared but was not significant. Minor Delamination of FRP on the compression side started at a load of 7.15KN at a drift ratio of 3.755%. Crushing on compression side was observed at a yield load of 7.43KN and drift ratio of 4.4%. No cracks were visible near the column-footing joint. The longitudinal steels were ruptured at 27cm from footing top at a drift ratio of 34.5%. No tearing of FRP was observed. Ref fig. 10

Flexural crack above CFRP wrap

Delaminating of CFRP and Concrete spalling.

Rupture of Longitudinal Reinforcement.

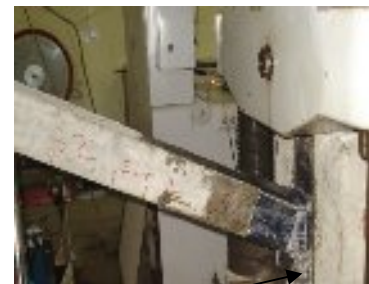
**Fig, 10.1a**

Early flexural cracks appeared at 24cm and 34cm from column-footing interface at a drift ratio of 2.03% and 3.11KN load. Crack at column-footing joint were seen at a drift ratio of 3.43%. Tearing of FRP jacket at 4cm from column-footing interface started at a drift ratio of 3.43% at a load of 5.46KN. Further increment of load enhanced the tearing and degraded load carrying capacity of column. At a drift ratio of 21% complete delamination of FRP from footing surface took place. In this specimen flexural cracks along the column span did not propagate rapidly but the crack at joint increased comprehensively spalling the concrete and delaminating the FRP jacket of footing top. Ref fig.10.1.

Tearing of CFRP

delaminating of CFRP

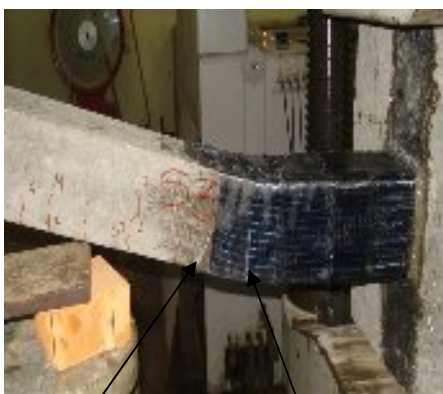
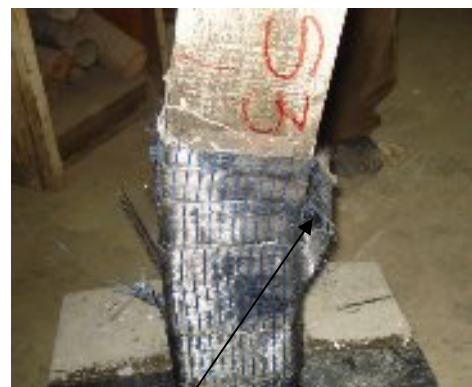
**Fig, 10.2a**

In this specimen early flexural cracks were observed at 33cm, 40cm and 47cm from column-footing joint. After further increment of load several hairline cracks were seen but did not propagate significantly. The earlier crack seen at 33cm propagated rapidly and degraded the load carrying capacity of column at a drift ratio of 5.311%. No cracks were observed at the column- footing joint. Ref fig. 10.2.

Flexural crack and tearing  
Of CFRP

Delaminating of CFRP

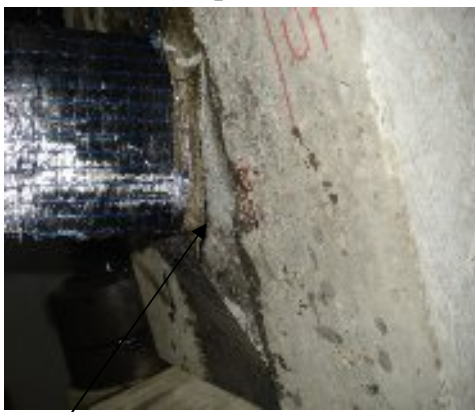
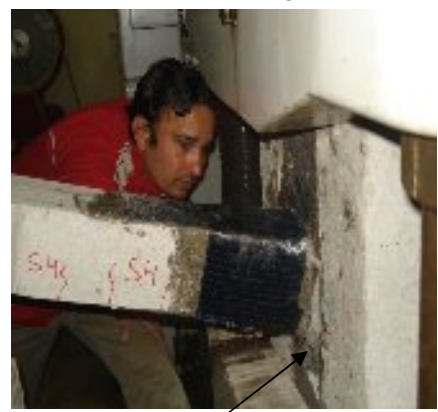
**Fig, 10.3a**

In this specimen the behavior seen was similar to S2. The flexural cracks were seen at 35cm, 44cm and 51cm from column-footing joint, but none of these cracks were propagated rapidly but the crack seen at column-footing joint at lateral drift ratio 2.86% propagated rapidly. On further increment of load and lateral drift, crack width at joint level increased and delamination of FRP from footing surface started and complete delamination was seen at drift ratio 18.1%. Ref fig 10.3.

Crack at joint.

Delaminating of CFRP.

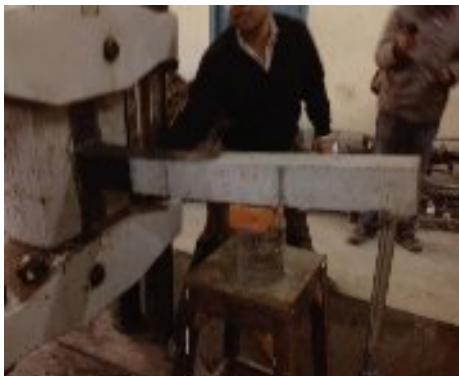
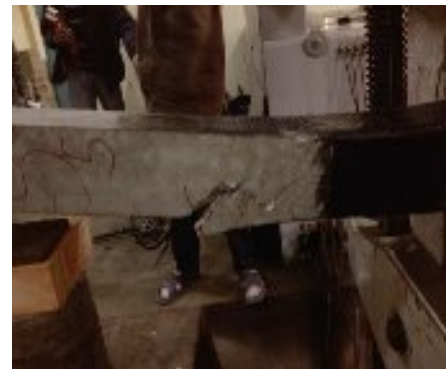
**Fig, 10.4a**

In this specimen several vertical cracks were seen along the span but the initial crack at 38cm from column-footing joint propagated and was extended towards footing side. At the drift ratio of 18.55% crushing of concrete and spalling of concrete was noticed at this location. Cover of concrete was completely spalled and longitudinal reinforcement was visible. Ref. 10.4.

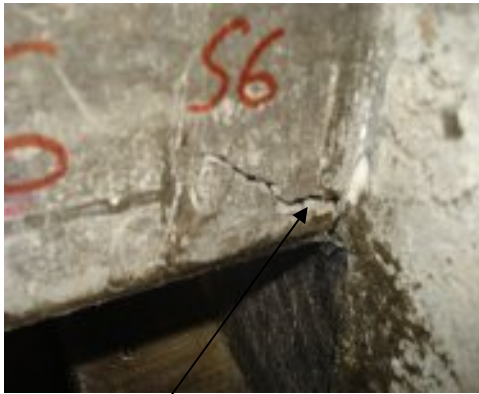
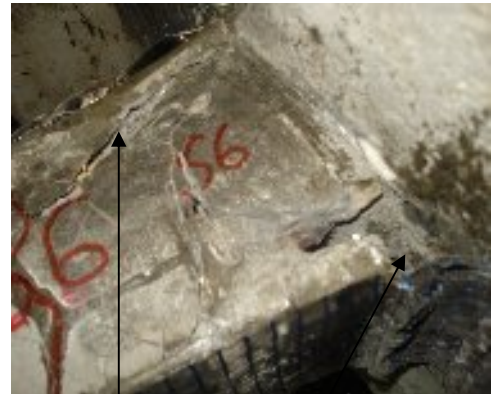
**Fig, 10.5a**

In this specimen the trend of cracks was different than other specimens. First crack was seen at 7cm from column-footing joint at drift ratio of 1.53% and 1.58KN load, but soon cracks were seen at column footing interface and along the span of column. On further increment of load the crack at interface propagated rapidly and it was extended along the footing heading towards compression zone. At the load of 3.11KN and drift ratio 2.918% crushing of concrete on compression zone was observed and it was propagated up to a length of 10cm on the increment of deflection. The load carrying capacity of column was decreased after 5.46KN. The major crack was interface crack which width increased rapidly and reinforcement was visible through it at drift ratio of 17.3%, delamination of FRP was also observed near column footing interface. Ref. fig. 10.5

Propagation of crack from interface

concrete crushing, delaminating of CFRP.

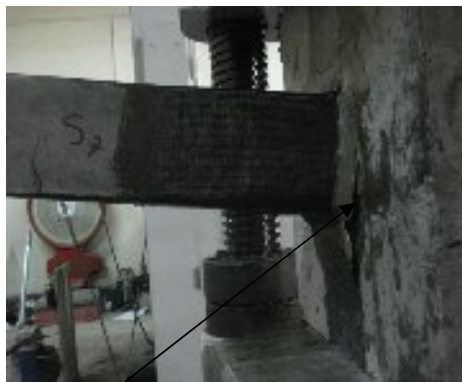
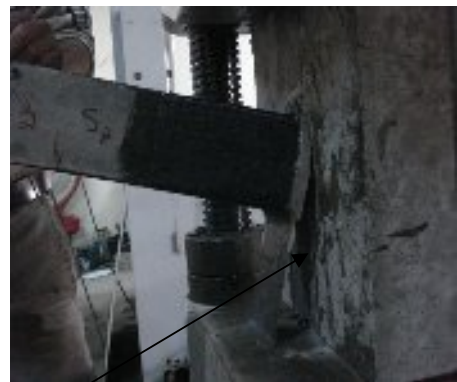
**Fig, 10.6a**

The behavior of this specimen was similar to that of S2, only difference was no tearing of FRP laminates was observed up to the drift ratio of 21.1%. like in specimen S2 complete delamination of FRP from footing surface was seen at drift ratio of 21.1%. Ref. fig. 10.6.

Crack at joint

complete delaminating of CFRP

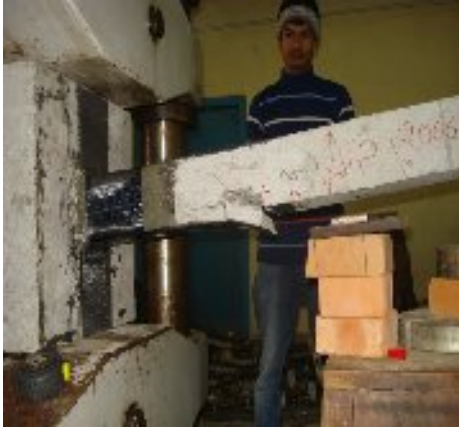
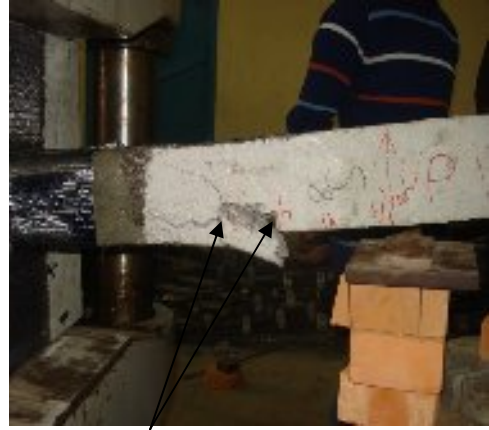
**Fig, 10.7a**

The pattern of failure in this specimen was similar to that of S5, but the lateral drift ratio was more at yielding i.e 5.41% whereas in S5 drift ratio at yielding was 3.49%. Ref fig, 10.7.

Delaminating of CFRP

Crack extending towards footing  
Side and concrete spalling.
