**TRIBHUVAN UNIVERSITY
INSTITUTE OF ENGINEERING
PULCHOWK CAMPUS**

THESIS NO: M-31-MSMDE-2019/2021

**Performance Analysis and Rehabilitation Prospective of Aged Small Hydropower
Plant – A Case Study of Fewa Hydropower Plant (1 MW)**

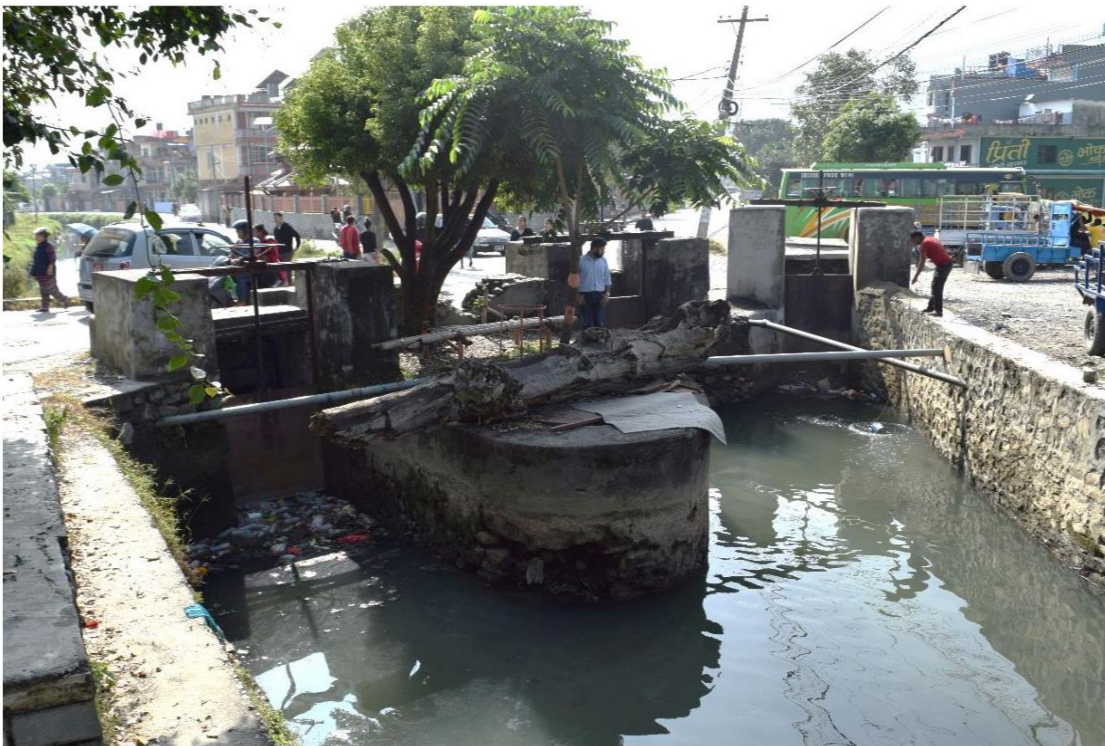
Figure 2: Bifurcation of canal into Irrigation Canal and Power Canal

The main canal is designed for open channel flow with stone masonry linings in some stretches, reinforced concrete lining in others whereas some stretches are left unlined. Some stretches of the unlined canal are suffering from the slope instability and blockage by the debris. The stone masonry lining is damaged in some stretches and facing the slope stability problems in the right bank whereas in some stretches, it is in complete failure state. The slope stability problem has led to the slope failure and it is damaging the roads which is constructed on the bank of the main canal. The concrete of the concrete lined canal has suffered from surface scouring and the reinforcements is exposed and need maintenance. Also, since the channel is open, the problem of floating debris like plastic bottles, polyethylene bags is quite prominent.

Structural maintenance is deemed necessary in canals. The earthen canal needs to be lined in some stretches. The Stone masonry lined and Reinforced lined canal need severe maintenance. The reinforcements in the canal are exposed due to scouring and need immediate maintenance because the failure can affect the stability of the canal in both banks. Forebay structure need major maintenance for spillway wall, which is damaged highly. Some of the Forebay structure is suffering from scouring which need maintenance. The Powerhouse structure should be demolished and reconstructed from Main Inlet Valve to the Draft tube according to the new dimensions of the electromechanical equipment. Considering the rusting and wearing of the Bifurcation pipe, it is recommended to replace the bifurcation pipe and the civil structure for bifurcation need to be demolished and reconstructed accordingly.

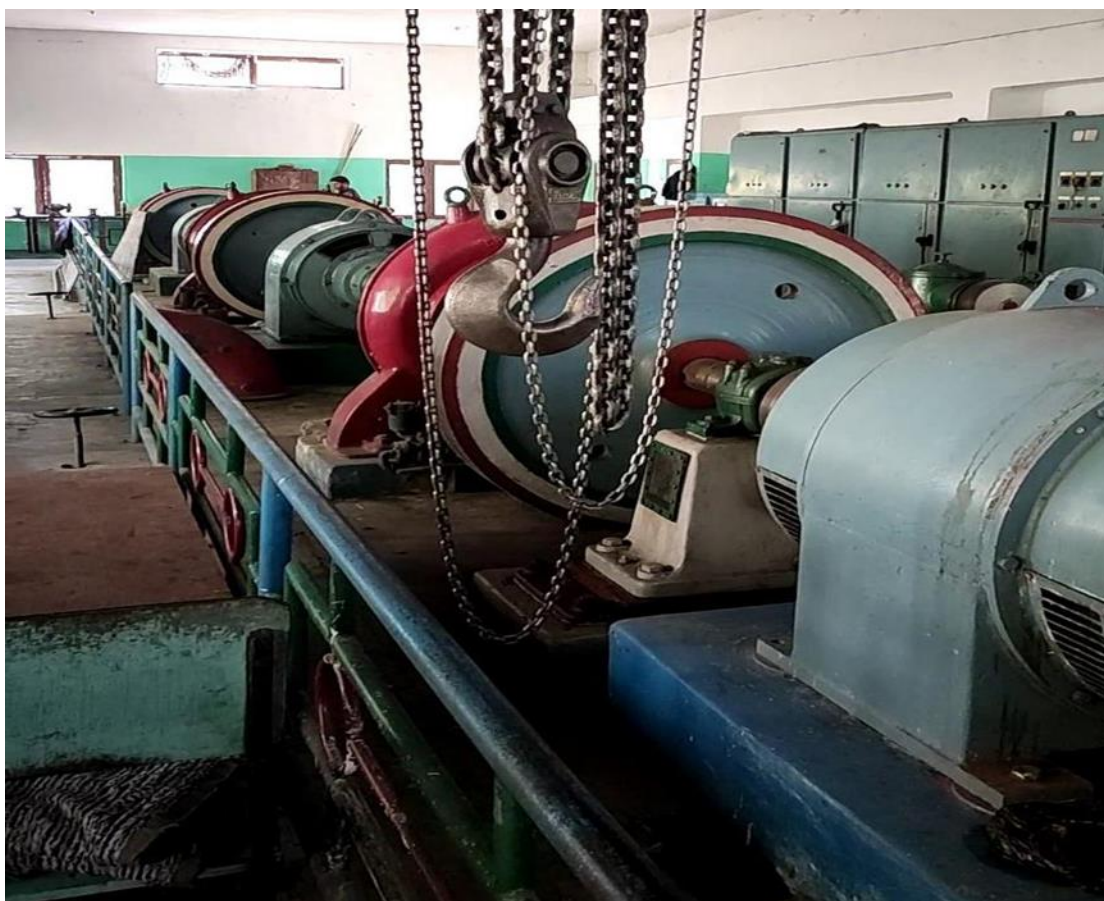
Figure 3: Turbine-generator units at Powerhouse

Fewa HPP has four sets of horizontal Francis Turbines each of 288 kW capacity. The turbines were manufactured in Germany.

Out of four power generating units of Fewa HPP, Presently, only two units are in operation but rest other two units are under partial and non-operational status. In last fiscal year i.e. 2077/78 this plant had achieved 1.85 GWh energy. The turbines have aged and suffered substantial wear over 50 years of continuous operation since its commissioning in 1969 AD. Moreover, the spare parts for the outdated equipment are unavailable in the market. Without spare parts, units has stopped operating altogether. And the remaining units have been operating in low efficiency requiring frequent shutdowns. The problems diagnosed at this stage are as follows:

- ❖ There is a substantial water leakage through shaft seal and head cover.
- ❖ Guide vane has suffered a heavy wear over the years; therefore, the unit efficiency has decreased significantly and operates below rated output.
- ❖ Turbine runners have undergone some pitting due to cavitation.
- ❖ Guide bearing of turbine has also suffered severe wear. On operation, the shaft vibrates, which affects the units' stability.
- ❖ Additionally, the deteriorated turbine poses a safety hazard.

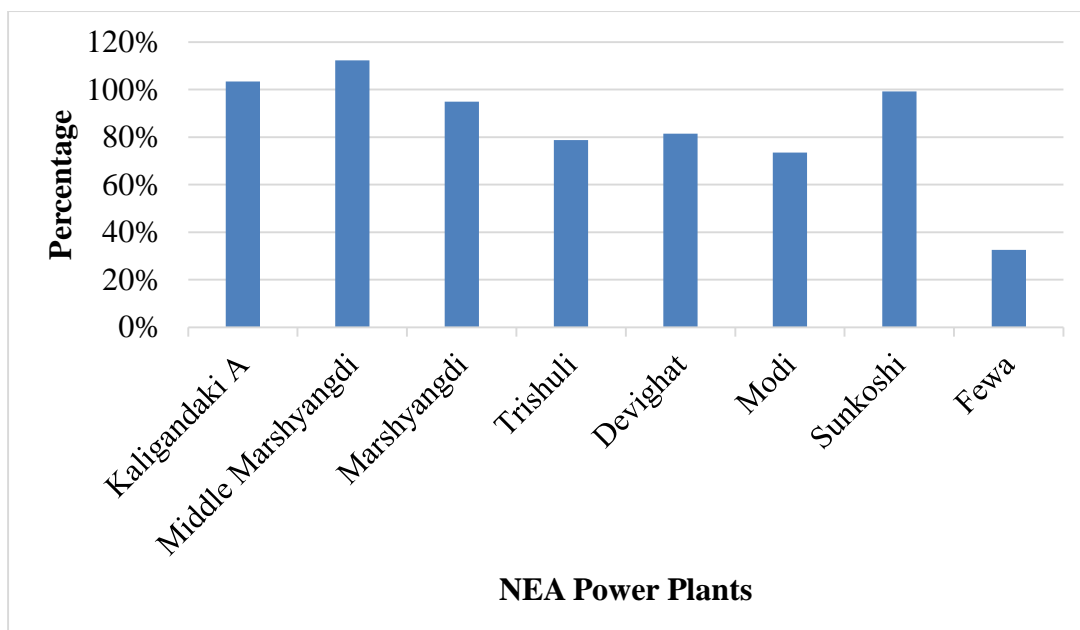
Figure 10: Capacity Factor of NEA Power Plants

The table and graph show that Middle-Marsyangdi HPP stands out above others because its average annual energy generation exceeds its annual design energy generation, whereas Fewa HPP has the lowest value due to its largely unsatisfactory performance during rainy seasons, primarily due to debris choking problems, uncontrolled outages, and machine breakdown problems resulting in unavailability for electricity generation.

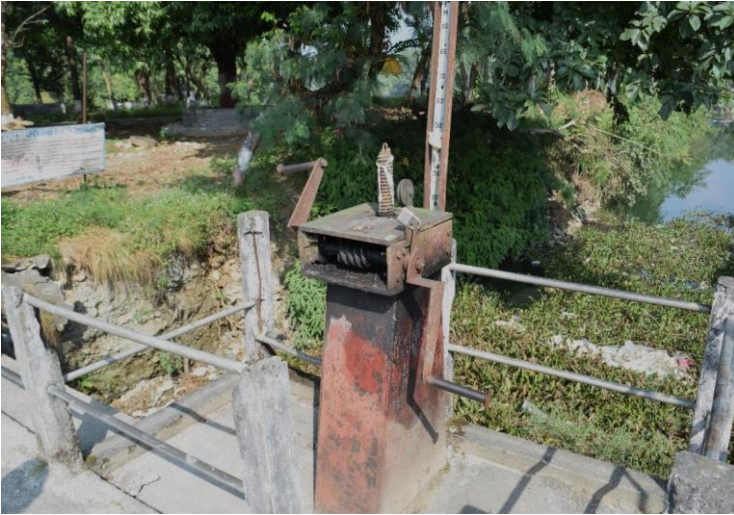
Photo 1: Main Intake Gate

The head works consist of a Gravity Dam and a common intake for withdrawal of total 8 m³/s of water; 2 m³/s of it is for power generation and remaining 6 m³/s is for irrigation. As the dam has been made with the main purpose of Lake Impoundment, its regulation and maintenance is not relevant in the current rehabilitation. The common intake is without any control structure. The intake gate is in operation but needs regular maintenance. Leakage was observed on all sides of the gates even in the closed position. The hoisting system was in poor condition. Both embedded part and the gate panel were found to be corroded. The railing posts in the intake structures are damaged.

There are in total, four number of gates in the Fewa HPP: First gate at the Intake of Main canal, second at the canal bifurcation point (Main and power canal) and remaining two at the Forebay outlet. Conditions of the gates as well as the hoisting of gates are very poor and need immediate maintenance.

Civil structures in Intake need maintenance for Intake slabs. The railing posts in the intake structure requires reinforcement. Also, since the intake area is exposed to the public, it is recommended to enclose it with a chain-linked fencing.

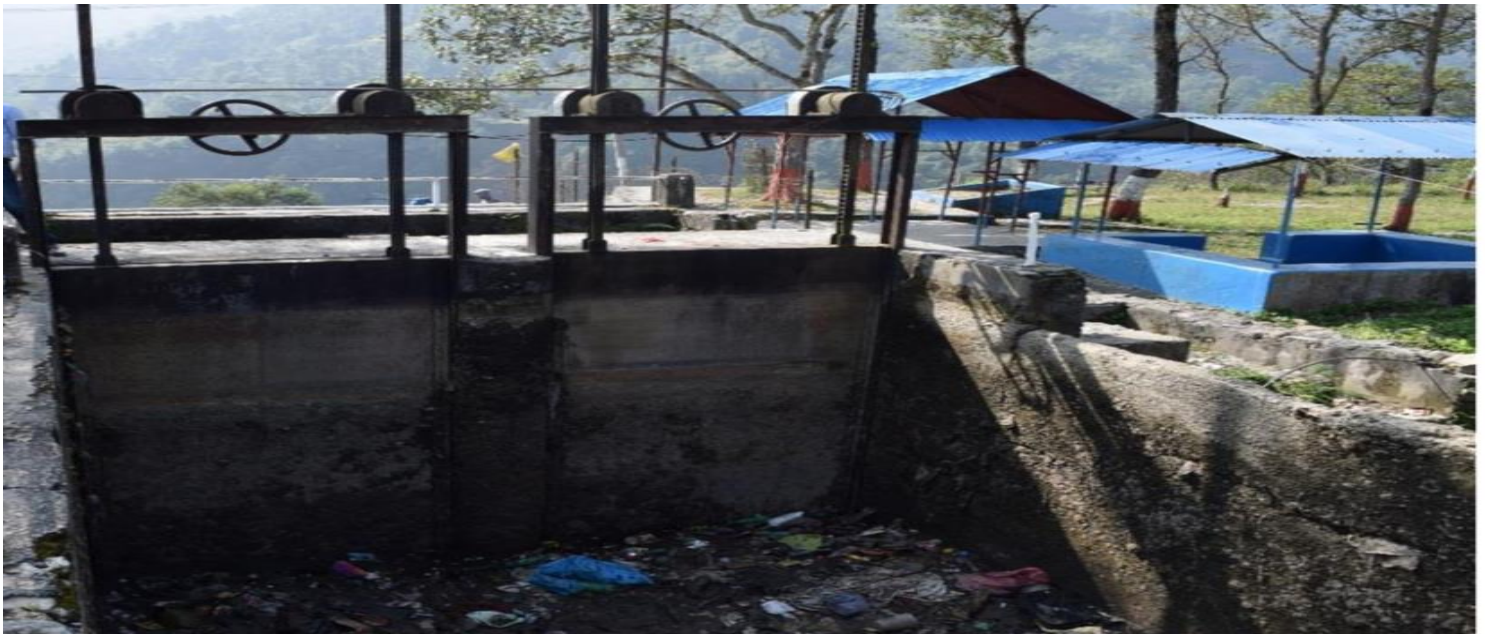
Photo 3: Forebay and Gates

The Reinforced Concrete structure forebay is constructed at the end of power canal to provide necessary submergence and reduce the water hammer pressure for penstock pipe. Forebay structure has suffered from the aging, scouring of the concrete surface and some cracks in the structure. The scouring in the concrete is not severe and the reinforcements are not exposed. The wall of the spillway is damaged and need maintenance. The Spillway water need to be properly conveyed to the nearest stream. Forebay is not fenced and elevation level is not marked. The strength of Concrete seems

satisfactory from the non-destructive tests conducted during site visit but this requires further tests to determine the actual strength of the concrete and the actual condition of rusting in the reinforcement bars.

Embedded guide frames of the gate were found to be exposed due to deteriorated concrete walls. Gate panels as well as the exposed surface of the embedded steel

structures were found to be corroded. Legs of the housing of hoisting pinion block were found to be broken for two blocks out of four. There was a remarkable gap between side rubber seal and side sealing frame which will lead to water leakage.

In the forebay gates, the concrete structure should be repaired so that all the embedded steel structures remain within concrete. All the metal surfaces also require a proper mechanical cleaning followed by Zinc rich primer and epoxy base paint. Fractured pinion block should also be replaced. Welding is not recommended for repair as it is a cast iron part. Proper design optimization shall be carried out to control leakage from the seal.

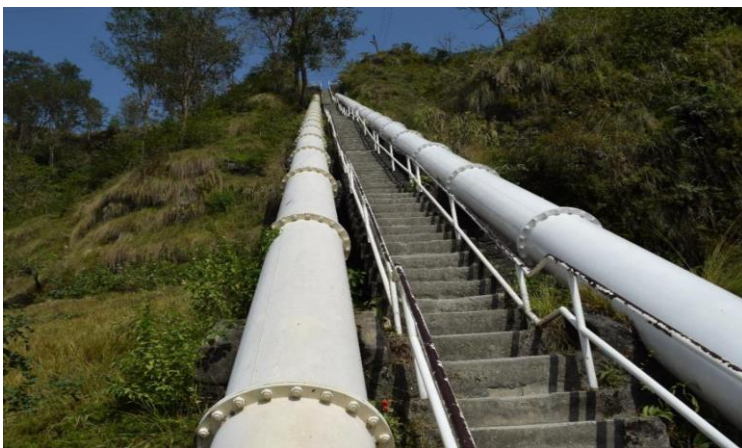
Photo 4: Penstock

From visual inspection, it was observed that the penstocks were basically intact with some painting deficiency and corrosions in some areas even though the penstock pipes seemed to be painted recently.

The bifurcation couldn't be inspected as there was no manhole or inspection hole over or near it. The penstock immediately after the bifurcation block was observed to be in a much corroded state with no painting whatsoever.

The current painting state of penstock was observed to be inadequate. A proper mechanical cleaning following surface cleaning and surface treatment standards is required along with coating of Zinc rich primer and epoxy base paint. Also, it is highly

required to replace the manifold pipes (pipes downstream of bifurcation blocks) and the draft tube.

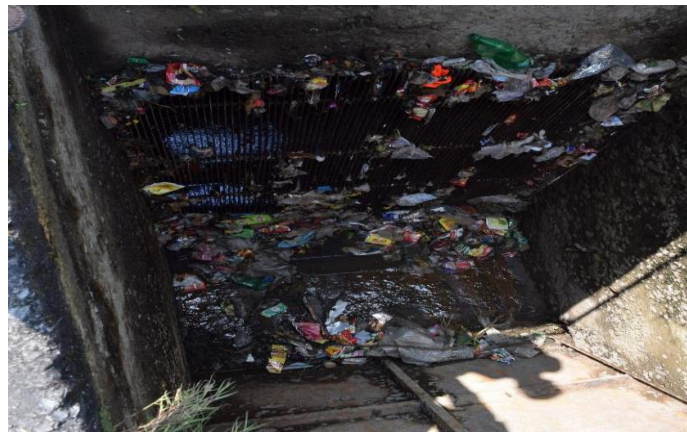
Photo 5: Trash rack

The problem of floating debris was quite evident as the water flows through open canal. Debris including mainly polyethylene bags, plastic bottles were found embedded in the trash rack panel which may pose a serious problem to the plant. Due to the unusual nature of the debris, it has become a one-of-a-kind problem that a conventional trash rack mechanism is unable to address. Although the trash rack at the inlet of forebay was repaired and maintained earlier, there are still problems with debris management. As of now, the trash rack is being cleaned manually but it seemed to be lacking a regular cleaning schedule.

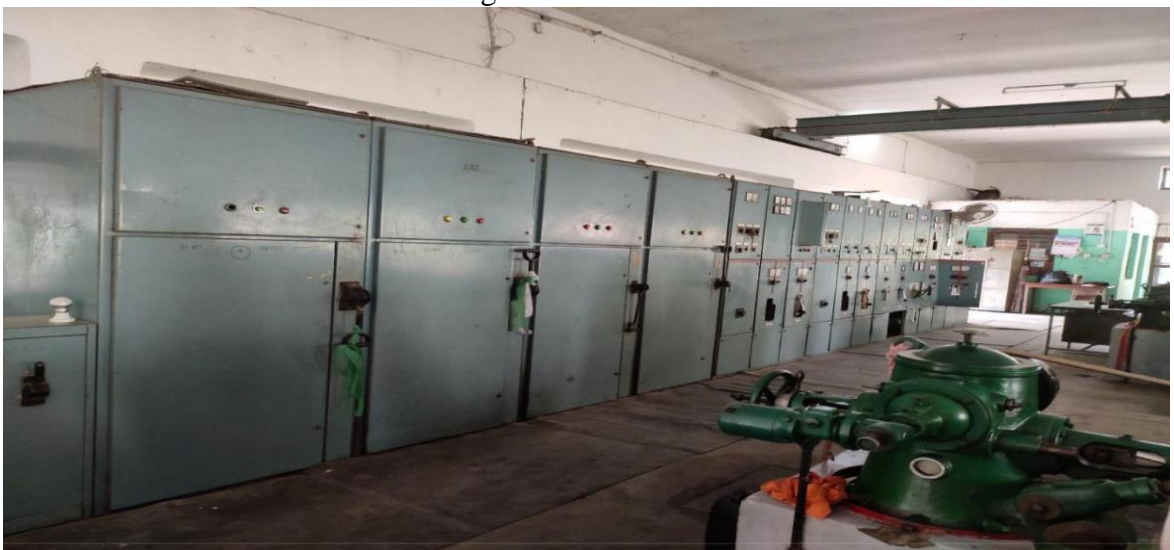
Photo 8: 11 kV Switchgear Panels

Four chambers of 11 kV high-voltage switch cabinets with fuse system are installed in the power station. Through 53 years operation, the insulation is aged and the performance is decreased, requiring frequent equipment shutdowns and maintenance. Eight chambers of 0.4 kV low voltage distribution cabinets and fixed low voltage switch cabinet are installed and in operation since 1969 A.D. The cabinet structure is outdated. Main components have problems of poor insulation, bad performance and poor reliability. The cabinets have severe safety hazard and so they need to be replaced entirely.
