**TRIBHUVAN UNIVERSITY
INSTITUTE OF ENGINEERING
PULCHOWK CAMPUS**

**Sand Erosion in Francis Runner: A Case Study of Middle Marsyangdi
Hydropower Station (MMHPS)**

A THESIS

AUGUST, 2020

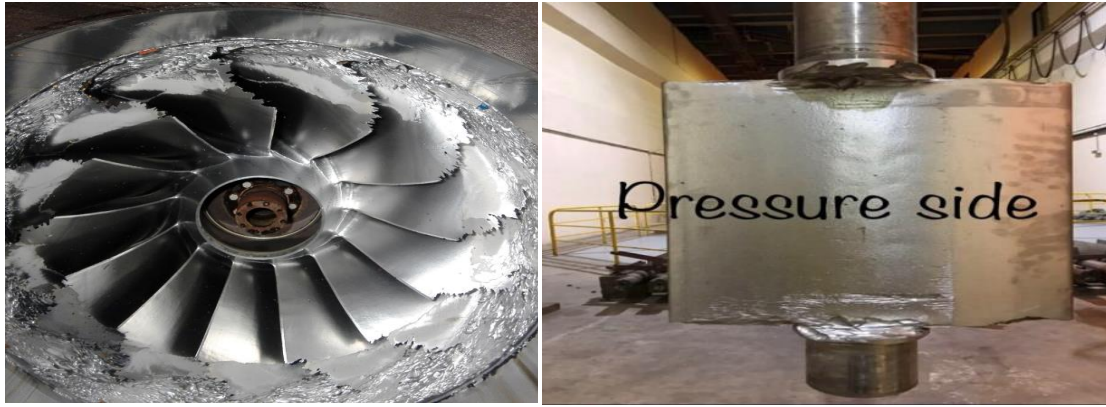
Figure 1.1: Eroded runner and guide vane of Kaligandaki HPS obtained during site visit

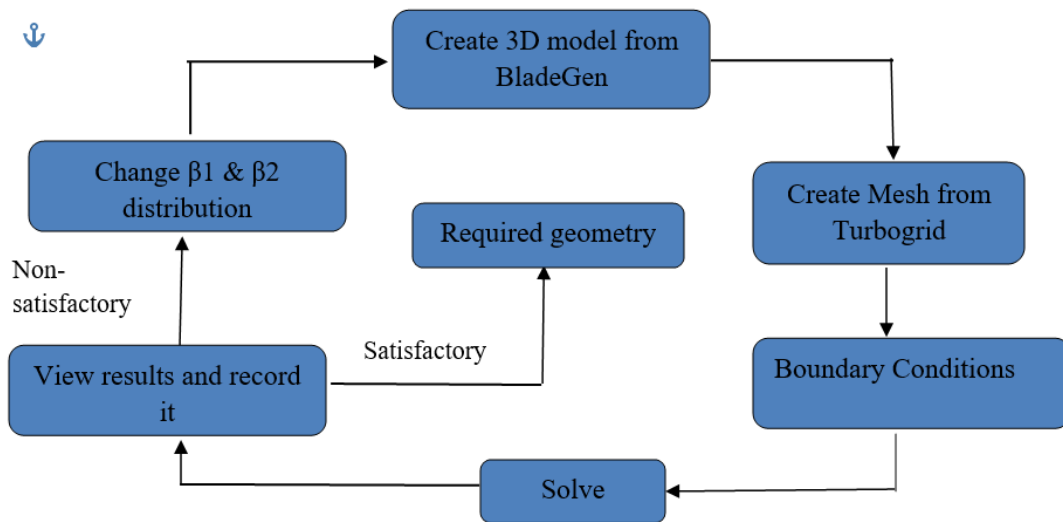
The process involved in designing the required runner geometry of the runner is shown in the flow diagram below in figure 3.2. The final domain from bladeGen and the runner snap can be seen in figure 3.3.

Figure 3.2: Process flow diagram of the Runner design

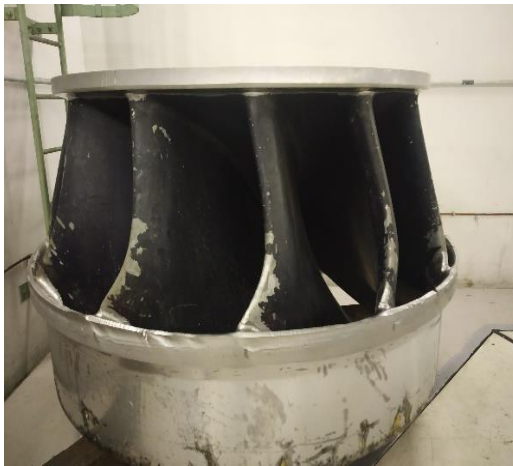
Figure 3.3: (a) Actual MMHPS Runner (b) Designed MMHPS Runner in bladeGen

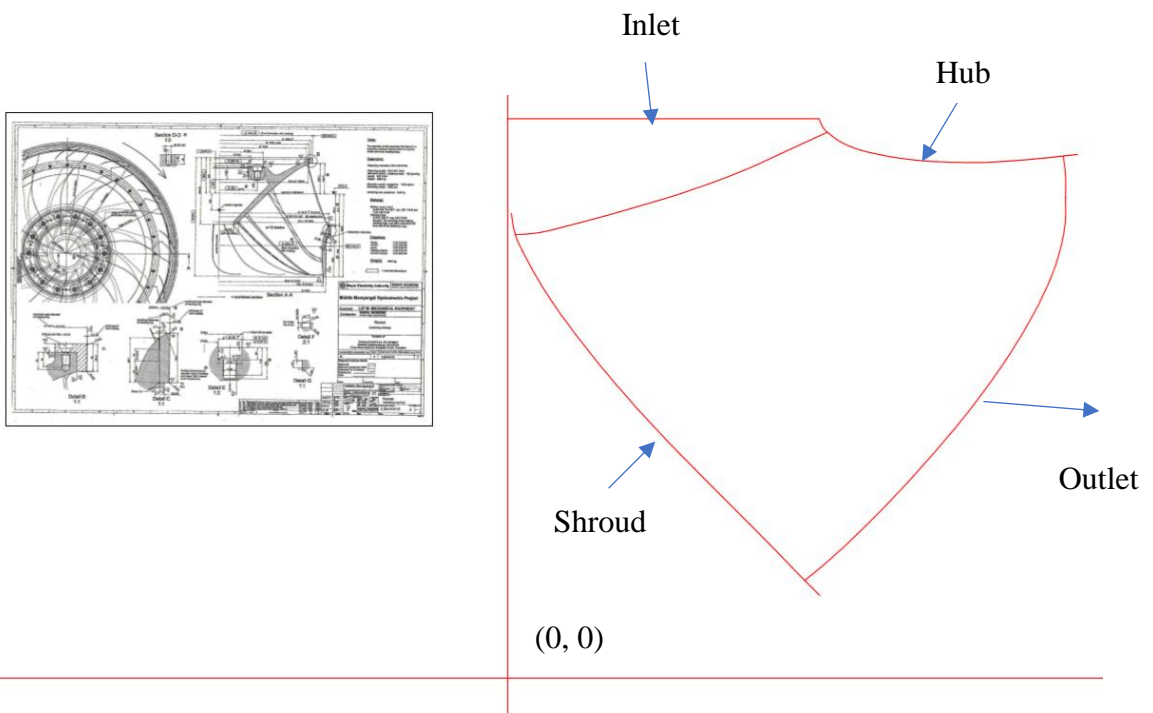
Figure 3.4: Tracing of MMHPS 2D drawing in AutoCad

First of all, manufacturing drawing is converted to CSV file using AutoCAD where the model is adjusted in 1:1 scale and the coordinate system is made similar to the bladeGen format which can be observed in figure 3.4. After that the curve file is translated to bladeGen compactable format using excel and is imported in the bladeGen. Subsequently, the blade angle is measured from the available drawing which provides the information about the blade distribution which then is adopted in the bladeGen angle distribution. The distribution is made as close as possible by looking at the numerous snaps of the physical runner which are taken from all the possible positions. Again, bladeGen have features to control the blade thickness from one streamline to another streamline starting from hub toward shrouds wherein this thickness is also traced from the original drawing. Furthermore, for closeness lean angle is varied so to match the original turbine.

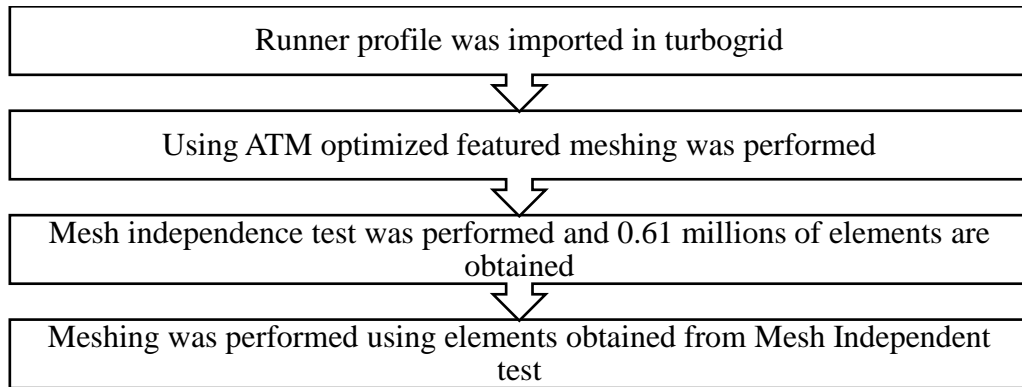
Figure 3.5: Steps involved in the meshing of blade domain

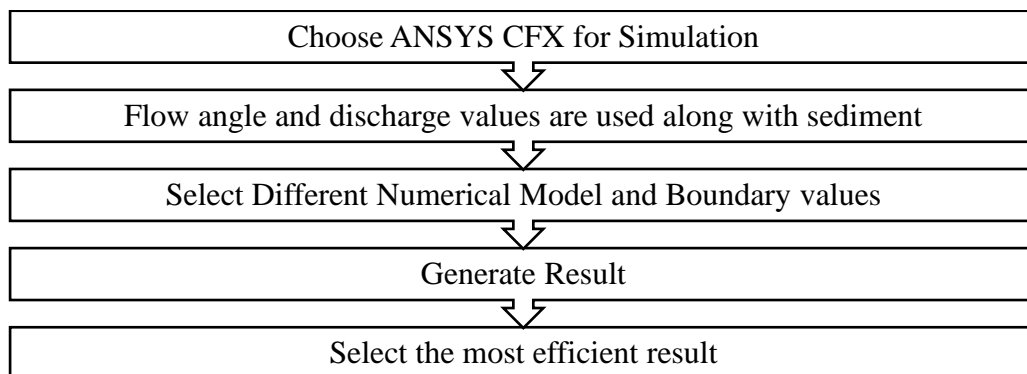
Figure 3.8: Different process involves in Flow simulation in ANSYS CFX

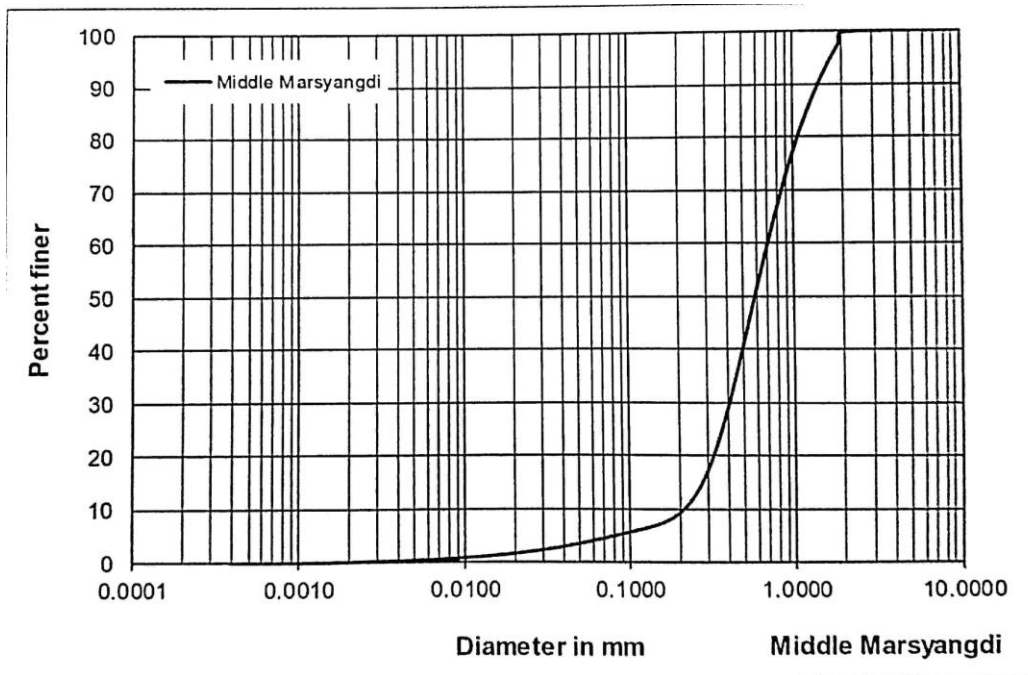
The particle size distribution of MMHPS reservoir are shown in figure 4.1 and it can be seen from the graph that most of the particles are on the size under range (0.1mm-1mm). Similarly figure 4.2 shows the particle size distribution graph of MMHPS draft tube in which the particles are on the size under range (0.01-0.1) mm. So, in the flow analysis the particle size of 0.1 mm was considered as an input parameter for sand.

Figure 4.1: Particle size distribution graph of MMHPS reservoir Sediment

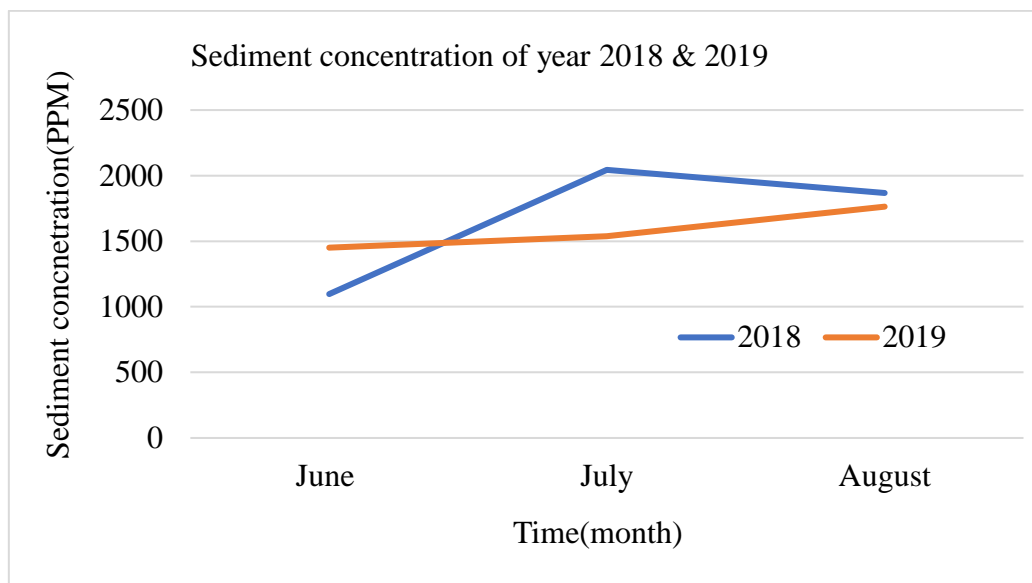
other months are not considered as there consist of lesser amount of sediment compared to these months. Figure 4.3 shows the sediment concentration data of year 2018 and 2019. The vertical axis shows the sediment concentration value and horizontal axis shows the time duration. It shows that the sediment concentration value in the year 2018 was relatively higher than that of 2019 in month July and august. It may be due to the flood occurring in the year 2018 as a result the sediment concentration increased. Sediment concentration is higher in the month July compared to June and august in both the year.

Figure 4.3: Sediment concentration of MMHPS in year 2018 and 2019

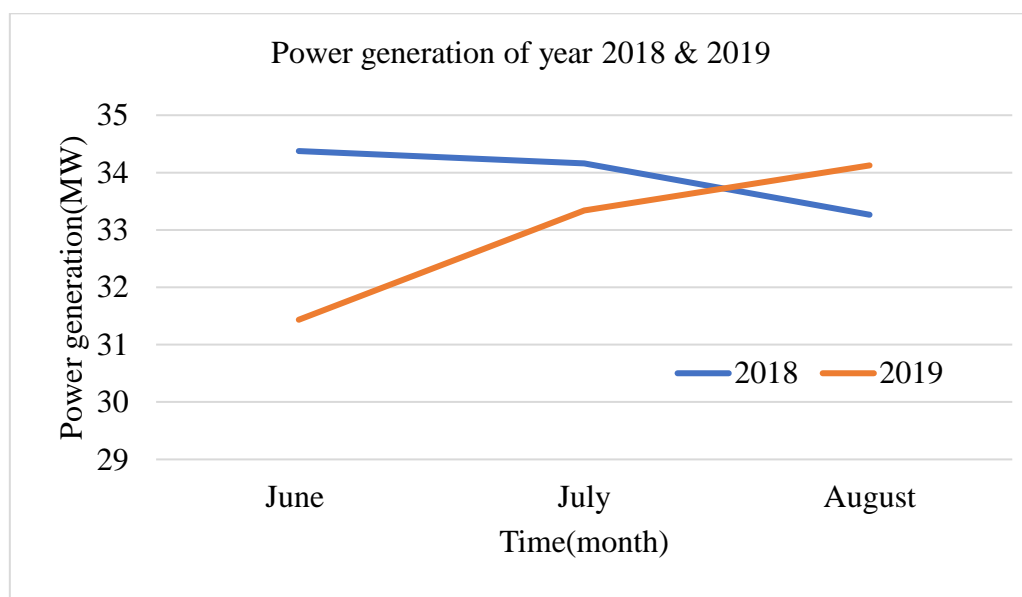
The power generated in the year 2018 and 2019 are shown in the figure 4.5. The data was secondary and are collected from the MMHPS control room. The vertical axis shows the power generated in MW and the horizontal values show the month June, July and August. The power generation of June in year 2019 was comparatively lower than that of 2018. It may be due to the low value of discharge or may be due to shutdown of turbine for maintenance. The power generation was maximum in June 2018.

Figure 4.5: Power generation data of MMHPS of year 2018 and 2019

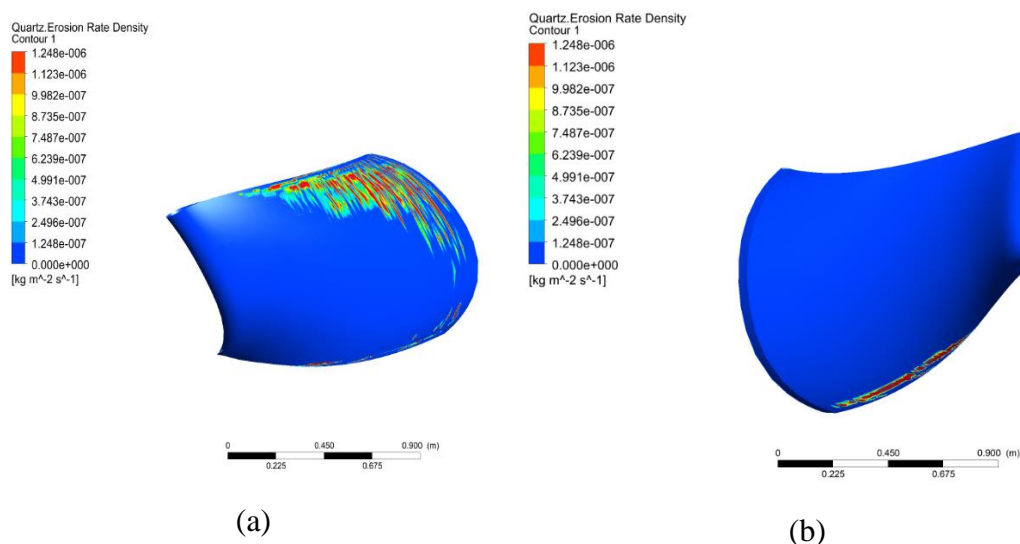
Figure 4.6 shows the Erosion rate density of the runner at the pressure and suction side respectively at full gate opening condition. The erosion pattern was obtained and the outlet side of the blade was found to be eroded highly. It may be due to the high velocity sand laden water flowing through trailing edge side of the blade and drop in pressure.

Figure 4. 6: Erosion pattern in Runner blade on (a) Pressure side (b) Suction side at full load condition

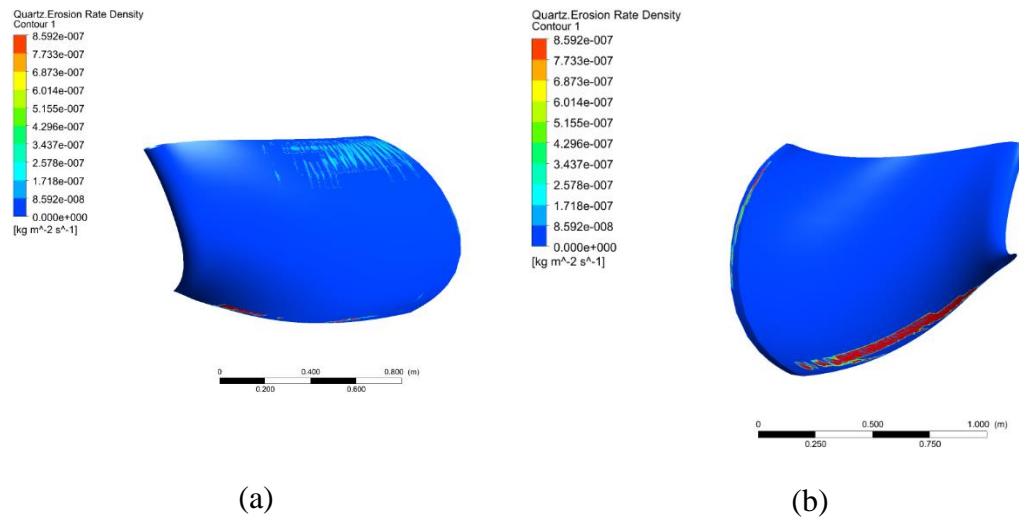
The erosion pattern of the runner blade at part load condition at the guide vane opening angle of 16 degrees at the pressure side and the suction side are shown in figure 4.8. The erosion pattern was found on the trailing edge side and was lesser than full load and BEP. It may be due to the lesser amount of flow in part load condition.

Figure 4. 8: Erosion pattern of Runner blade at (a) Pressure side (b) Suction side on part load condition

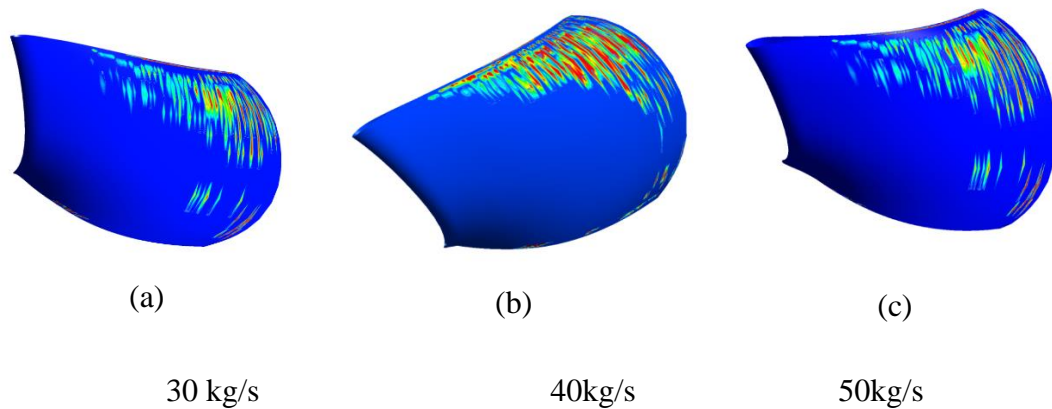
The sediment inflow rate was varied to see the change of erosion rate density. Different flow rate was given at BEP. There was no specific distinction in erosion pattern and the vulnerable region to erosion was almost the same for various inflow rates but erosion rate density increased. The erosion pattern obtained with varying sediment inflow rate are shown on figure 4.11 below.

Figure 4.11: Erosion pattern at a different mass inflow rate

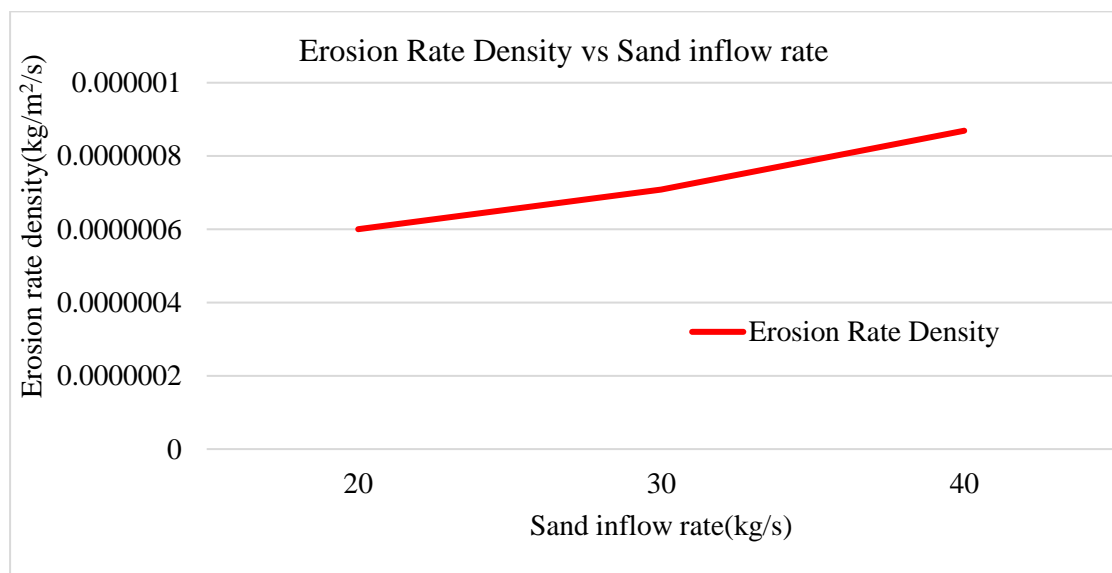
The variation of Erosion rate density with the sand inflow rate are as shown on figure 4.12. It was clear that with the increase in sand inflow rate, the sediment ERD goes on increasing.

Figure 4.12: Erosion rate density vs Sand inflow rate

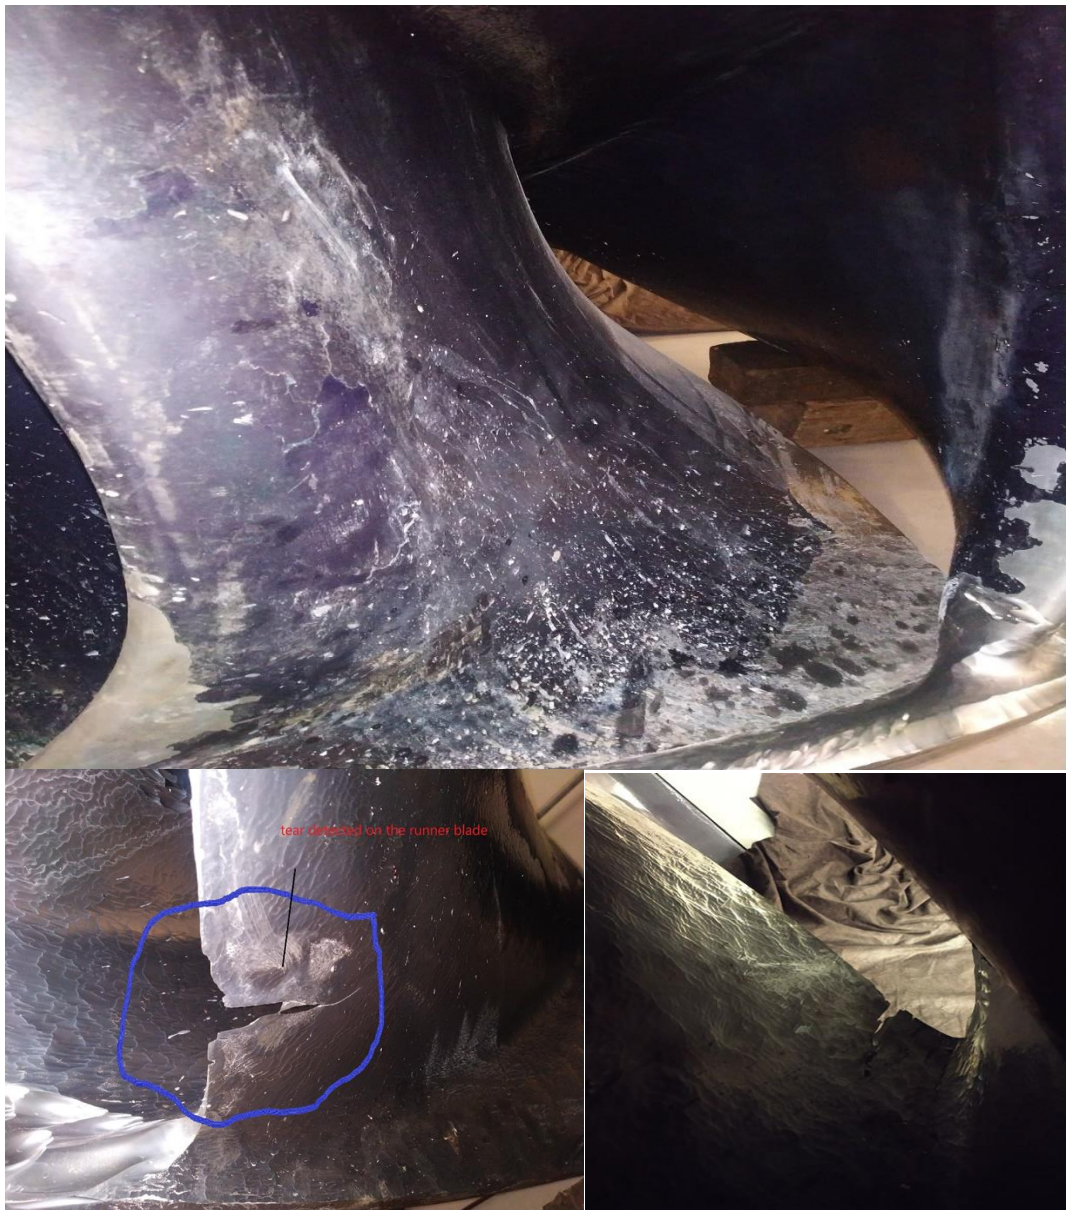
There was a huge amount of coating loss and reduction in the blade thickness found on the dismantled runner. It was due to the reason that the profile of the runner was curved shaped at the outlet. As a result, there was a direct impulse action of water in the blade as well as water containing sediment flows through high velocity at the outlet and also there was a huge amount of drop in pressure. Consequently, there was the possibility of the problem of cavitation also. The loss of coatings and the materials at the outlet is shown in figure 4.16. It shows there was a loss of coatings and materials of runner blade and tears detected in the outlet of the runner blade.

Figure 4. 16: Erosion pattern and tear in the trailing edge

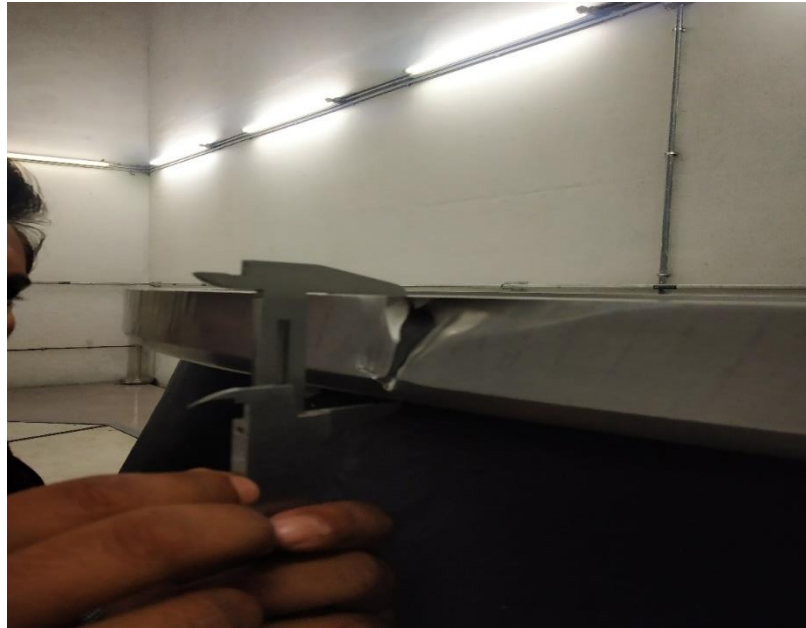
Figure A.1: Measurement of erosion outside Crown of runner

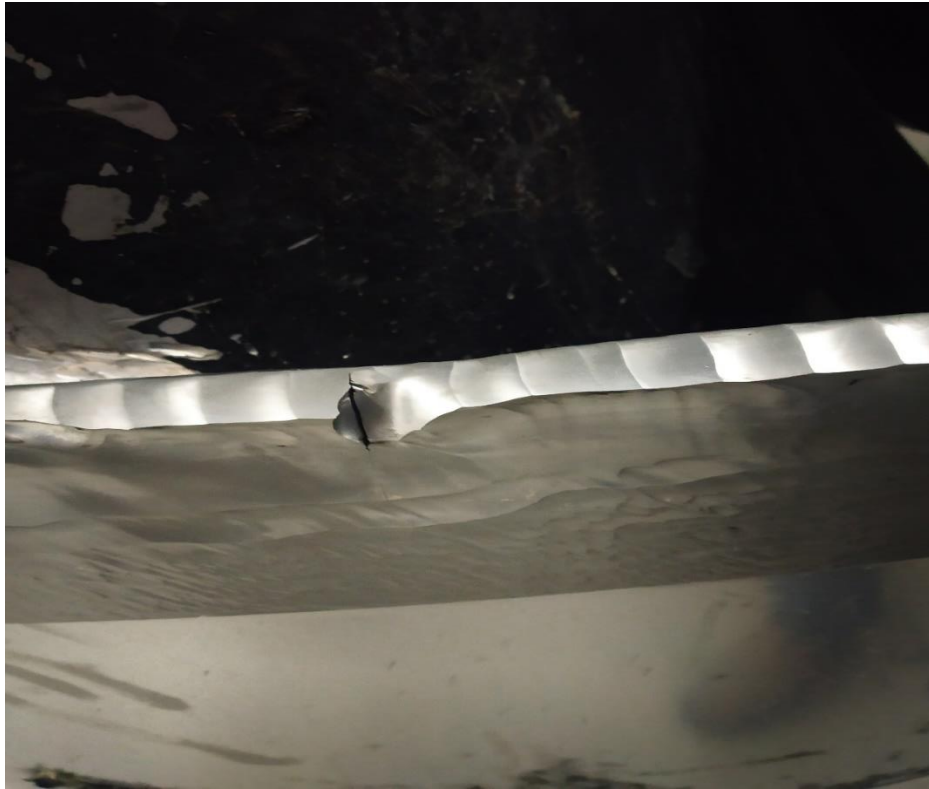
Figure A.3: Erosion detected outside band

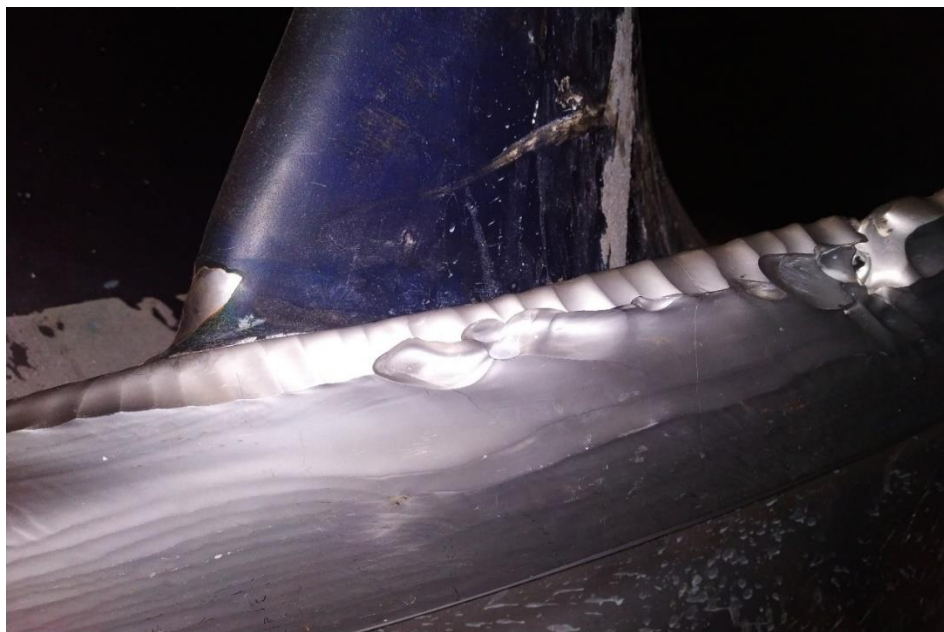
Figure A.4: Erosion detected in the leading edge and band side

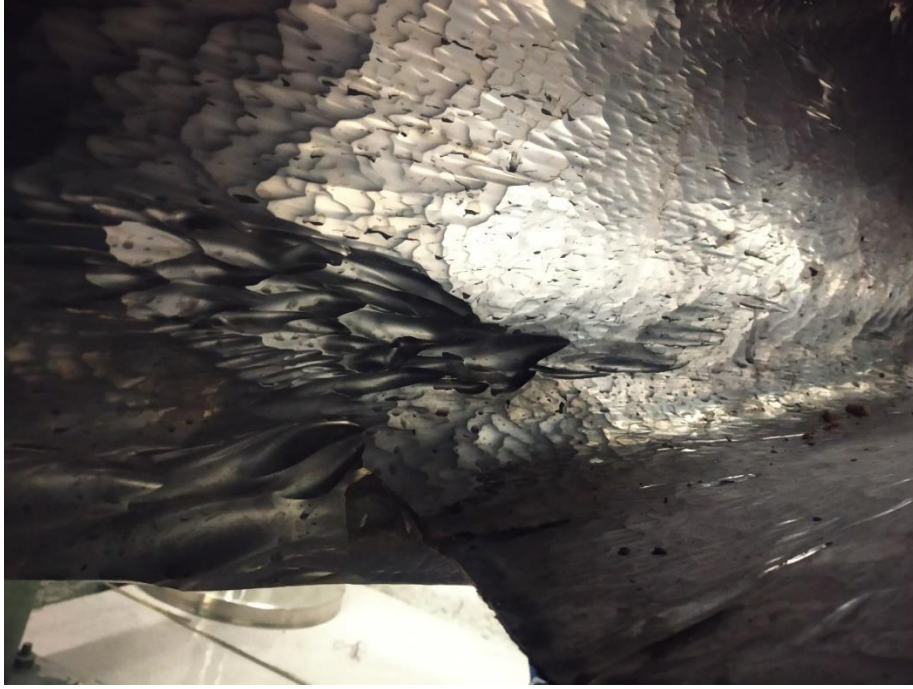
Figure A.5: Erosion detected in joining of shroud and blade (inlet side of Shroud)

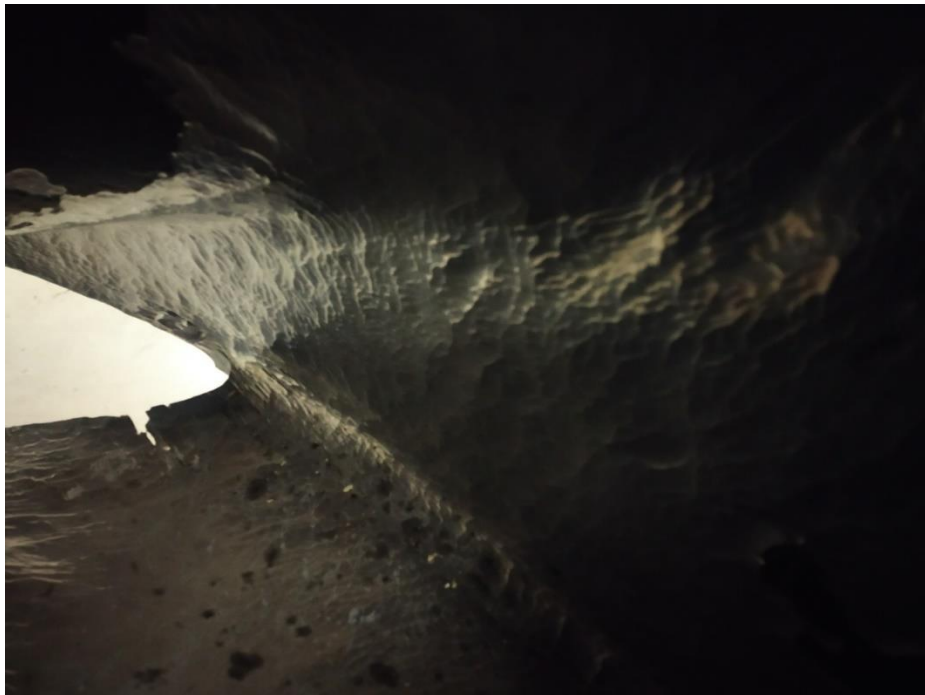
Figure A.6: Tear detected in the outlet side of runner blade

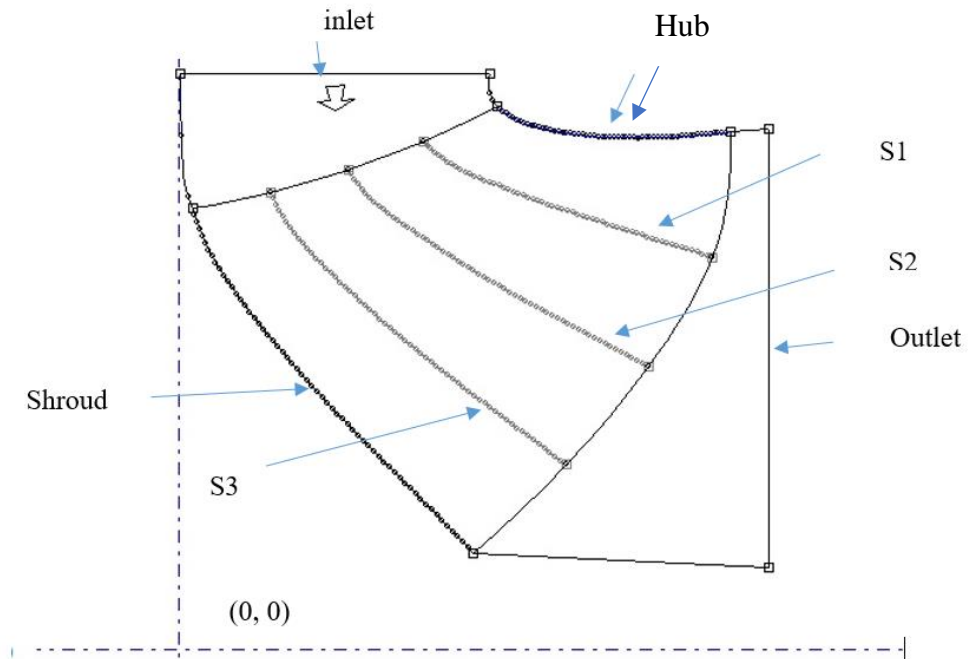
Figure B.1: Meridional view of MMHPS runner in BladeGen

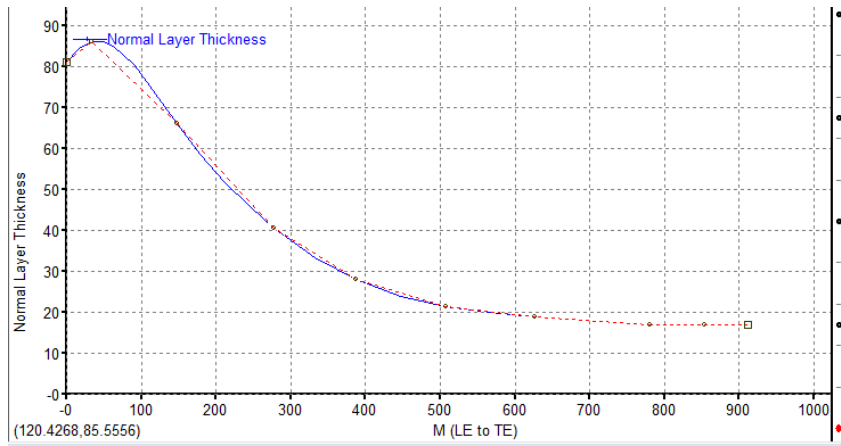
Figure B.3: Blade thickness curve in BladeGen
