RIVER DYNAMICS AND RESTORATION
DESIGN OF THE NAKHU KHOLA

A DISSERTATION

THE CENTRAL DEPARTMENT OF GEOLOGY
INSTITUTE OF SCIENCE AND TECHNOLOGY

NOVEMBER, 2010

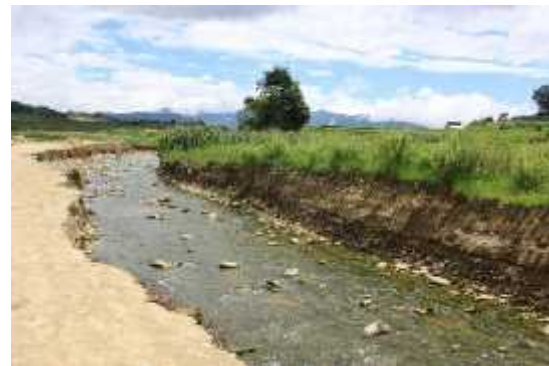
Parallel flow erosion: Parallel flow erosion is detachment of grain from the bank face by flow along the bank. High flow velocity during bankfull stage and flooding scour the banks as well as channel bed. Undercutting of the toe/lower bank relative to the bank top is common in this type of erosion. In the study area, bank and bed erosion by scouring due to parallel flow is very common due to unconsolidated muddy gravel as bank material and lack of natural riparian vegetation zone. At upstream segment near Nallu area, scouring is also triggered by gravel mining from river channel of the Nallu Khola (Figure 9.5).

Figure 9.5: Parallel erosion at the right bank at the Nakhu Khola

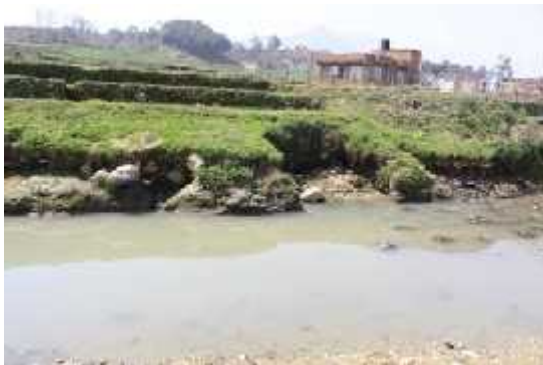
Impinging flow erosion: The impinging flow erosion is detachment and removal of grains or aggregate by a flow attacking a bank at steep angle. Impinging flow is caused by deflection of flow and striking of bank, meander bends where radius of curvature of outer bank is less than that of the channel centerline. It is observed in the Nakhu Khola wherein stream obstruction deflects and disturbs the orderly flow of water. Channelization by construction gabion walls at upstream also caused scouring at downstream (Figure 9.6).

Figure 9.6: Impinging erosion at the left bank of the Nakhu Khola near Nakhu Bazar

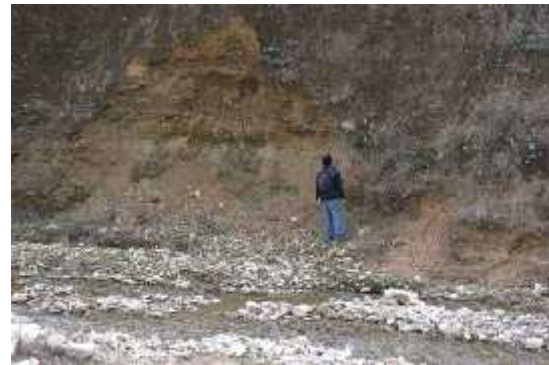
Figure 9.7: Earth slump at the left bank of Nallu Khola near Nallu VDC

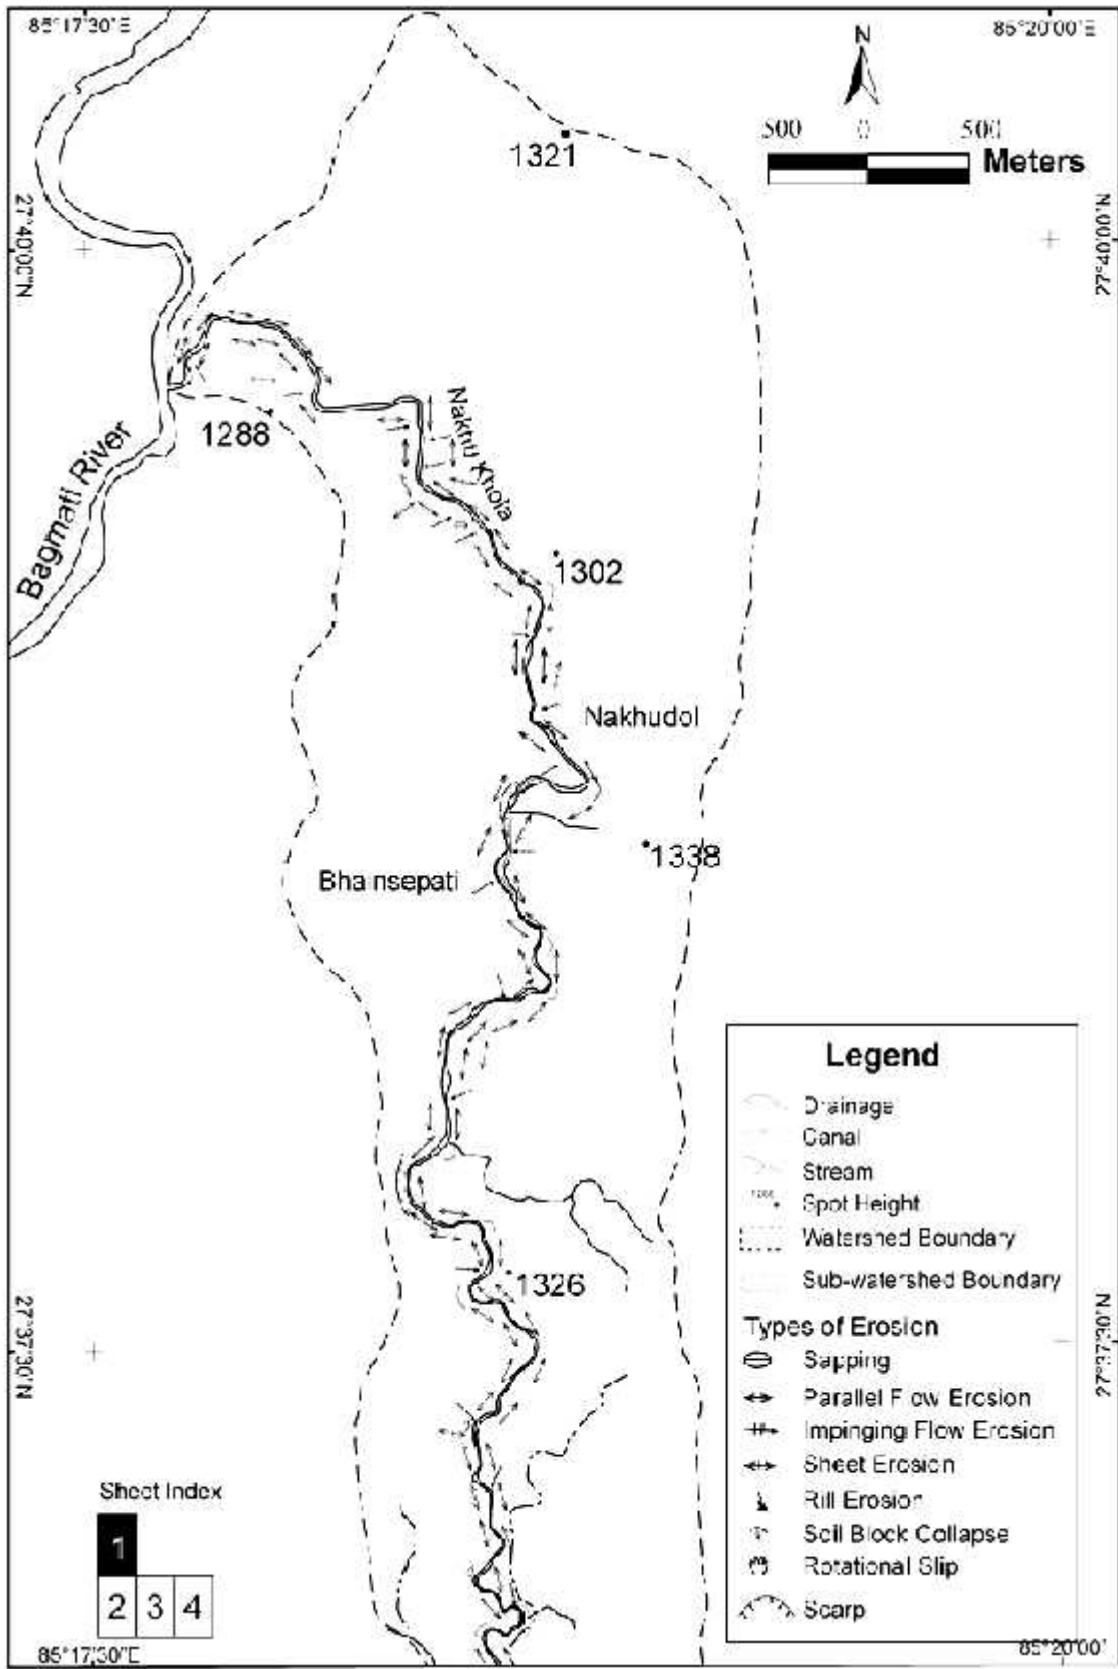
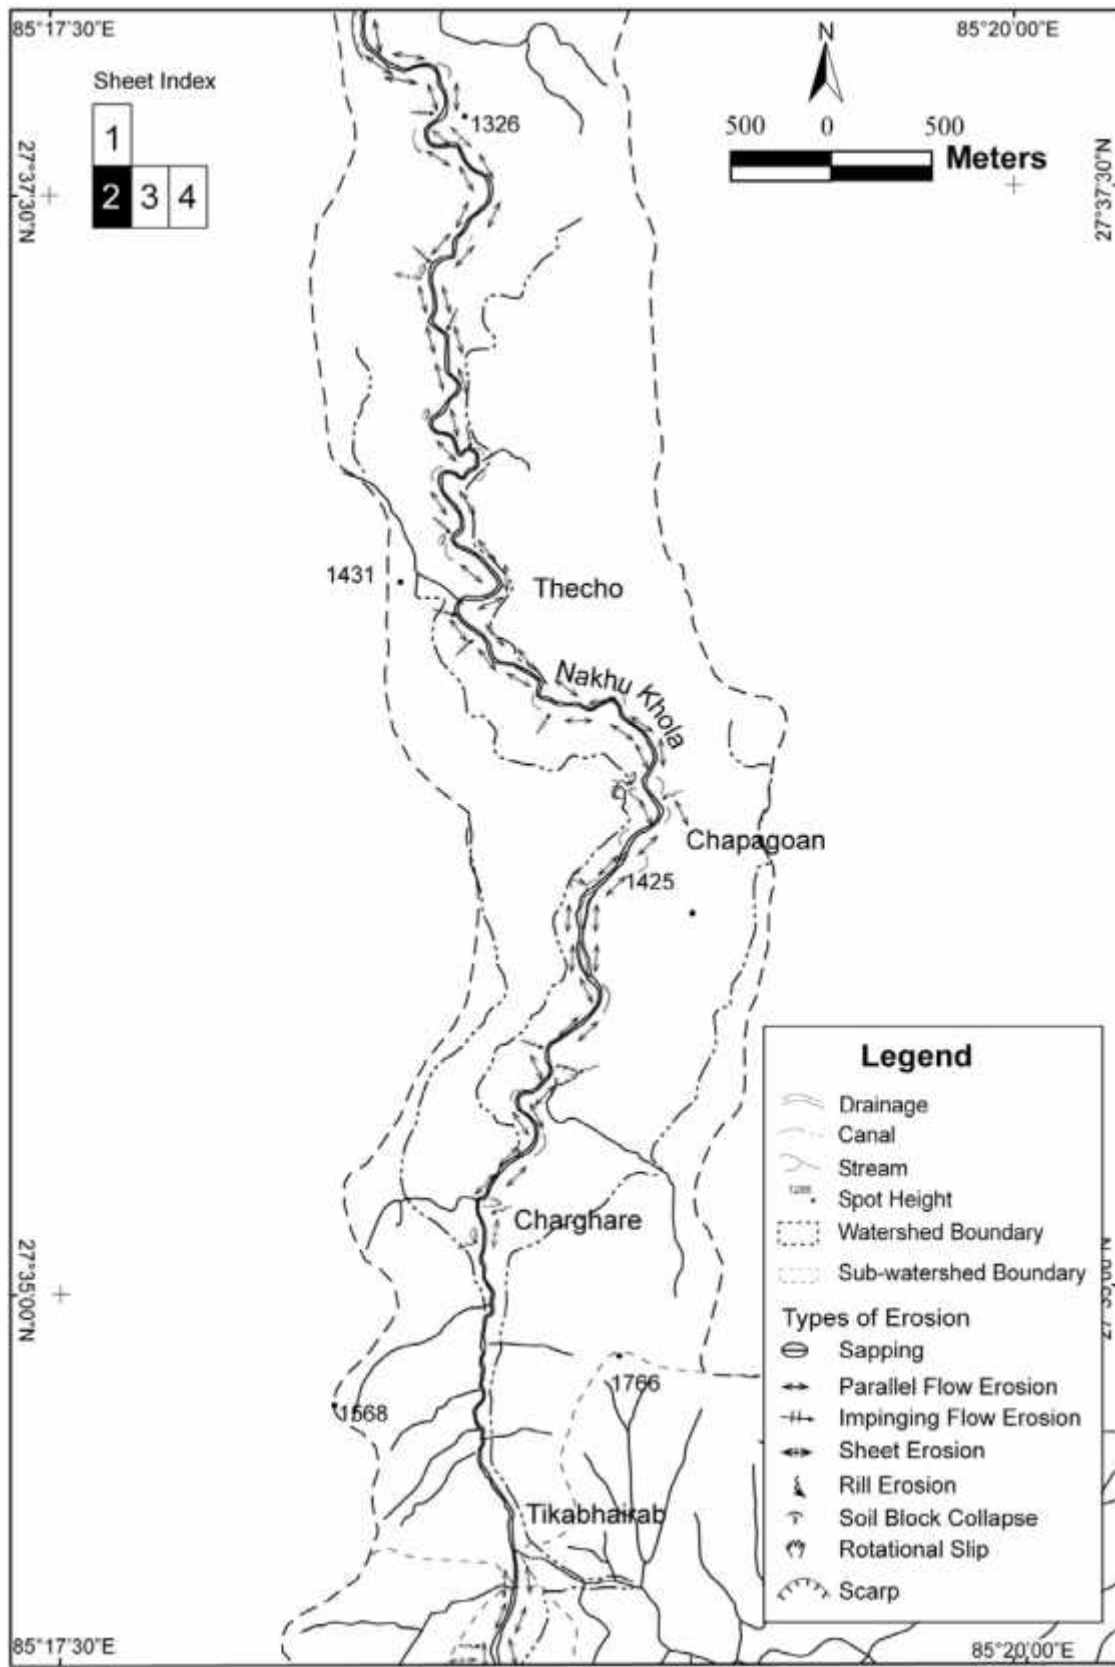
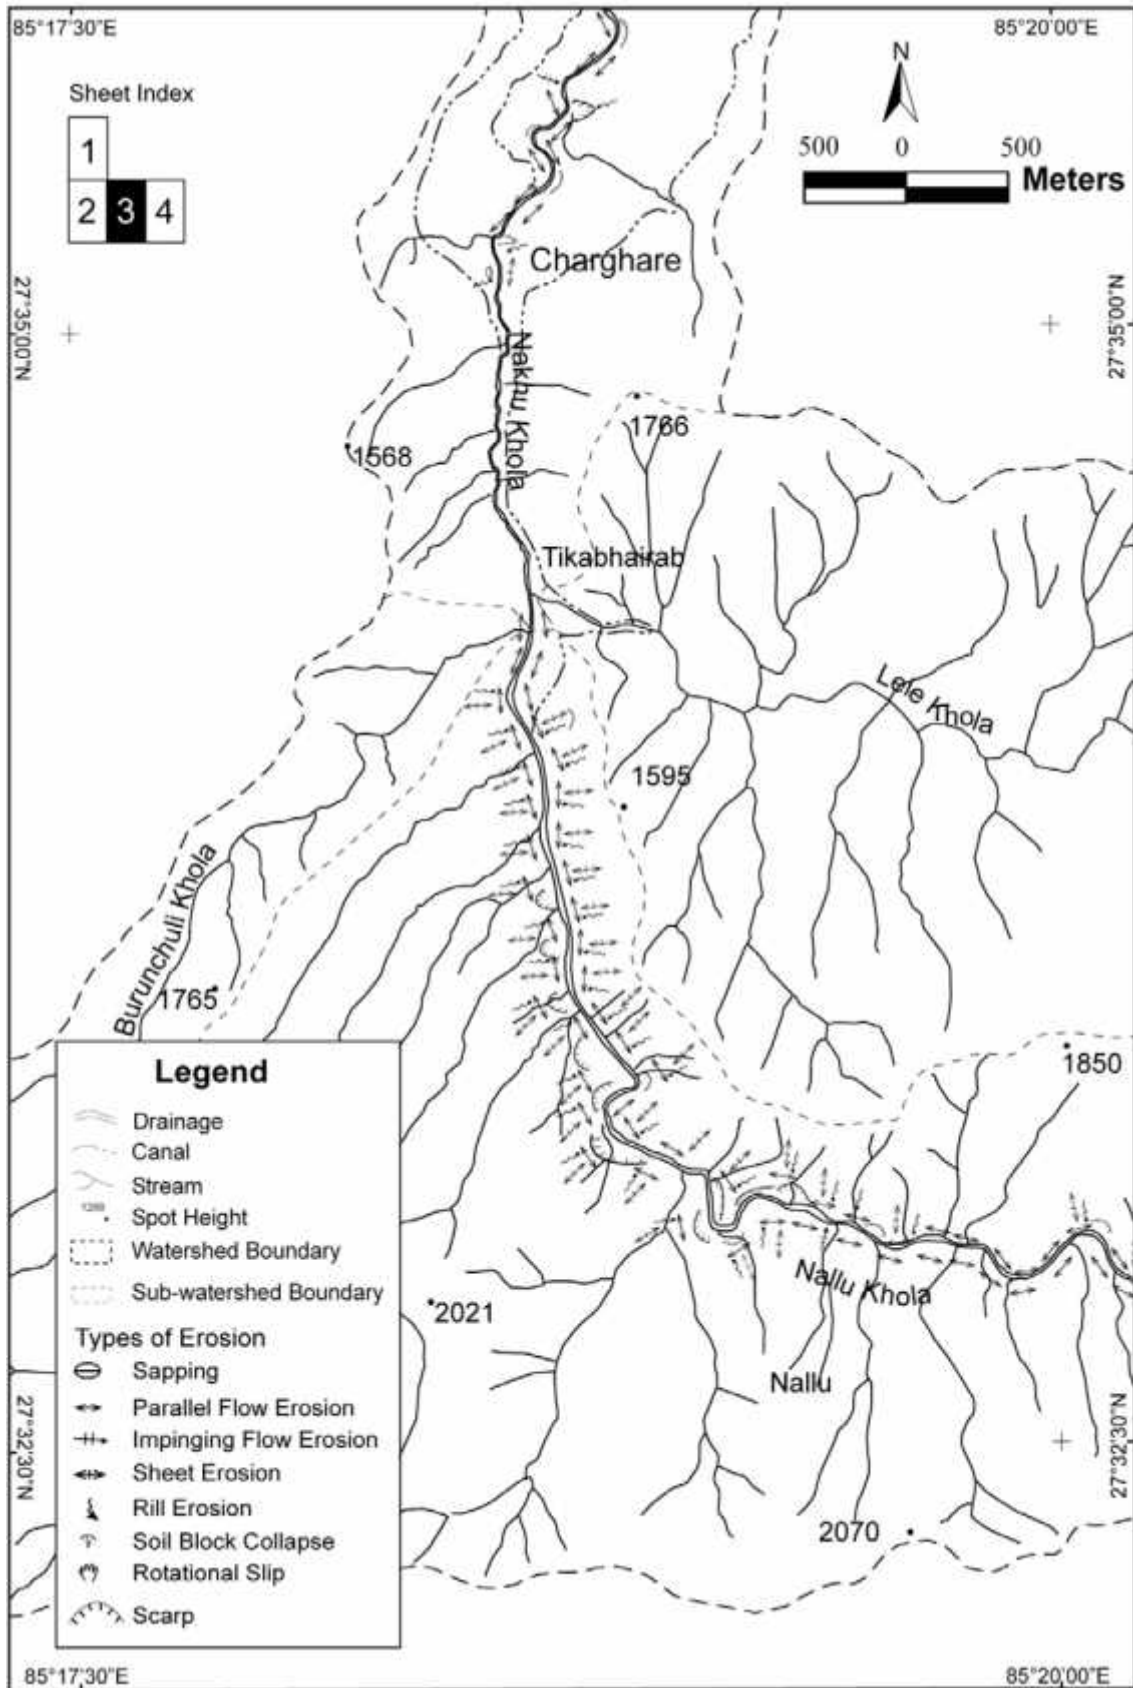
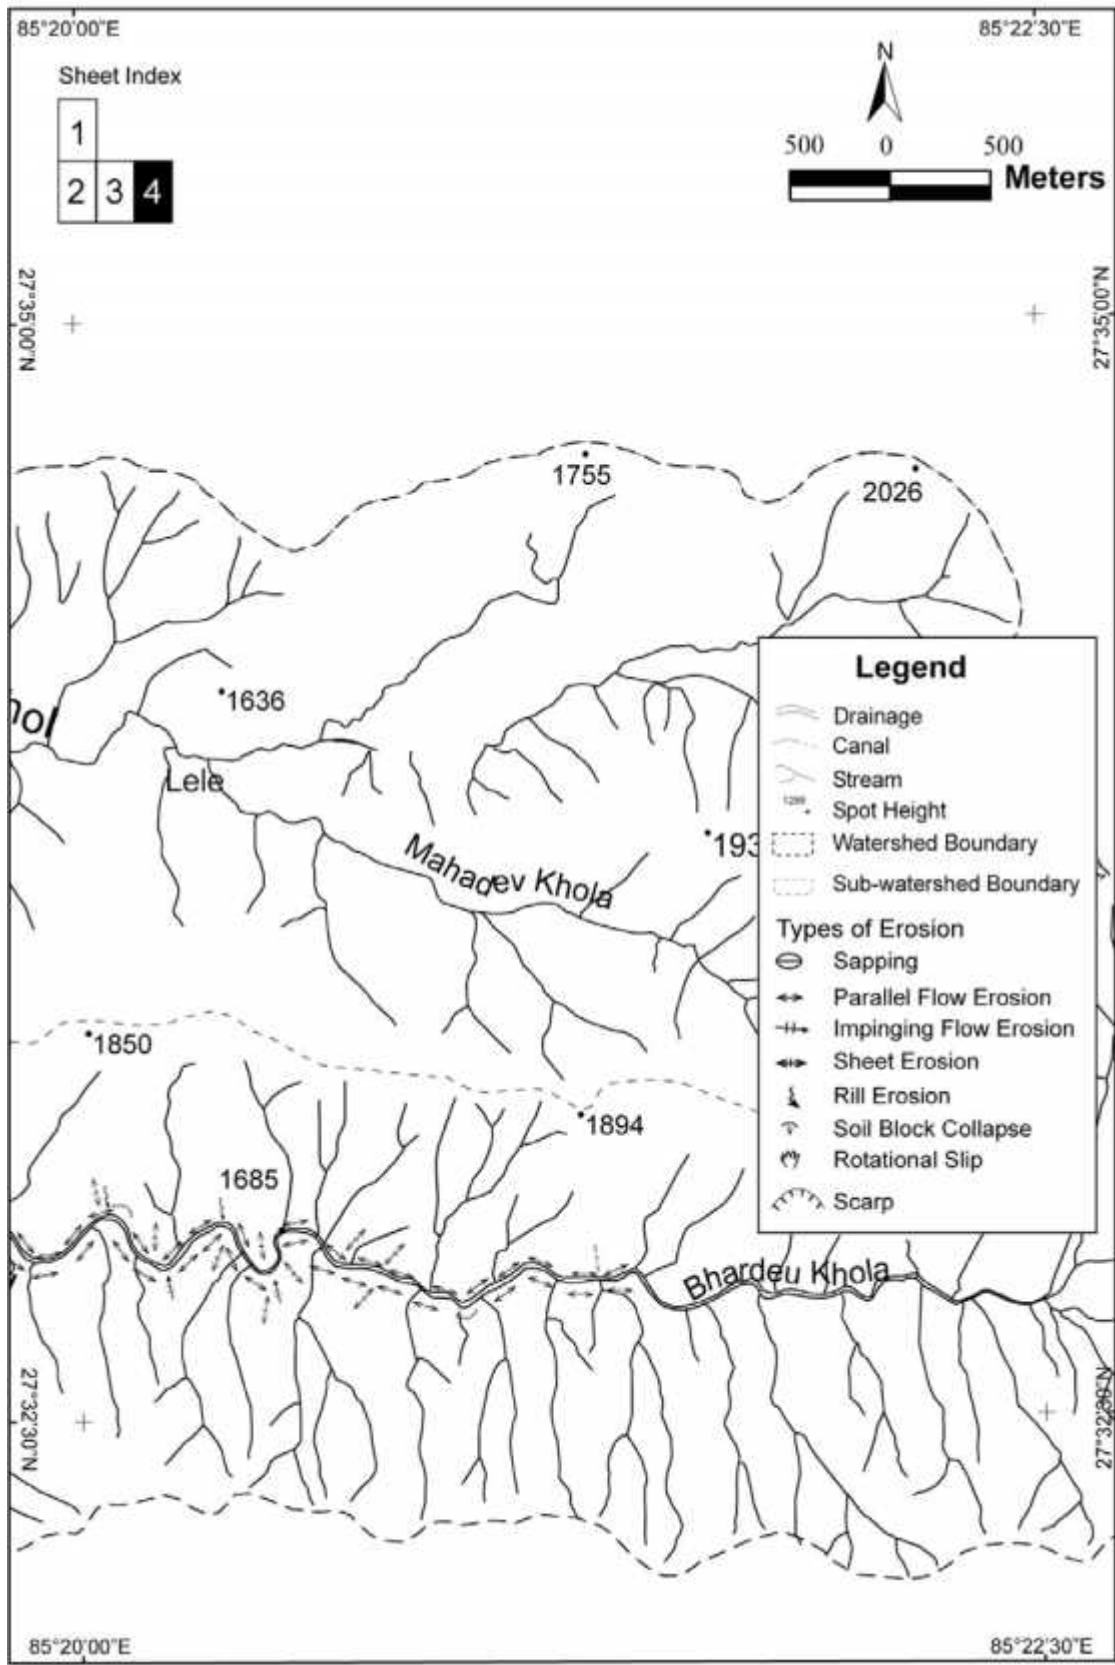
Figure 9.8: a, b, c, and d Erosion process map along the Nakhu Khola

Rill and gully erosion, sheet erosion, scouring, impinging, parallel flow erosion, slumping, are the major erosional processes observed along the Nakhu Khola. Their distribution (Figure 9.8) and description is given below.

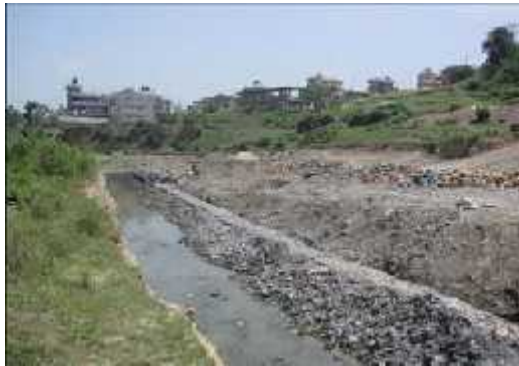
along bank erosion problem is triggered and in order to control erosion structures such as gabion walls are constructed (Figure 10.1). These structures channelize the river and hence cause river instability.

Figure 10.1: Bank encroachment and channelization for settlement

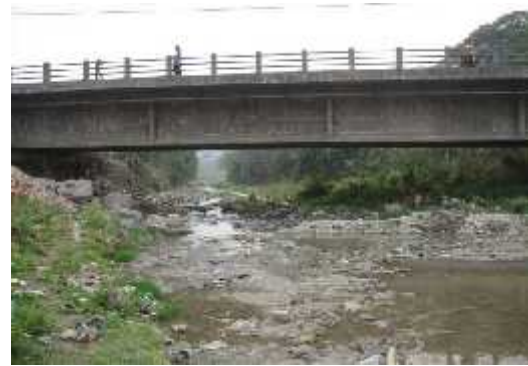
River is used as the easy means of disposing of solid waste and sewer in the cities. These are the potential factor for decreasing water quality (Annex VIII). This is one of the major disturbances in the downstream part of the Nakhu Khola, along whole Nakhu Segment (Figure 10.2).

Figure 10.2: Sewage and solid waste dumped in river channel

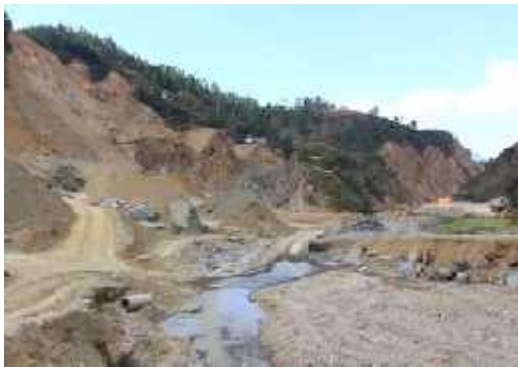
Riparian vegetation is referred to those plants that grow in the stream bank. Riparian plants play an important role in stream ecosystems by providing shade, regulating microclimates, stabilizing stream banks, controlling sediment inputs from surface erosion, and trapping excess nutrient and pollutants helping keep the water clean. In the Nakhu Khola removal of riparian vegetation for cultivation, quarry and settlement is the major problem along the whole river channel(Figure 10.3).

Figure 10.3: Vegetation destroyed and river landscape changed in quarry area

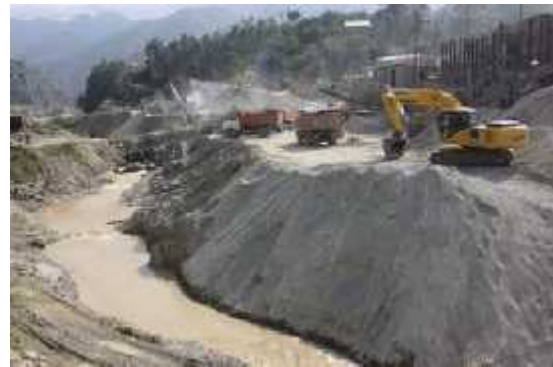
Figure 10.4: Sediments from quarry dumped along river channel and obstruction to river flow
